航空事故調査報告書

キャセイ・パシフィック航空会社所属
ロッキード式L1011-385-1型VR-HOC

新東京国際空港

平成2年3月24日

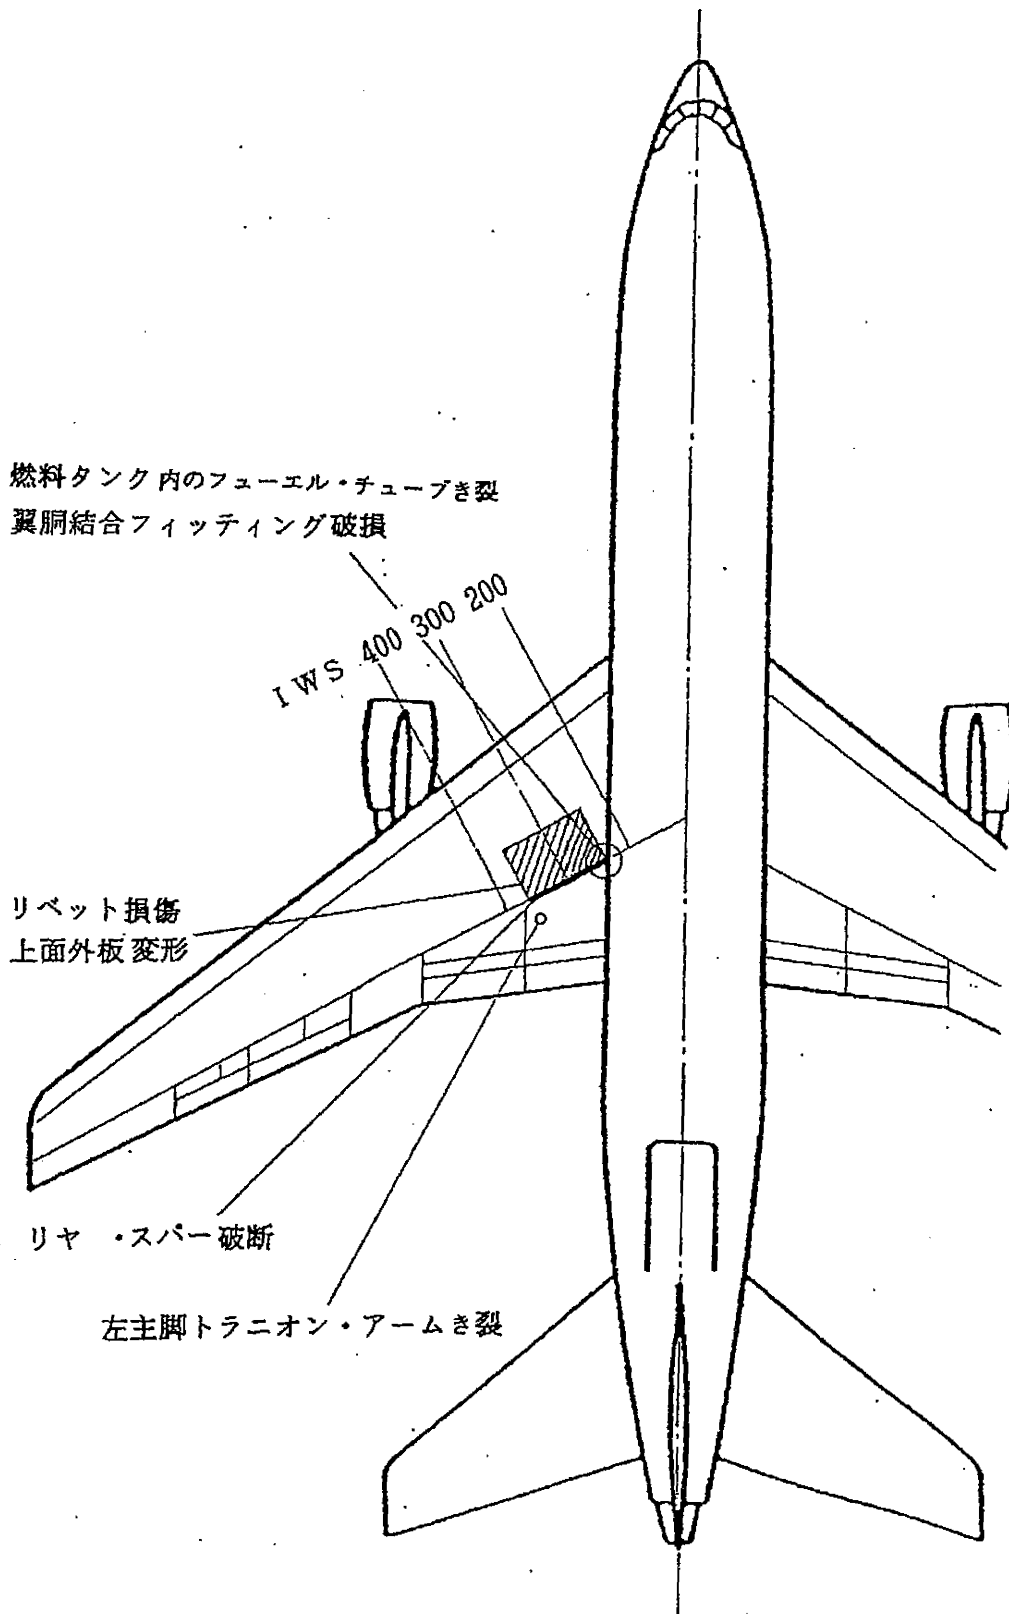
付図 4 機体損傷状況

左主翼翼根部リヤ・スパー及びその周辺部が破損し、第1燃料タンクから燃料が流失した(付図4及び5、写真1及び2参照)。

(1) IWS(インナ・ウイング・ステーション)241における左主翼リヤ・スパー・ウェブの破断

左主翼リヤ・スパー・ウェブは、IWS241に取り付けられたスティフナのリベット・ホールに沿って垂直に剪断破断していた。アッパ・スパー・キャップはこれよりわずかに翼端側に寄つた、アッパ・アウトボード・フィッティングの先端部分で破断し、付近の上面外板に変形を生じていた。ロワー・スパー・キャップはロワー・アウトボード・フィッティングの先端部分で上向きに座屈していた。

左主翼リヤ・スパー・ウェブは、IWS 300 を中心に座屈して後方へ突出変形し、下端から上方約 70 パーセントの高さまでき裂の進展・分岐が見られた。ウェブの下端のき裂から約 15 センチメートル翼端側において、ロー・スパー・キャップのパーティカル・タンクにもき裂が入り、そこからロー・スパー・キャップのコーナに沿って IWS 346 までき裂が伸びていた。アッパ・スパー・キャップは、スパー・ウェブのき裂位置よりやや胴体側の IWS 290 付近から IWS 346 ま でスパー・キャップのコーナに沿ってき裂を生じ、アッパ・フランジ側は上面外板 とともに約 7 センチメートル上方に盛り上がっていた。

アッパ及びロー・スパー・キャップとリヤ・スパー・ウェブを結合するリベットが、リヤ・スパー・ウェブの座屈部分（上記（2））と付け根近くの剪断破断部分（上記（1））との間で剪断破断していた。

左主翼リヤ・スパーのアッパ・フォワード・インボード・フィッティング及びアッパ・アウト・ボード・フィッティングにき裂が生じていた。

左主翼上面外板のリヤ・スパーとフロント・スパーの間で、翼付け根から IWS 346 までの範囲でリベット頭部が抜けたり、浮いたりする損傷があった。

第 1 燃料タンクの一部を構成している後部リヤ・スパーのき裂部分からタンク内の燃料が流出した。推定流出量は約 7,000 ポンドである。

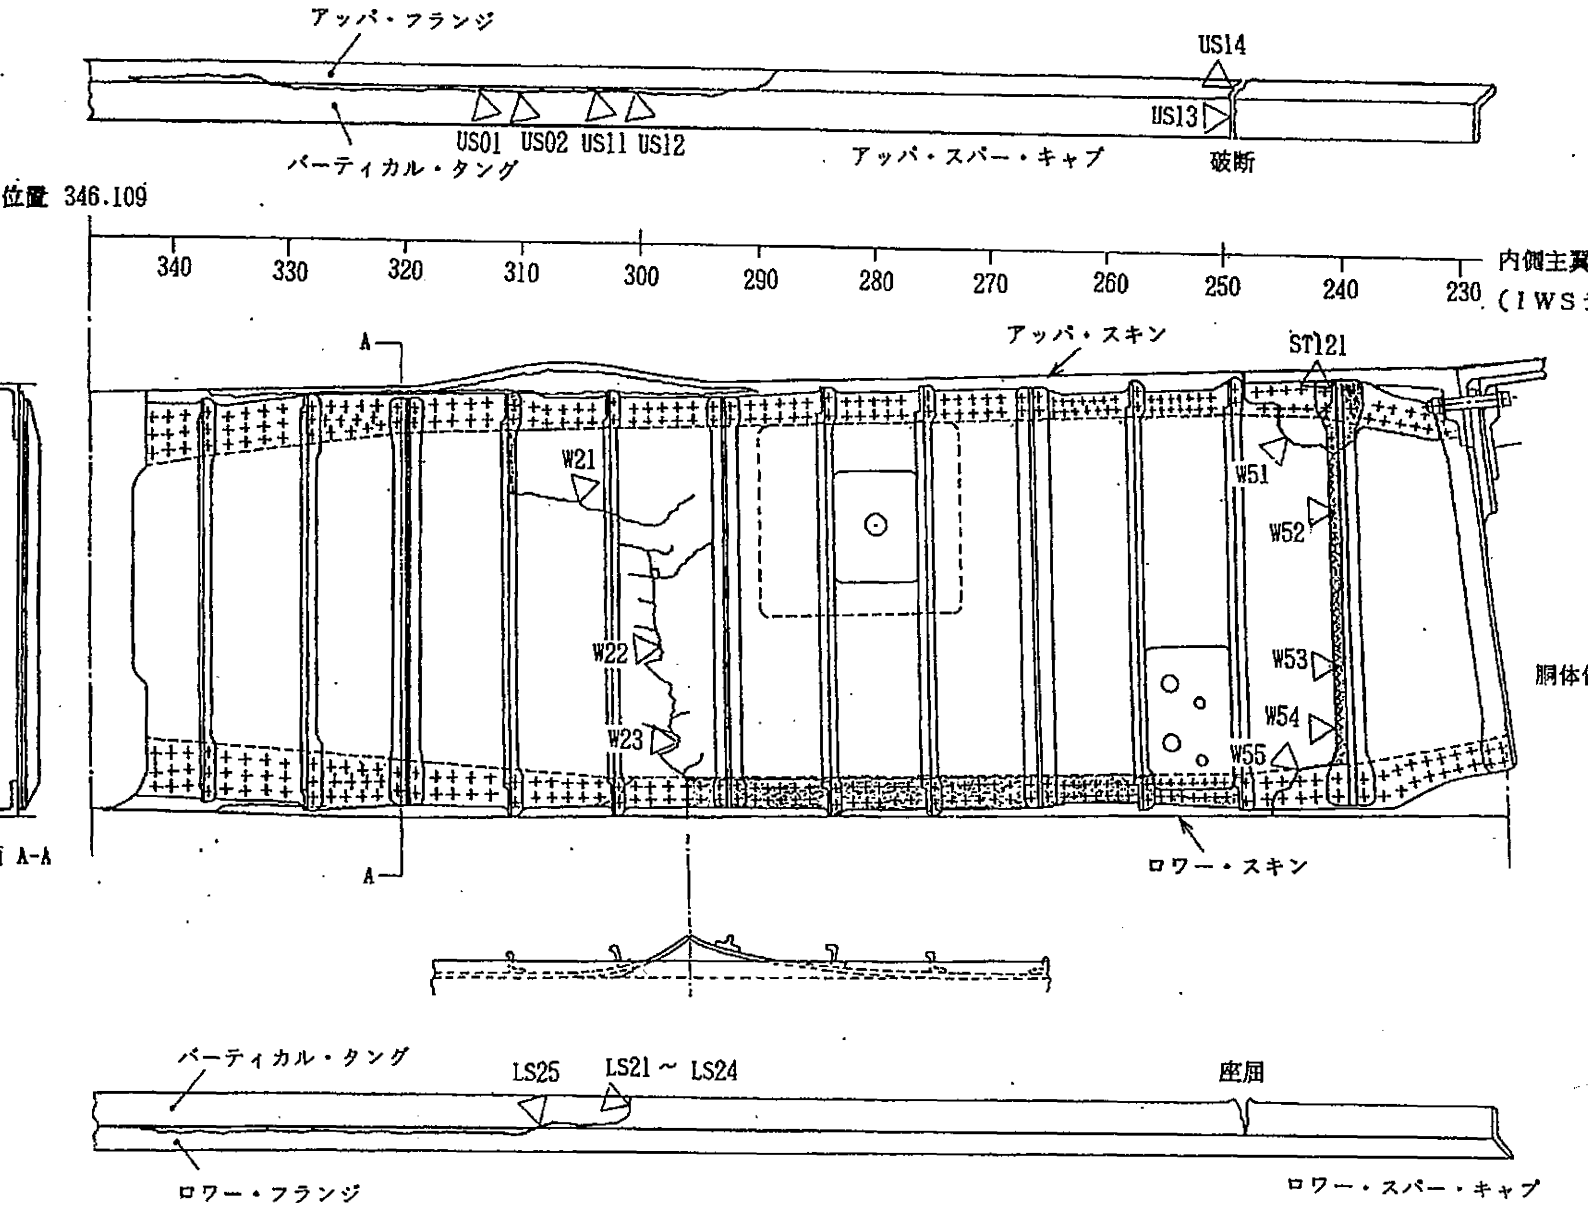
付図 5 左主翼リヤ・スパー付け根付近の損傷（後方より見た図）

すなわち、事故機は異常に大きな沈下速度で左主脚から接地して、その結果生じた過大な接地荷重により左主翼リヤ・スパー・ウェブが翼付け根近くでせん断破壊し、また、アッパ及びロワー・スパー・キャップとリヤ・スパー・ウェブを結合するリベットも IWS 300 付近までせん断破壊した。その結果、左主翼後部付け根付近の剛性は大幅に低下して大変形を許し、スパー・キャップ及びフィッティングの損傷、リヤ・スパー・ウェブの座屈、上面外板の変形及びリベット頭部の損傷等を生じた。

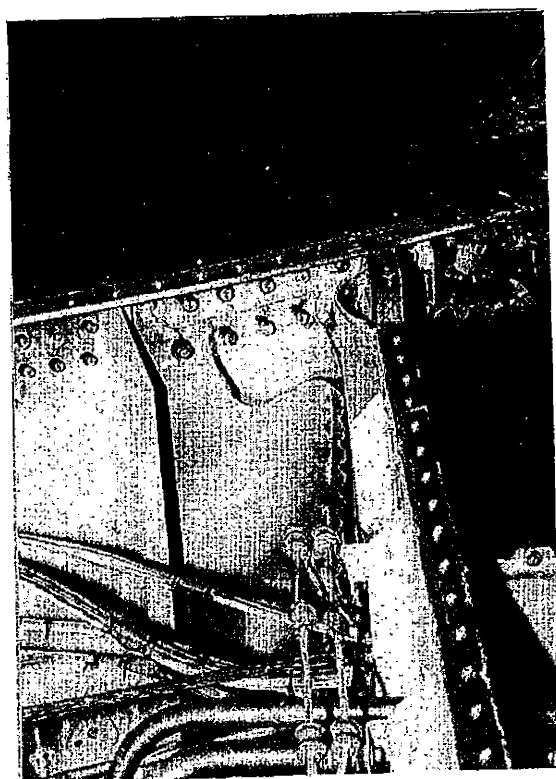
写真 2 左主翼リヤ・スパーの損傷状況(IWS241付近)

リヤ・スパー・ウェブについてはリベット孔に沿って、せん断及び引張荷重による静的破壊によって破面が形成されたものと認められる。リベット孔縁に半径2ミリ程度の扇状の疲労破面が1箇所認められた以外はすべて静的破壊に特有のディンプル状破面が支配的であった。上記の疲労破面は今回の静的破壊の起点ではなかったと認められた。

同部のスティフナは上部左のアップ・スパー・キャップへの取付部付近に破損が認められたが、せん断及び引張荷重による静的破壊によって破面が形成されたものと認められた。

同部のアップ・スパー・キャップ破断部についても同様の破面であることが認められた。

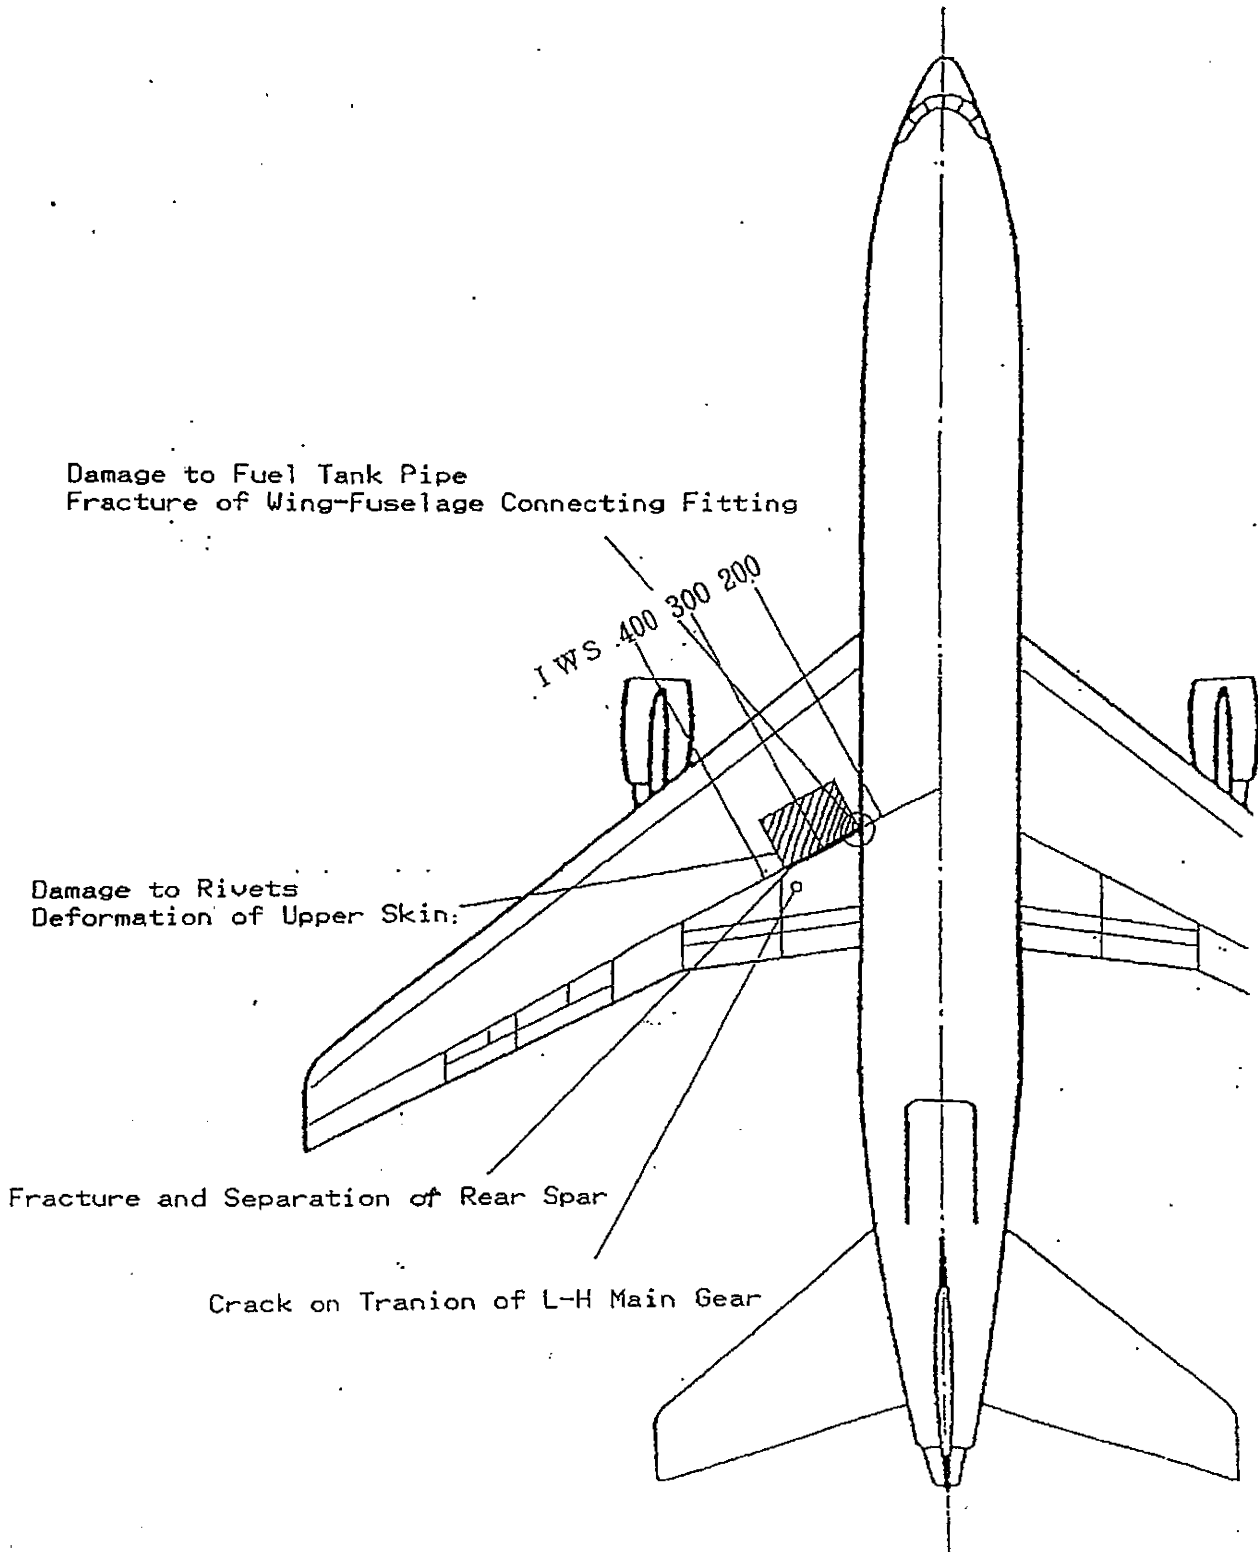
Attached Fig. 4 Damage to Airframe

The rear spar of the left wing root and its vicinity were fractured and fuel leaked out from No.1 fuel tank. (see Attached Figs. 4 and 5, Photos. 1 and 2)

(1) Fracture of the left wing rear spar web at IWS (Inner Wing Station) 241

The left wing rear spar web was shear-fractured vertically along rivet holes of the stiffener attached to IWS 241. By this fracture the upper spar cap was fractured at the tip of the upper outboard fitting located slightly nearer to the wing tip, causing a deformation of the upper skin in the vicinity. The lower spar cap was buckled upward at the tip of the lower outboard fitting.

The left wing rear spar web was buckled making its center at IWS 300, projecting backward, and a crack was found propagated and branched from its lower tip upward to its 70 % height. On the wing tip side, about 15 cm from the crack at the lower tip of the web, another crack was also initiated on the vertical tang of the lower spar cap, from where the crack extended up to IWS 346 along the corner of the lower spar cap. As to the upper spar cap, a crack was initiated at the vicinity of IWS 290, somewhat nearer to the fuselage side than the crack of the spar web, up to IWS 346 along the corner of the spar cap, and the upper flange side was heaved about 7 cm upward together with the upper skin.

Rivets connecting the upper and the lower spar cap with the rear spar web were shear-fractured between the buckled portion of the rear spar web (refer to (2) above) and the shear-fractured portion near the root portion (refer (1) above)

Cracks were observed on the upper forward inboard fitting as well as on upper outboard fitting of the left wing rear spar.

Rivets were damaged, with their head coming off or floated, on the upper skin of the left wing between the rear spar and the front spar with a range from the wing root to IWS 346.

Fuel within the tank leaked out from the cracks at the aft rear spar which constitutes part of No.1 fuel tank. The estimated leakage is approximately 7,000 pounds.

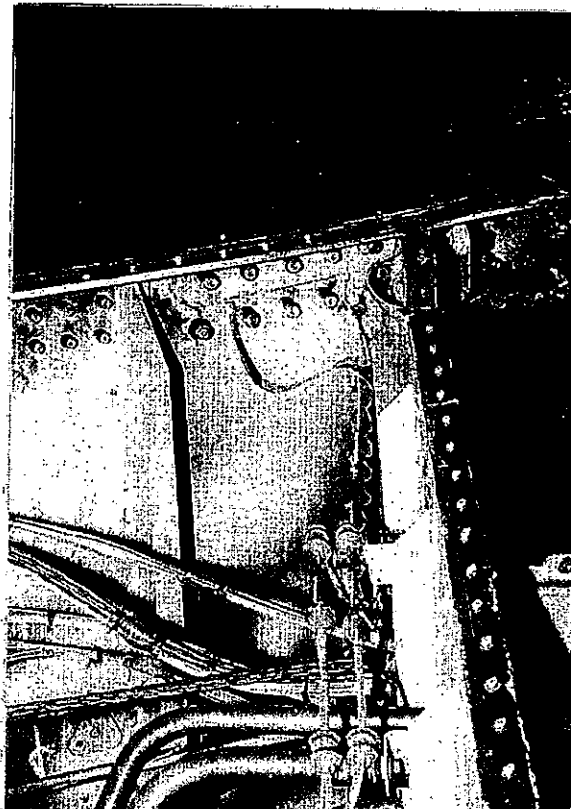
Photograph 2

Damage: Wing Rear Spar (L/H) (near IWS241)
