Chapter 2 Railway accident and serious incident investigation

1. Summary of major investigation report

Railway 1 During emergency braking of a freight train, one of the container wagons derailed by the coupling force from the following wagons.
(Derailment, in the Suita signal station, the Tokaido Line, Japan Freight Railway Company)

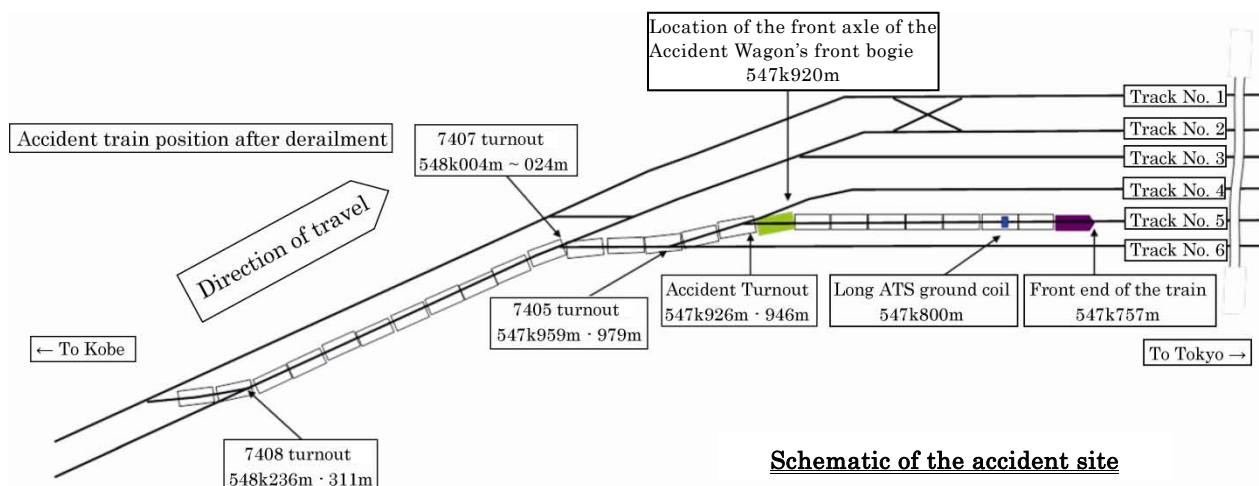
After the train stopped, it was found that all four wheels of the two-axle front bogie of the 8th wagon (the Accident Wagon) had derailed to the left. The driver was not injured.

Schematic of the accident site

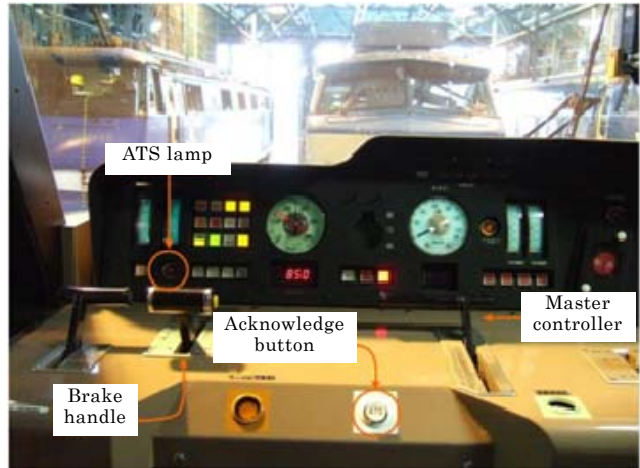
The ATS onboard unit is designed in order that the emergency brake will not operate and the train can continue to travel if the driver took “acknowledgement action” within 5 seconds after the ATS acoustic alarm. In this case, if the overlap time when the braking notch is in selected position and acknowledge button is in pressed position, is too short, relay excitation will be insufficient. As a result, the relay ACR (the ACR), which is designed to detect the driver's “acknowledgement action,” will operate instantaneously, failing to activate the relay UR, which prohibits the operation of the emergency brake. As to the reason why the emergency brake operated, it is probable that while the driver took “acknowledgement action”, the overlap time was too short. It is somewhat likely that a contributing factor is that the drivers' operating standards set forth by the Company do not specify the appropriate sequence for operating the braking notch selection and the acknowledge button when the acoustic alarm is ringing. It is therefore necessary that the drivers' operating standards should be reviewed to ensure that the implementing standards are strictly followed, and to ensure a sufficient overlap time between selecting a braking notch and pressing the acknowledge button. In addition, the logic circuit should be revised so that even if the overlap time is too short, the emergency braking will not be activated immediately, and the driver can try pressing the acknowledge button again within 5 seconds after the ATS acoustic alarm.

Controllers in the cab of the accident locomotive

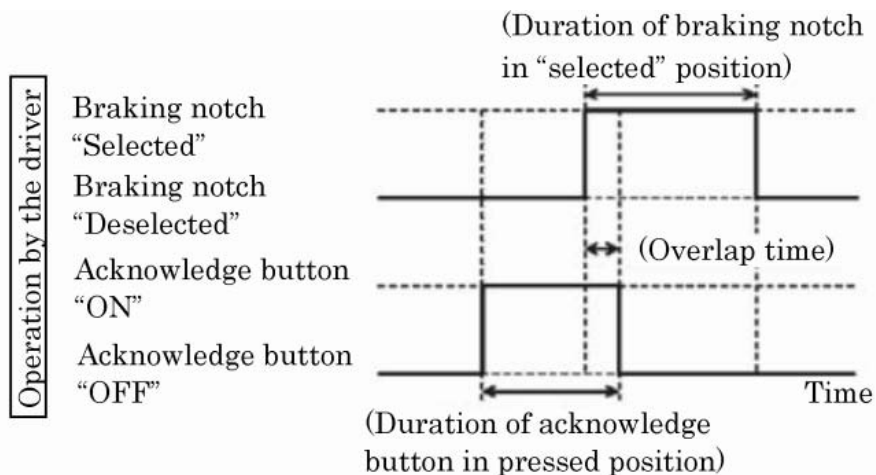
Overlap time

It is probable that the overlap time for “acknowledgement action” was too short to prevent the emergency braking. As a contributing factor to this, it is somewhat likely that the “acknowledgement action” that the driver took based on the drivers' operating standards was not in line with the implementing standards. Therefore, it is necessary that the drivers' operating standards be revised accordingly and the Company drivers be thoroughly trained on ATS mechanism and the correct procedure to secure sufficient overlap time. In addition, the logic circuit should be revised so that, even if the overlap time is too short, the emergency brake will not activate immediately, and the driver can try pressing the acknowledge button again within 5 seconds. It is probable that longitudinal force applied by trailing wagons, a typical characteristic of the automatic air brake system equipped to the train set, played a role in the derailment. It is therefore desirable that the ongoing work to replace by the automatic electromagnetic air brake equipment to get a no-time-lag braking force on all wagons be given a further push.

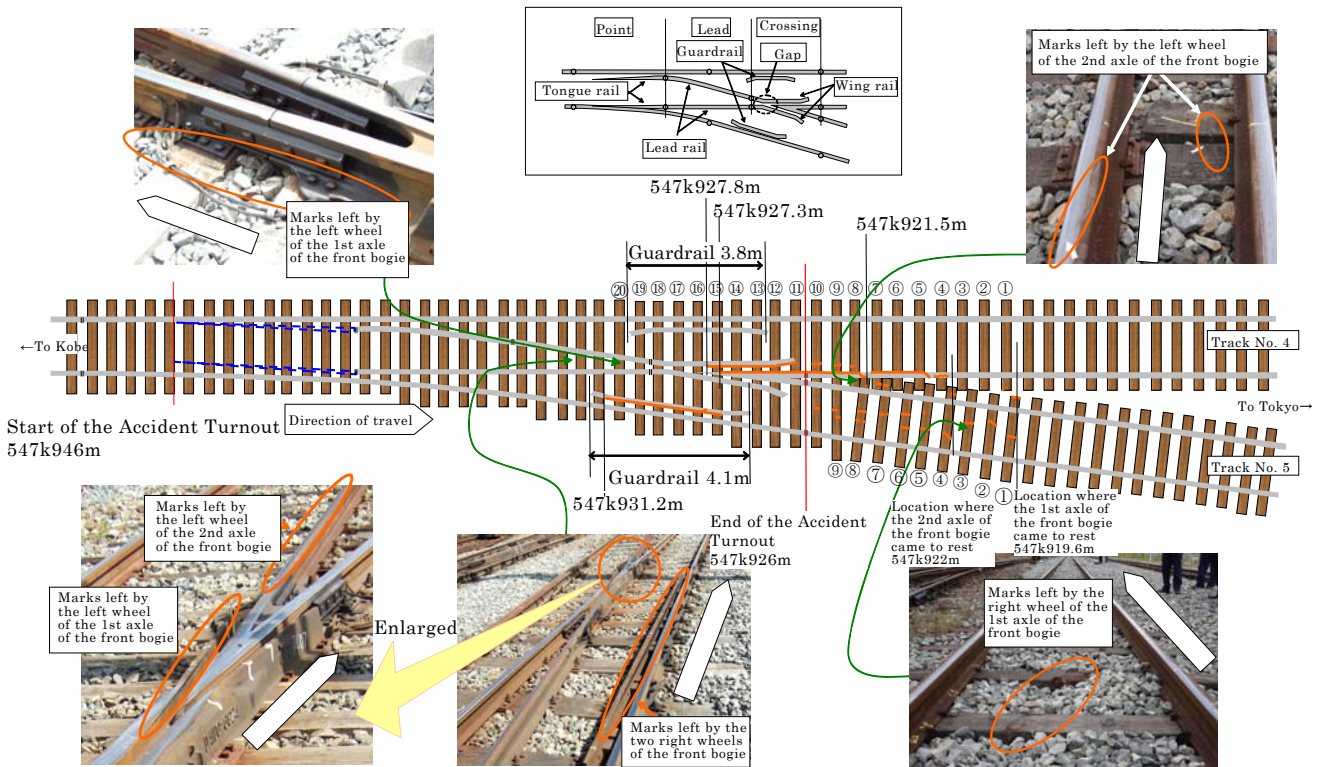
According to the findings of an analysis, which the Company committed to the Railway Technical Research Institute, it is probable that the train experienced lateral buckling*² in the following manner: as the train run through the Accident Turnout for Track No. 5 with the emergency braking applied, and as the 1st axle of the Accident Wagon's front bogie entered the branch line (Track No. 5) at the Accident Turnout and reached a gap in the crossing*³, the backside of the inside wheel rode over a guardrail while at the same time the outside wheel entered through the gap at the crossing into a flangeway of the main line (Track No. 4).

In addition, (a) the Accident (8th) Wagon and the 9th wagon were not carrying any containers or cargo and therefore were lighter than the leading wagons, (b) no marks were left on the rail immediately on the Kobe side from the gap at the crossing that would indicate the left wheels of the front bogie riding over the rail, and (c) the coupler had longitudinal and lateral dents on its right side. Considering these facts, it is probable that the Accident Wagon was about to enter the Accident Turnout when the driver took "acknowledgement action," which resulted to trigger the emergency braking, causing the following wagons, which had not yet braked, to apply longitudinal force to the coupler of the leading two empty wagons and making the Accident Wagon sway laterally. As a result, it is probable that both axles of the front bogie of the Accident Wagon, which was lighter than the leading wagons, were lifted off the rails and that the coupler force, which was applied in the direction of Track No. 4 (the main line of the turnout), prevented the Accident Wagon from turning right onto Track No. 5 as had been intended, and caused the wagon instead to continue moving straight ahead (in the direction of the main line) as the inner sides of the right wheels of the front bogie slid over the guardrail.

As the train set length is about 507.8 m, it is probable that the 14th, 16th and 21st wagons, which were also empty loaded, were either at the exit of the 7407 turnout or on a straight line with no turnouts when the ATS operated, and that as a result, the longitudinal force from the trailing wagons acted to the leading wagons along the rail.

Details of the derailment

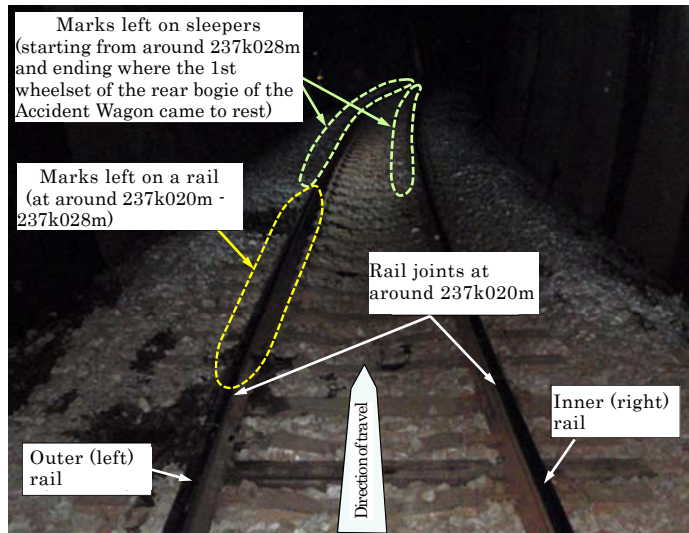
At around 237k020m, relatively large alignment is observed which will act in such a way that the curve radius is reduced. Considering this, it is probable that the outside (left) wheel of the 1st wheelset of the Accident Wagon's rear bogie had a large angle of attack^{*2}. It is therefore somewhat likely that the equivalent friction coefficient^{*3} between the wheel flange and the rail also increased.

At around 237k020m, there are rail joints, and some of the bolts and spring clips for the rail fasteners in the area were missing. It is probable that this played a role in increasing the alignment in the area.

Site of the accident (circular curve A in the Ichitana tunnel (at around 237k020m))

It is probable that the alignment may be deformed at any area where rail fasteners are missing in a tightly curved track. In such areas, repair must be carried out as soon as possible.

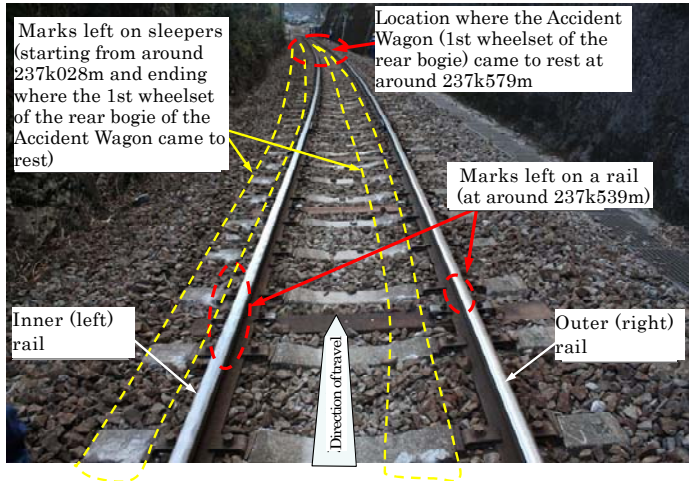
Marks left on sleepers (starting from around 237k539m and ending where the 1st wheelset of the rear bogie of the Accident Wagon came to rest)

It is probable that the train was subsequently running with the 1st wheelset of the rear bogie derailed and that at around 237k539km in the 302-m-radius circular curve B, the 2nd wheelset of the rear bogie derailed to the left. As to the reason why the 2nd wheelset of the rear bogie derailed in the circular curve B, it is somewhat likely that the relatively large cant in that area and the effect of the derailed 1st wheelset to generate greater leftward force to the rear bogie.

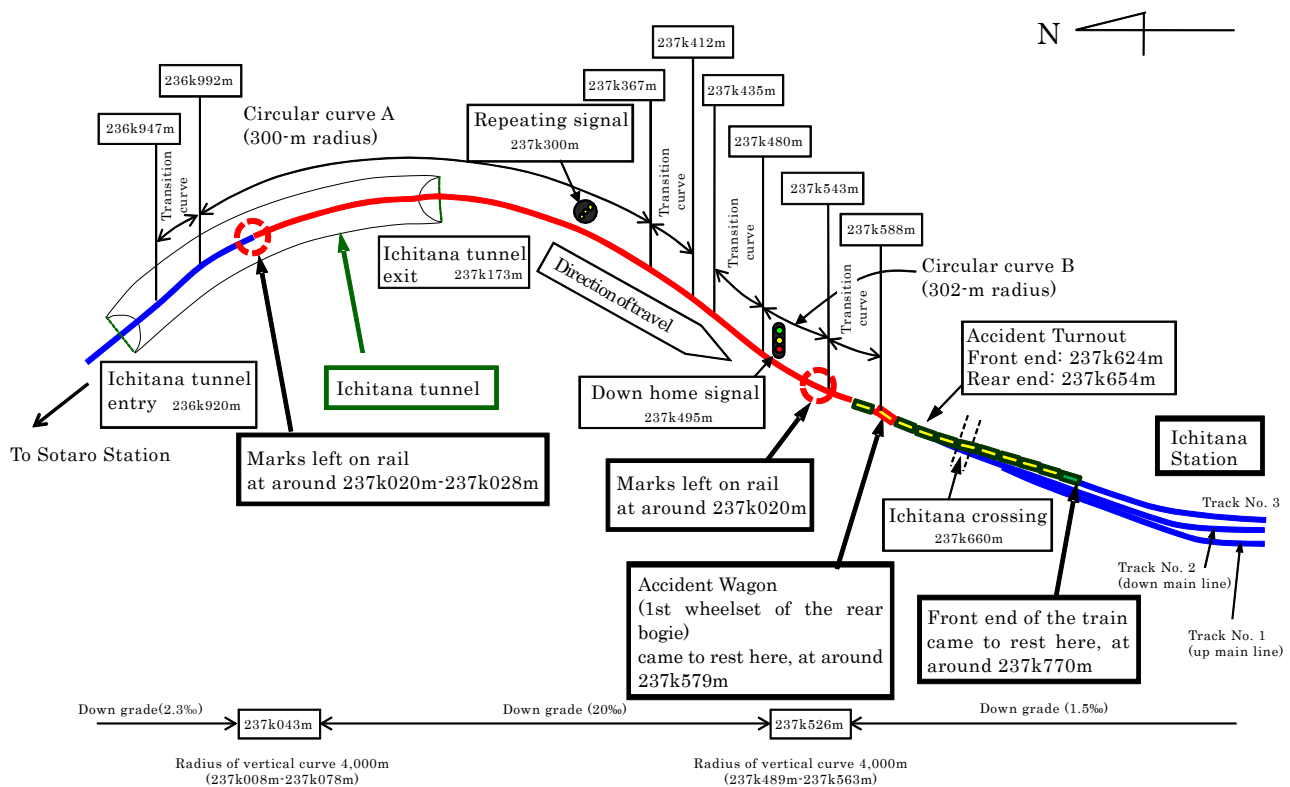
Considering the dents left on the underframe and cable conduit near the left wheel of the 2nd wheelset of the Accident Wagon's rear bogie that appeared to have been caused by

the wheel, it is somewhat likely that following the derailment of the 2nd wheelset of the rear bogie, the Accident Wagon sank deeply, allowing its rear coupler to slide down and come off the front coupler of the rearmost wagon. Considering that the damage on the right side of the rear coupler of the Accident Wagon extended upward while the damage on the left side of the front coupler of the rearmost wagon extended downward and that the top surface of the front coupler of the rearmost wagon had marks apparently caused during contact with the underframe, it is somewhat likely that the rear coupler of the Accident Wagon pushed up the front coupler of the rearmost wagon.

Schematic of the accident site

A regular inspection conducted prior to the accident showed track irregularity surpassing the limit specified in the instructions for track maintenance. With this in mind, Kyushu Railway Company, owner and in charge of maintenance of the track of Nippo line, had scheduled track repair in accordance with the facilities maintenance instructions and related details. However, the accident occurred prior to the scheduled repair. The regular inspection conducted on December 11, 2009 found twist and the combination of alignment and cross levels, both exceeding the relevant limits. These parameters significantly affect running safety and must be monitored closely. It is therefore desirable that appropriate action be taken, such as advancing the repair timing, in areas such as those in tunnels subject to a leakage of groundwater where track irregularity may be accelerated.

In track maintenance beyond regular inspection, careful attention must be paid to any change in track irregularity that may occur after maintenance work. This is especially important in cases of large twist in small-radius curved track: post-maintenance check is inevitable even when only one sleeper is replaced.

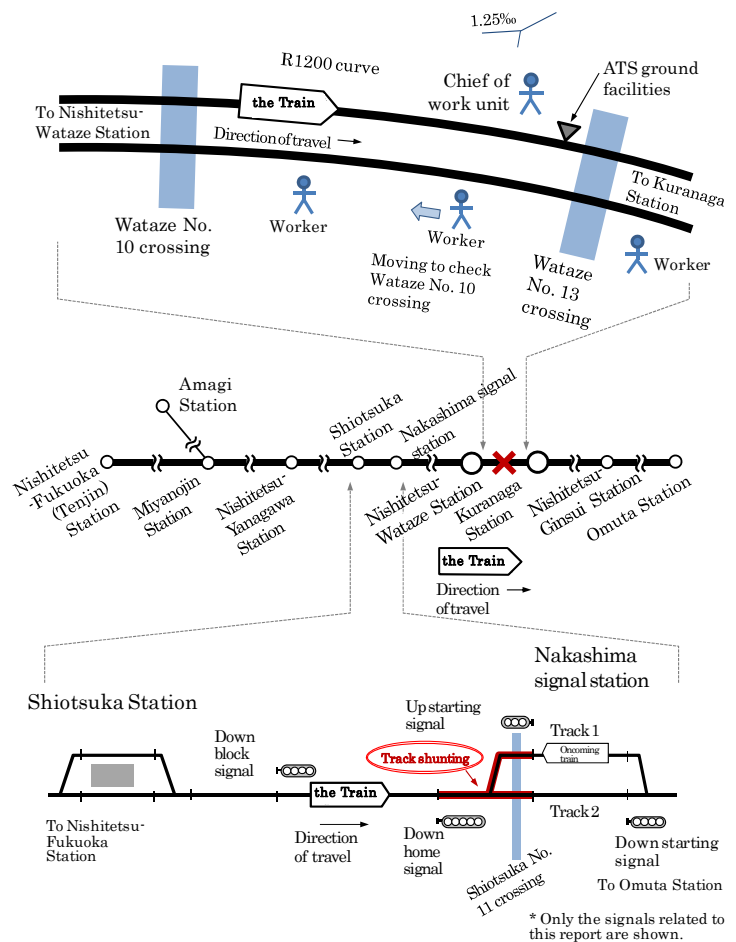
In this serious incident, it is highly probable that approval to start the Work on the Closed Track was issued by the train dispatcher without thorough confirmation of the traffic conditions at that time and without double-checking with other relevant train dispatchers, allowing the work to start even though the day's train operations had not yet ended.

At that time, it is highly probable that, as the Train, the day's last train, had not yet passed the section of the Work on the Closed Track and the train operation control apparatus could indicate entry approval, namely no specific action was taken to prevent the Train from entering the work section.

Facilities related to this serious incident

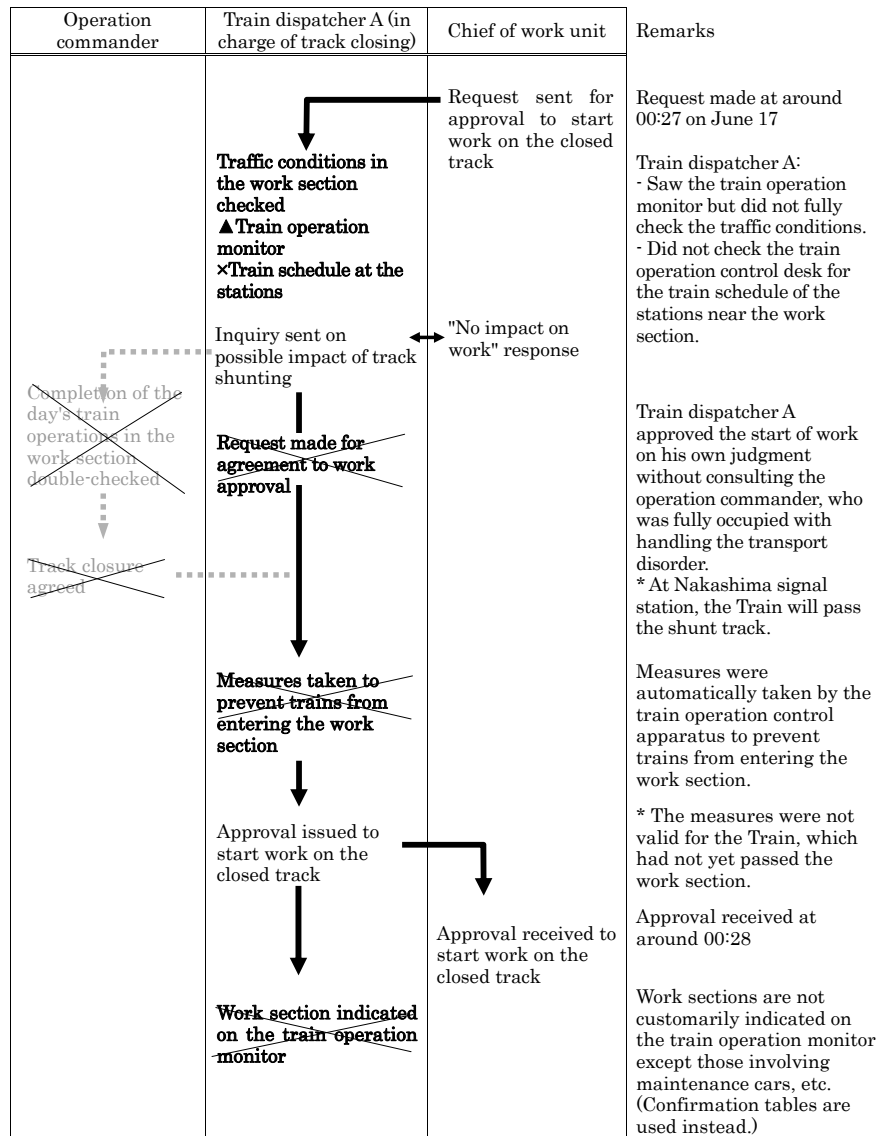
In this serious incident, it is highly probable that approval to start the work on the closed track was issued by the train dispatcher without thorough confirmation of the traffic conditions at that time and without double-checking with other relevant train dispatchers, allowing the Train, which had been running behind schedule due to a transport disorder at a nearby signal station, to pass through the section of track where the work was in progress.

NOTE: "×" indicates that action was not taken. "▲" indicates that action was not thoroughly taken.

Procedures for approval to start the Work on the Closed Track

- c. Any discrepancy found between the regulations on procedures for approval to start work on the closed track and the actual application of the regulations must be corrected without delay. More fundamentally, the regulations and related systems currently in place must be thoroughly reviewed against the principles of track closing for possible revision.

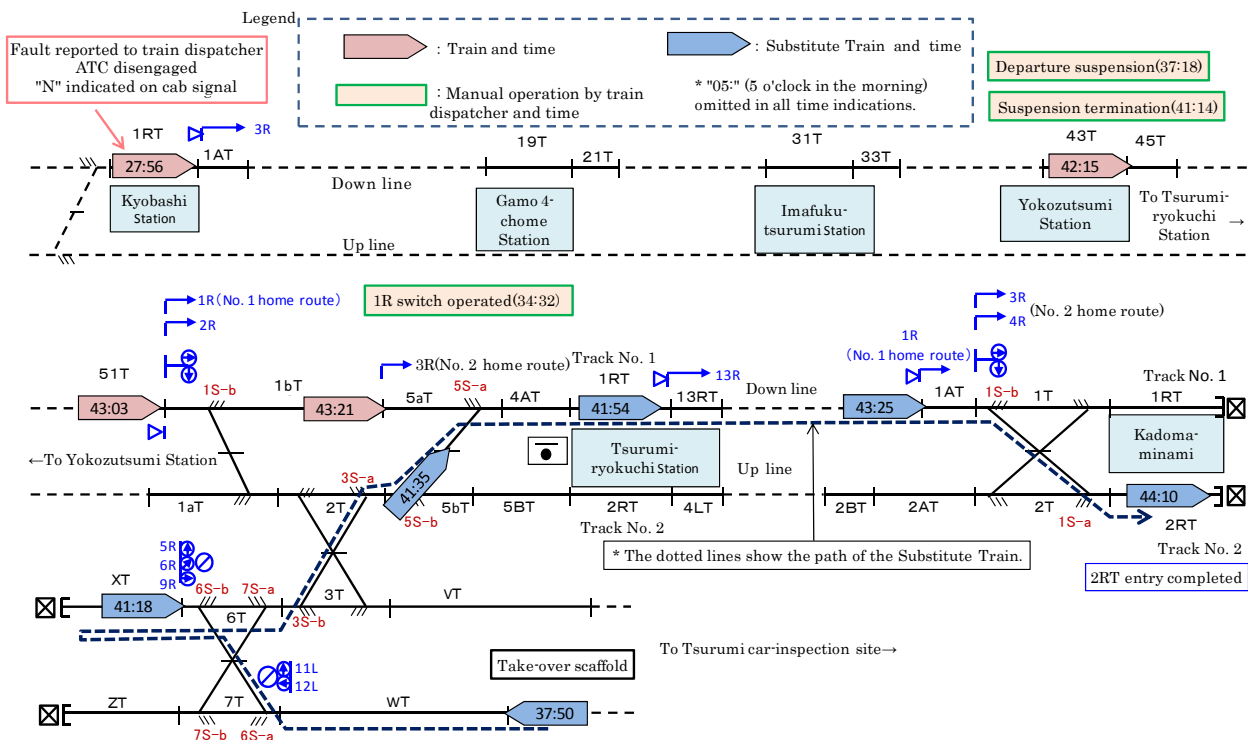
- c. It is probable that although the Train was running in an abnormal circumstance with the ATC system disengaged and the cab signal showing “N”^{*2}, the driver did not check the opening direction of point 1S-b at Kadoma-minami Station.
- d. The Train lost its train number at Tsurumi-ryokuchi Station and no programmed route control was made at the home signal Kadoma-minami 1R and 3R.

Operations of the Train and the Substitute Train (1)

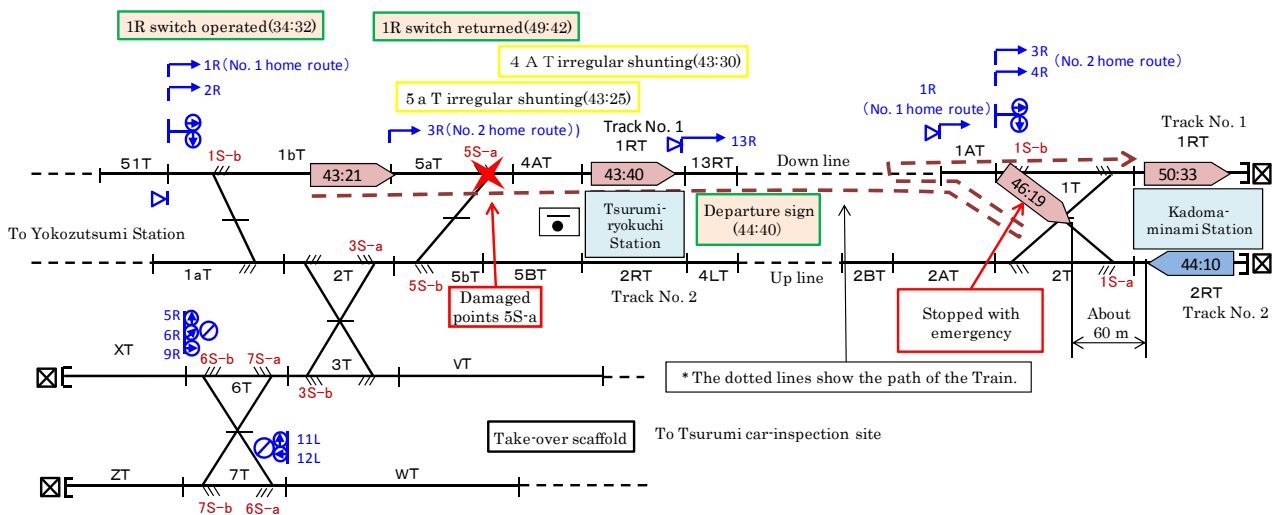
Operations of the Train and the Substitute Train (2)
