## Chapter 3 Marine accident and incident investigation

### 1. Summary of major investigation report

**Marine 1** While a ship was proceeding in the North East Offing of Iriomote Shima, she pitched, and two passengers each suffered a compression fracture in the lumbar spine  
(Passenger ship AN-EI GO No. 98, Casualties of passengers)  
[investigated by Tokyo Office]

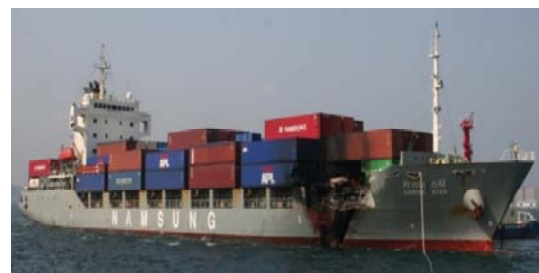
Situation of Ship A

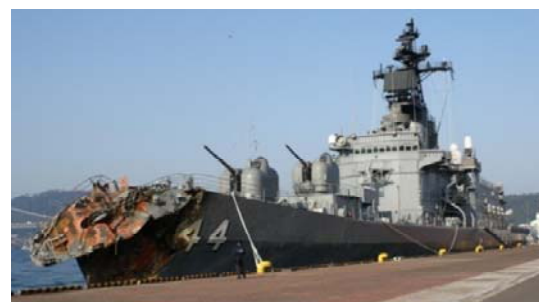
Situation of Ship B

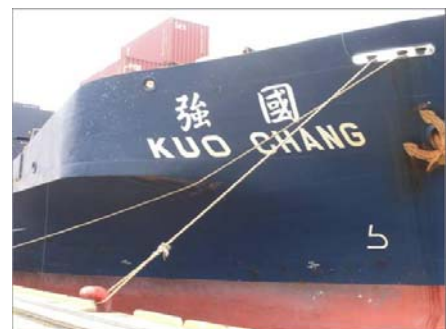
- (1) It is probable that, on docking at the Berth, the pilot was actually in command of the vessel and the master and the chief officer at the bridge gave order to the second officer on the bow and the third officer on the stern under the pilot's advice.
- (2) It is probable that the broken mooring line (the Line) was a synthetic fiber rope used for less than a year, but it was worn due to repetitive use while touching a bend point where the sheer strake and outside plating

**Forward spring line of the Ship**

touched at almost a right angle (the Bend Point).

It is probable that the Line was broken due to the wear it had incurred and by the combined tensions on the Line touching the Bend Point: the impulsive tension due to the winding moment in the hawser drum; the tensions due to the forward headway of the Ship; the wind pressure.

Therefore, it is recommended to clearly state and require to pay attention to the route of mooring ropes and the bitts to moor the ropes onto in order to prevent mooring ropes from touching corners such as the Bend Point to the extent possible and obtain safe and effective mooring forces, and to place a person in charge to take command of operations in such a position from where the person can acquire the knowledge of the overall conditions of mooring ropes. At the same time, it is recommended to make all the ships under management comply with such requirements.

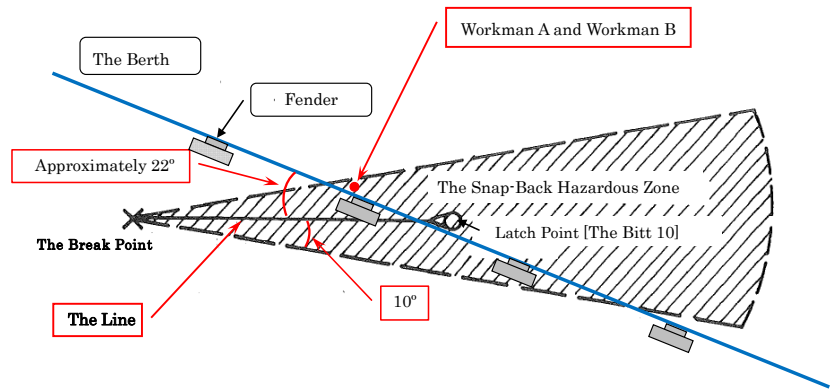
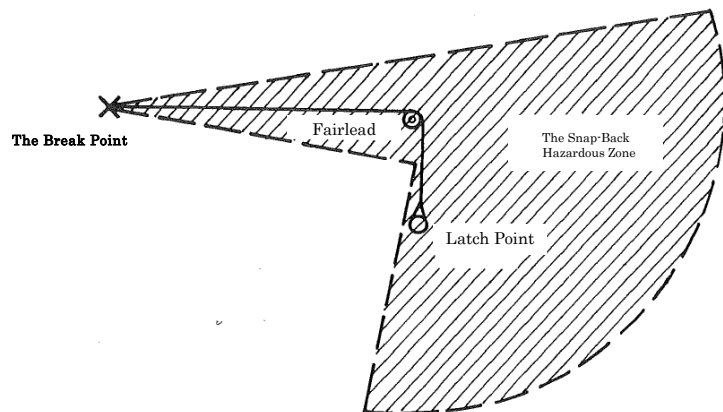
(6) It is highly probable that Workman A and Workman B were hit by the Line which had snapped-back at the moment of breaking, as they were working inside the hazardous zone of snap back<sup>\*2</sup>.

(2) Snap-back hazardous zone in case of break of a mooring line bent at a fairlead

#### The Situation of the accident and the snap-back hazardous zone

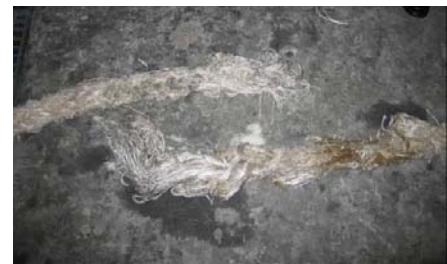
The Broken part of the Line

The accident occurred when the mooring line with wear broke due to the additional tensions on the mooring line, which was touching the Bend Point, including the impulsive tension due to the winding moment in the hawser drum, the tension caused by the forward headway of the Ship and that caused by the wind pressure, and hit the two mooring workmen, causing them to die.

The JTSB made its remarks to manufactures of mooring ropes regarding the need to establish guidelines in order to replace or discard their products by examining their appearance and provide users of the ropes with the guidelines, and also to line handling service providers regarding the need to provide their mooring workers with information on the extent of the snap-back hazardous zones of ropes when broken under tension, and give them instructions such as to avoid working inside the zone unless necessary.

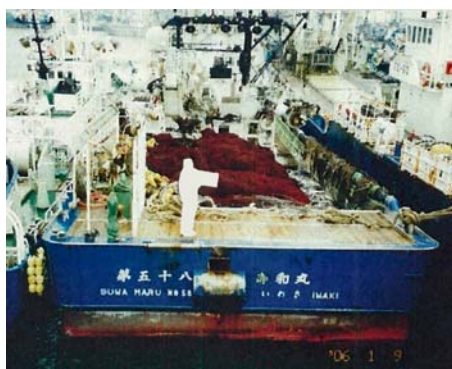
- b. It is somewhat likely that: the boat's total weight increased by the fishing nets which had been soaked with water and patched for repair; the boat's center of gravity shifted higher than that in the normal state because fishing gear, ropes and other items were loaded on the wheelhouse's canopy; the transverse weight distribution was imbalanced because heavy chains, fishing nets and floats were loaded in that order from the starboard side; and, the initial listing to starboard occurred due to the shift of the fishing nets toward the heavy chains as the boat rolled.

It is somewhat likely that the causes of the higher center of gravity than that in a normal state and the initial listing to starboard were as follows: the fishing nets gained weight because they had been soaked with water and been patched for repair; the fishing gear, ropes and other items were loaded on the wheelhouse's canopy; the imbalance in the transverse weight distribution was caused by the loading of the heavy chains, the fishing nets and the floats in that order from the starboard side; and, the fishing nets shifted toward the heavy chains as the boat rolled.

Loading situation of fishing nets

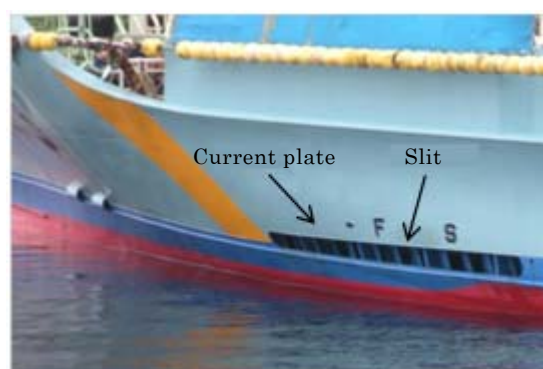
It is somewhat likely that the structure around the scupper contributed to hampering water drainage.

Structure of scupper  
(photo of similar type of boat)
