Chapter 3 Aircraft accident and serious incident investigations

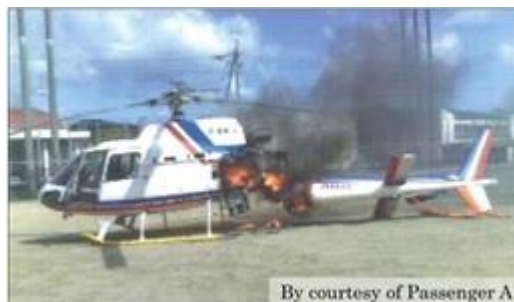
On board the helicopter were a pilot and two passengers, but none of them suffered injury. After the forced landing, the helicopter caught fire and was destroyed.

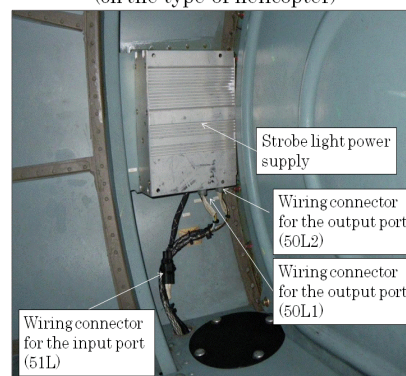
Installation of the strobe light power supply
(on the type of helicopter)

This is because the wiring was not designed and structured so that it was fully protected so as to prevent it from being damaged due to the movement of embarkation and preclude a risk of occurring a fire even if

It is also possible that since it was not covered with nets to prevent its movement, embarkation in the rear hold damaged the wiring, which was not fully protected from damage due to the movement of the embarkation.

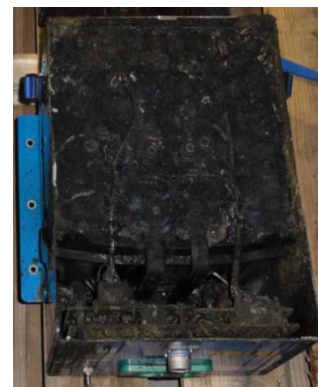
Interior of main battery

Internal heat generation in cell 6 very likely developed into venting, making it the initiating cell, resulting in cell-to-cell propagation and subsequent failure of the main battery. It is very likely that cell 6 internal heat generation and increased internal pressure caused it to swell, melt the surrounding insulation material and contact the brace bar creating a grounding path that allowed high currents to flow through the battery box. The currents generated arcing internal to the battery that contributed to cell-to-cell propagation consequently destroying the battery.

Cell 6 heat generation was probably caused by internal short circuit; however, the conclusive mechanism thereof was not identified.

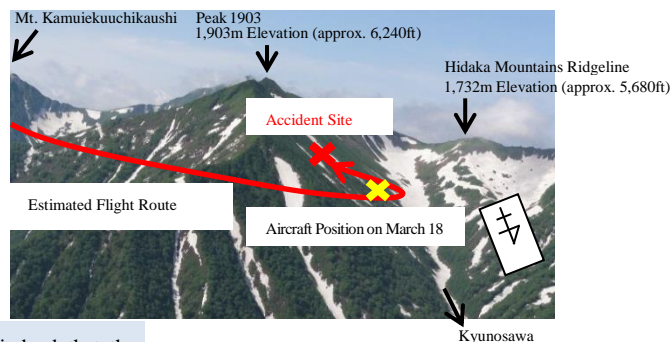
The slope was covered with snow. It is highly probable that the Aircraft had slid down to the position located approximately 1,600 m in elevation after the crash.

While the Aircraft decreased its ground speed against the downdraft, the pilot judged that the Aircraft would be able to maintain the altitude to safely pass over the ridgeline, and began to approach Kyunosawa Valley at an altitude of approximately 2,000 m, where the accident occurred. However, as the downdraft became stronger than the pilot had expected, he could not stop descent. It is probable that the Aircraft approached the valley at an altitude with almost no margin, in hindsight. It is probable that approaching the valley at an altitude with almost no margin was one of the reasons why the Aircraft had descended below the safe altitude.

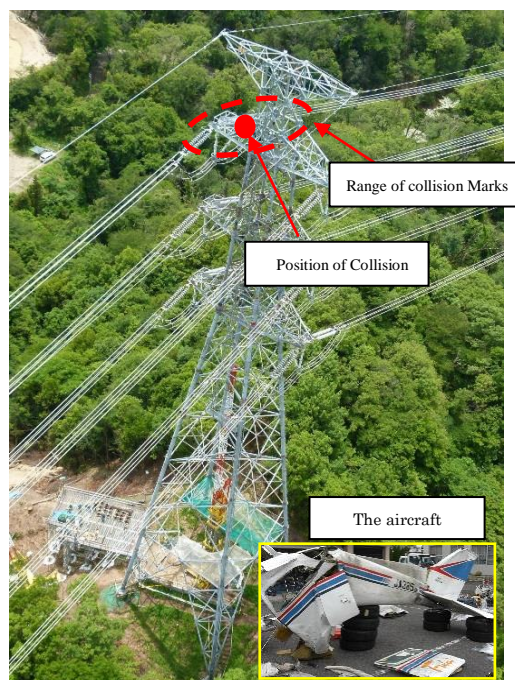
《Immediately before the Collision》

The Aircraft needed to achieve an altitude of 150 m or more from the ground surface according to the requirement as it flew over from the city area to the hilly area. According to the GPS data and the ground surface elevation, it is probable that the Aircraft did not comply with the requirement of the minimum safety altitude.

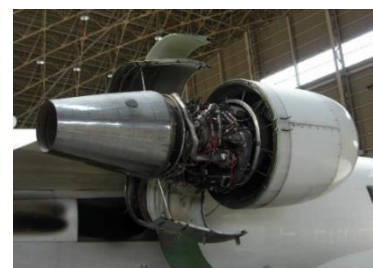
Exterior view of the right engine

When the Aircraft was on the ground, the thrust reversers were used for approximately 19 seconds from 12:14:40, immediately after landing. It is highly probable that this caused both the engine RPM and internal temperature to increase and that the reduction in aircraft speed caused a reduction in the quantity of cooling and ventilation air.

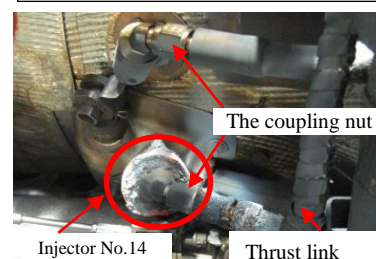
Injector No.14

The coupling nut
