Chapter 4 Railway accident and serious incident investigations

9 Summaries of major railway accident and serious incident investigation reports (case studies)

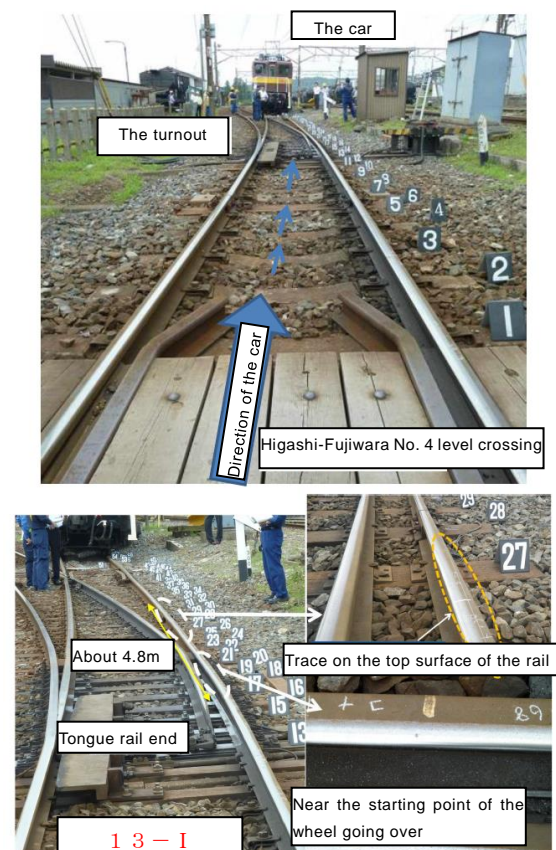
Derailed site

The driver of the train set, noticing an abnormal condition when it was passing the Higashi-Fujiwara No. 13-I turnout, immediately applied the emergency brake to stop the train. The first axle in the front bogie of the second locomotive was derailed to the right.

Since specifications of curves have been clarified for curves of our Sangi main line between each station,

we have utilized them for track maintenance. However, some specifications of curves were not clarified in the main line, side lines, and curves with turnouts on the premises of each station. We had depended on the “long experience” and “review” of field workers.

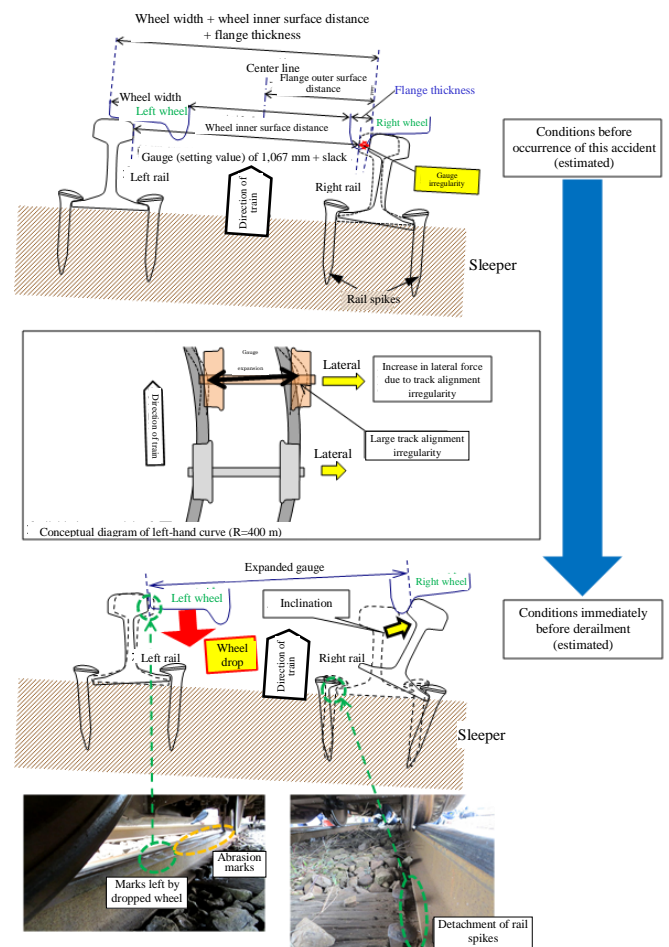
It is probable that there was a lack of basic awareness in the entire Track Maintenance Management Office responsible for regular inspections of track irregularities near the accident site and maintenance based on inspection results, as a party engaging in track maintenance, and it is also probable that at the Track Maintenance Station of the Track Maintenance Management Office, which serves to supervise track maintenance management, the duties involving maintenance of the tracks by the Track Maintenance Management Office were not properly supervised, and therefore the actual conditions had not been fully understood.

It is somewhat likely that at the Track Maintenance Division of the Head Office's Engineering Department, which is responsible for planning and management so that the Track Maintenance Management Office and Track Maintenance Station reliably implement track maintenance management duties, the status of duties implemented by site organizations required for track maintenance management had not been properly confirmed, and that the actual status of duties involving track maintenance themselves had not been sufficiently confirmed as well.

Probable causes (Excerpt): It is highly probable that the accident had occurred as the left wheels in the rear bogie of the 6th vehicle derailed to inside of the track by the lateral motion and tilting of the rail due to large lateral force generated while the train passed around the accident site, where the track was in the states that the gauge was easily widened due to the effects of the alignment extremely exceeding the maintenance standard values, by the lateral force caused by the passing trains, because the maintenance works were not implemented properly although the alignment and the irregularity of gauge exceeded the maintenance standard values extremely.

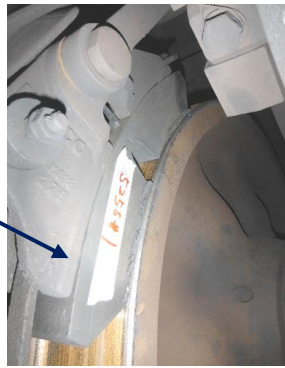
Example with no deposits
Brake shoe of wheel #1 of seventh vehicle
Brake shoe replacement date: January 30, 2014

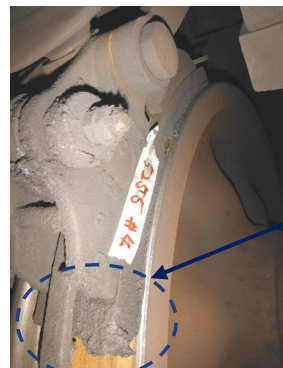
It is probable that the brake shoe deposits were a mixture of friction adjusting material (*) and oil applied to the rails (*) remaining on the treads of the wheels and the wheel flanges, that had accumulated around the brake shoes, together with abrasion powder and dust from the wheels, rails, and brake shoes, and since cleaning had not been performed on the following train after replacement of its brake shoes, it is somewhat likely that the accumulation of brake shoe deposits had progressed in association with the duration of use of each brake shoe.

Example of accumulated brake shoe deposits
Brake shoe of wheel #4 of seventh vehicle
Brake shoe replacement date: April 10, 2013

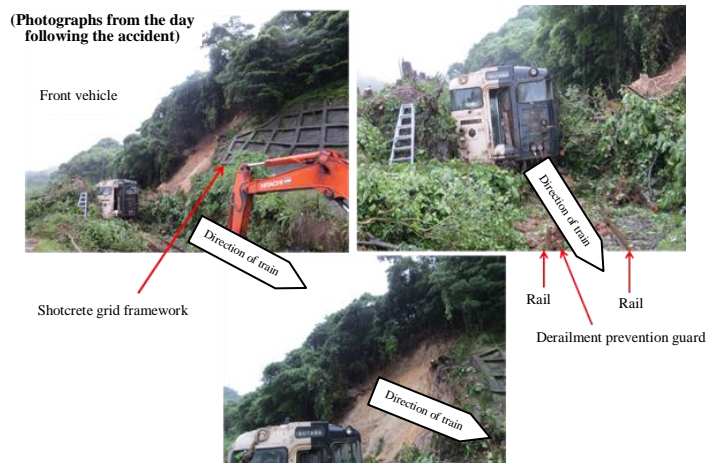
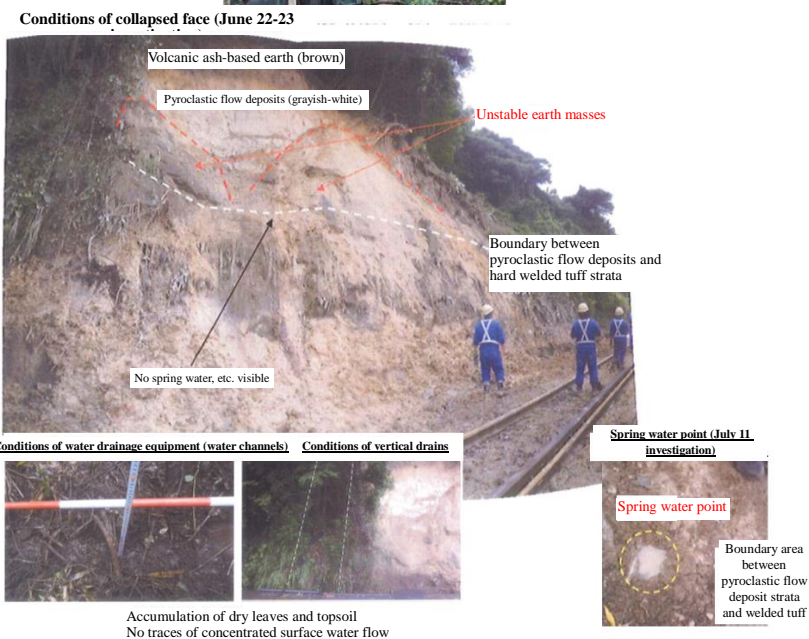
The slope that collapsed had a steep gradient on its side face due to ridged topography, composed of strata consisting from the lowest layer of welded tuff, pyroclastic flow deposits, weathered pyroclastic flow deposits, loam, and solidified volcanic ash, and it is probable that the main area of the collapse consisted of pyroclastic flow deposit and weathered pyroclastic flow deposit strata. In addition, approximately 80 years had passed since the area surrounding the collapse was cut, and so it is probable that the stability of the slope was in nearly its limit level due to the deterioration of the dynamical firmness by age of the ground of the cut slope, and that this was a factor other than rainfall affecting the accident.

Probable causes: It is highly probable that the accident occurred as the train collided with the trees and ran onto the trees and the earth and sand stacked on the track, and derailed because the trees and the earth and sand flew into the track from the cut slope in the left side of the track.

It is somewhat likely that the slope collapsed because of the increased weight of earth due to rain of the maximum hourly rainfall of 39 mm and the continuous precipitation of 100 mm, where the stability of the slope was in nearly its limit level due to the deterioration of the dynamical firmness by age of the ground of the cut slope, in addition to the topography and geological conditions of the collapsed slope.

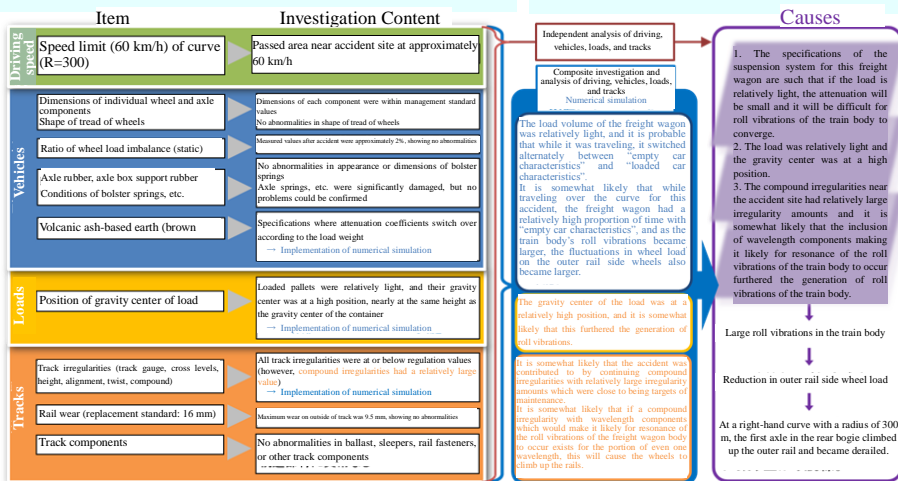
Although the track irregularities near the accident site were within the maintenance standard values, it is somewhat likely that the combination of alignment and cross-level being continuous irregularities with relatively large amounts which were close to maintenance targets, and the inclusion of wavelength components in the travel speed that would increase the roll vibrations of the train body, became causes of the accident, and that they were furthered by the repeated occurrence of roll vibrations of the train body and fluctuations in the wheel loads.

It is somewhat likely that the occurrence of derailment, even though the track irregularities near the accident site were within the maintenance standard values, was affected by combination of alignment and cross-level of track which existed in opposite phases, contributing to the motion of the wheels to climb up the rails. It is also somewhat likely that if a compound irregularity with wavelength components which would produce resonance of the roll vibrations of the freight wagon exists even one wavelength, roll vibration will occur and cause fluctuations in wheel loads, causing the wheels to climb up the rails.

Probable causes: It is probable that the accident occurred as the first axle in the rear bogie of the Ko-Ki 106 type freight wagon climbed up the outer rail and derailed, because the wheel load of the outer rail side wheel reduced at the accident site while the train passed the 300 m radius right curved track. It is probable that the wheel load acting on the outer rail side wheel reduced by a large rolling vibration of the freight wagon running around the accident site.

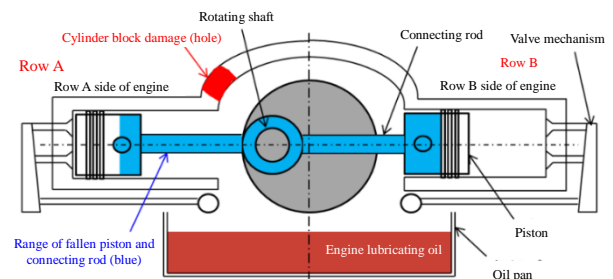
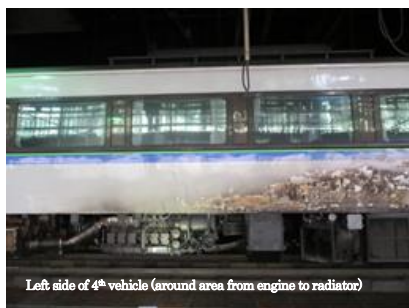
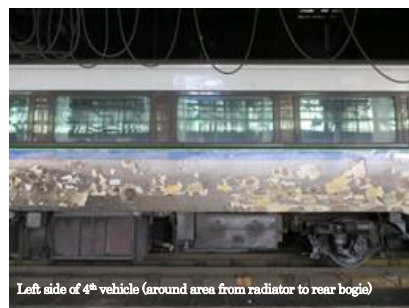
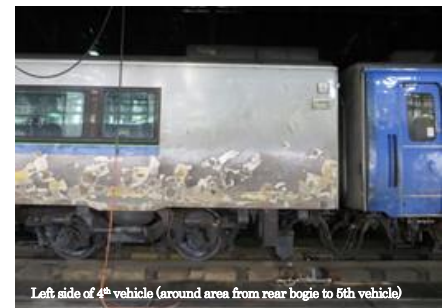
It is probable that the reason why the engine was damaged by the over speed operation were related with that the control rack was designed to act to increase fuel injection rate when the pin of the sliding block was damaged, and that there was no mechanism to stop the engine operating in over speed, forcibly.

- [1] As the pin press fitted into the guide arm of the sliding block, used as the speed governor for the diesel engine installed in the 4th vehicle of the express train, broke by metal fatigue at the edge of press fitted part, then the engine became uncontrollable and over speed operation caused damages of the piston and connecting rod etc., equipped inside of the engine.

- [2] The fuel and the lubricating oils for the engine and antifreeze corrosion inhibitor included in the coolant of the engine spouted from the bored holes caught a fire by the spark generated by the broken connecting rod stabbed and destroyed the cylinder block, and these oils etc., stacked on the high temperature surfaces of the exhaust manifold, the turbo charger, the exhaust pipe, etc., and combusted.
