Annual Report 2018

JTSB Mission

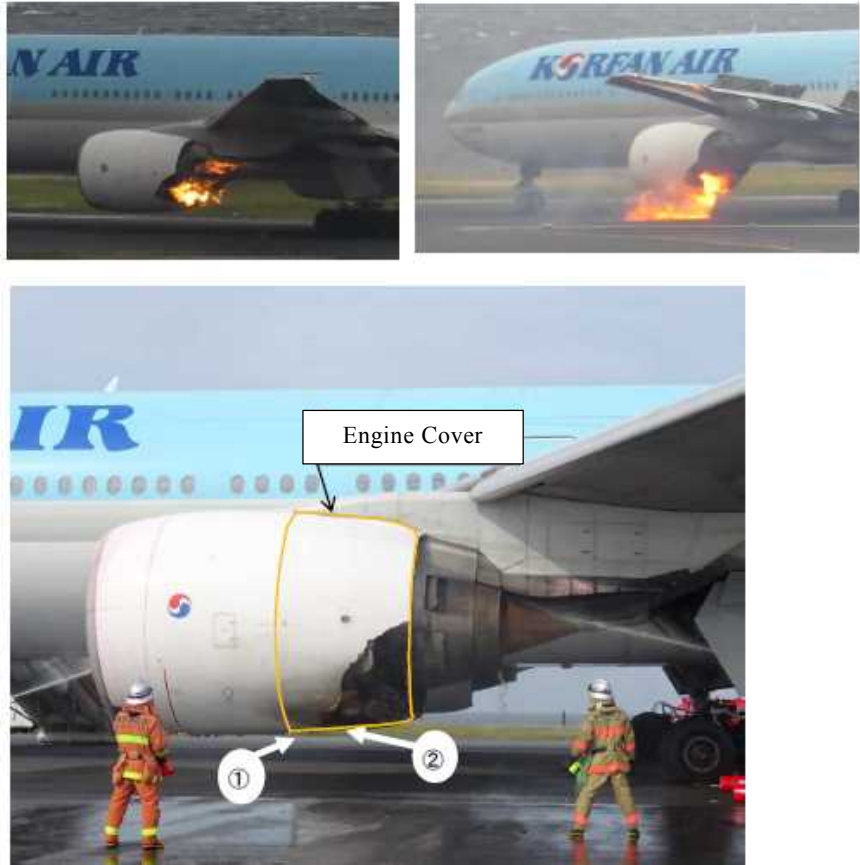
Fire Breakout on No. 1 Engine

Closeup view from (1)

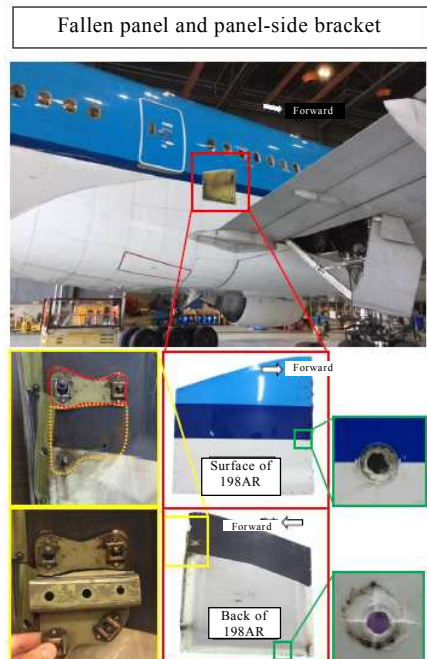
- Fractures found in the bracket (metal fitting P/N:149W5913-4) fixing the panel (198AR) to the fuselage

- After removing the bracket, bolts and screws fixing the panel to the fuselage were found fitted to the fuselage. But a wrong bolt was used.
- The panel had a hole with signs showing the passage of a bolt and a screw.

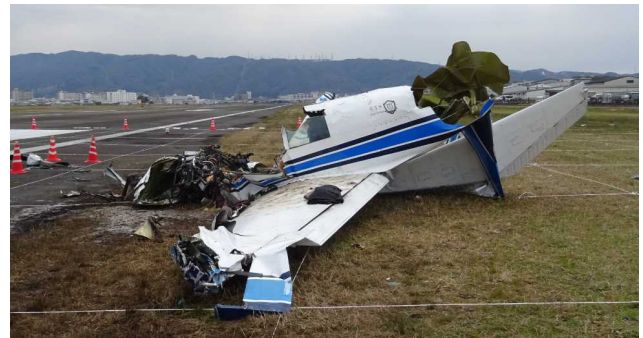
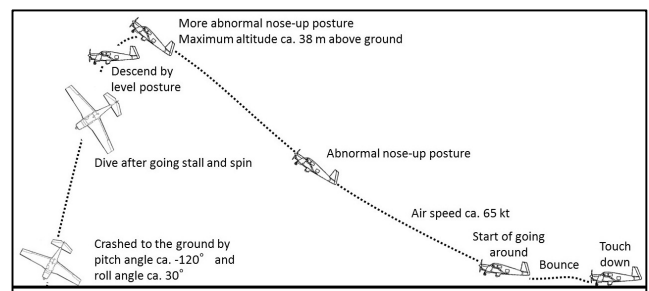
Situation of the crash (conceptual figure)

- the stability at low speed was reduced by the aft CG location.
- the aircraft approached the runway taking deep approach angle.

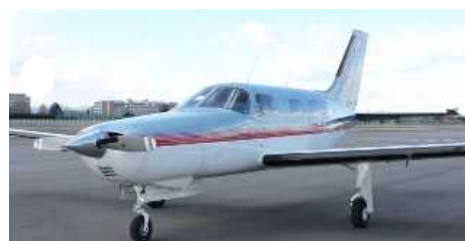
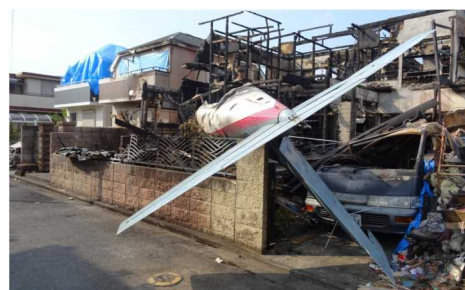
Probable Causes: It is highly probable that this accident occurred as the speed of the Aircraft decreased during takeoff and climb, which led the Aircraft to stall and crashed into a residential area near Chofu Airport.

- It is necessary to promote pilots of small private aircrafts to understand the importance to confirm that requirements (takeoff distance) for performance prescribed on the flight manual are satisfied before departure. As for the actions to the situation of degraded flight performance, it is necessary to enforce instructions and trainings to pilots of small private aircraft to plan the actions in advance.
- It is necessary to study and compile the cases of effective measures connecting entrance taxiways to runway thresholds in order to make maximum use of runway length and inform aerodrome providers and administrators of these case studies.
- It is necessary for small private aircraft to be securely maintained based on a proper understanding of technical information.

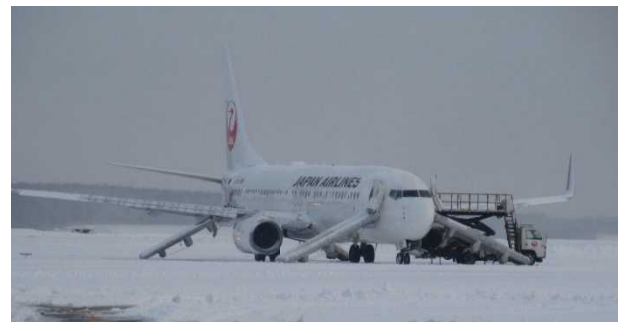
→One passenger suffered serious injury

Probable Causes: In this accident, it is probable that while holding on the taxiway to taxi following the heavy snowfall, odd smells and smoke were generated within the cabin, following these events, because the flame from rear of No.2 engine was continued, the flight crew conducted the Emergency Evacuation from the aircraft. At the time, a passenger descended the slide, fell down to the ground from the hip of the passenger and suffered serious injury.

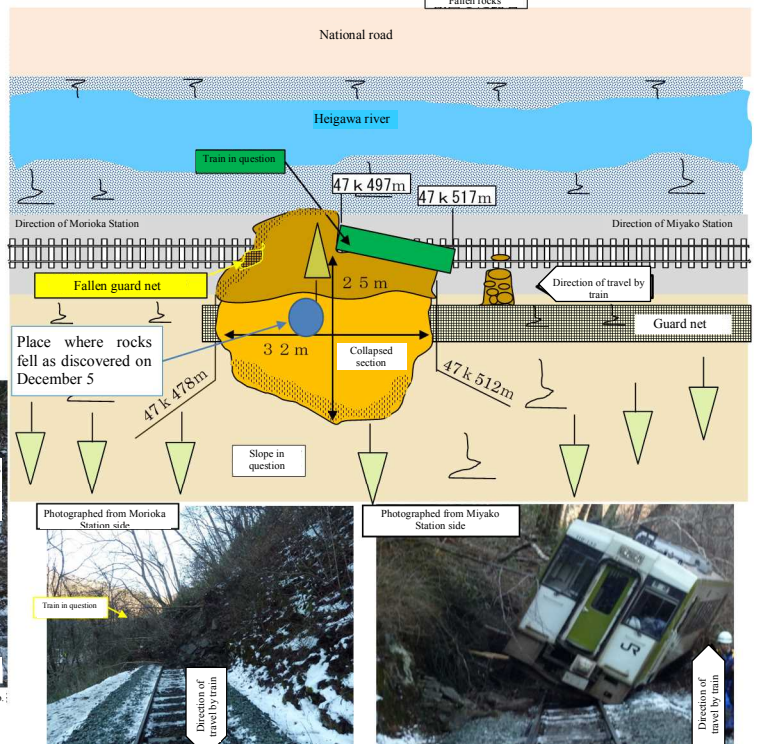
Probable Causes: It is highly probable that the accident had occurred as the train was derailed by hit and ran onto the fallen trees or earth and sand, etc., flowed into railway track due to the collapse of the slope in track side.

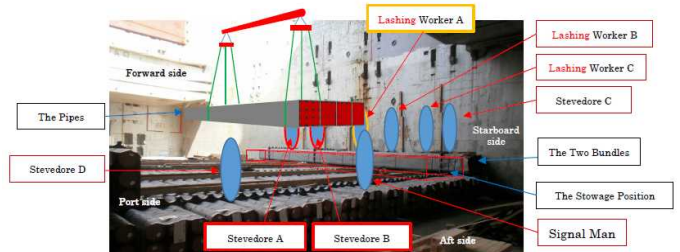
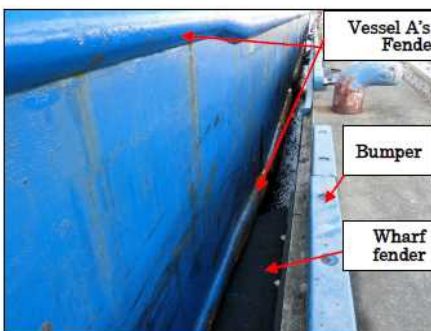
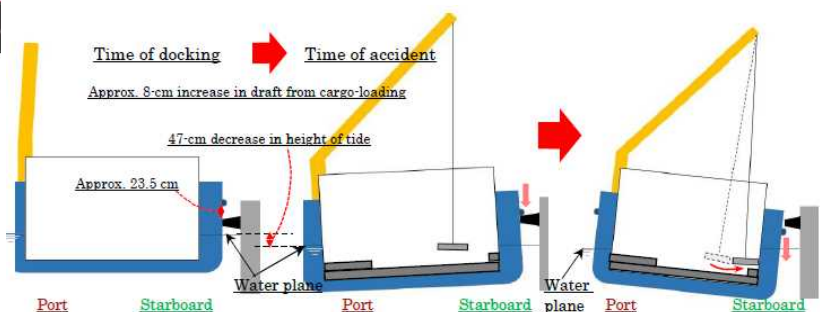
(Arrangement of workers at the time of the accident)

Probable Causes (excerpt): It is probable that the accident occurred when the Pipes which had been hoisted and then stopped by the No. 1 crane swung to the starboard side, and as a result, two stevedores and one lashing worker, who had been standing by and doing other activities on top of the cargoes that had been stowed on the starboard side, were caught between the Pipes and starboard wall, as Vessel A was being loaded with cargo starboard-side alongside at Shinko East Quay T Wharf, Kobe Section, Hanshin Port.

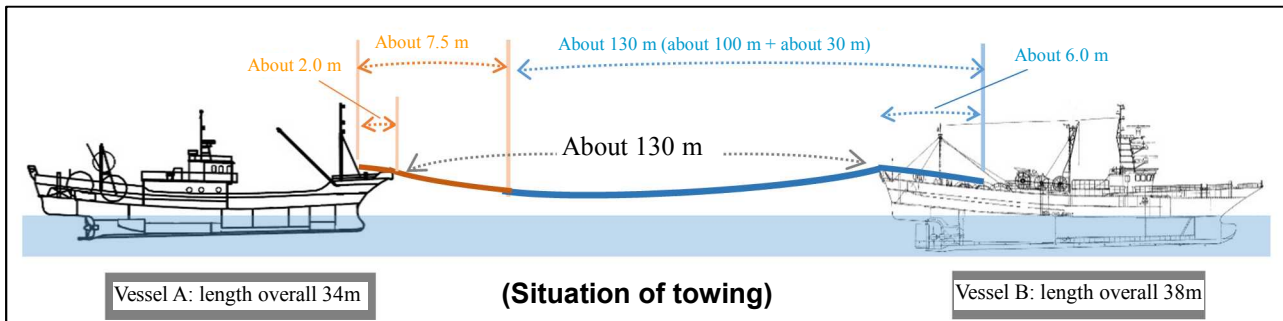
(Situation of capsizing)

Probable Causes (excerpt): It is somewhat likely that the accident occurred as follows: The main engine of Vessel A stopped at night when the ship's stability was reduced and its freeboard decreased. While being towed southeast by Vessel B north of the Mihonoseki lighthouse, Vessel A became almost unable to regain stability as the angle of the heel exceeded the bulwark submerge angle and capsized by continuous waves.
