Chapter 3 Aircraft accident and serious incident investigations

3 Statistics of investigations of aircraft accidents and serious incidents

Aircraft accident investigation reports published in 2018

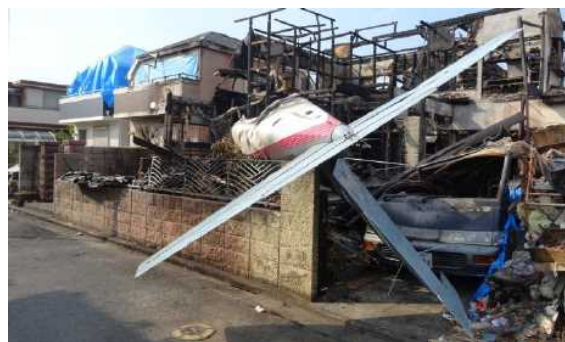
On Sunday, July 26, 2015, at around 10:58 Japan Standard Time (JST: UTC + 9 hrs: unless otherwise stated, all times are indicated in JST using the 24-hour clock), a privately owned Piper PA-46-350P, registered JA4060, crashed into a private house at Fujimi Town in Chofu City, right after its takeoff from Runway 17 of Chofu Airport. There were five people on board, consisting of a captain and four passengers.

The captain and one passenger died and three passengers were seriously injured. In addition, one resident died and two residents had minor injuries.

The aircraft was destroyed and a fire broke out. The house where the aircraft had crashed into were consumed in a fire and neighboring houses sustained damage due to the fire and other factors.

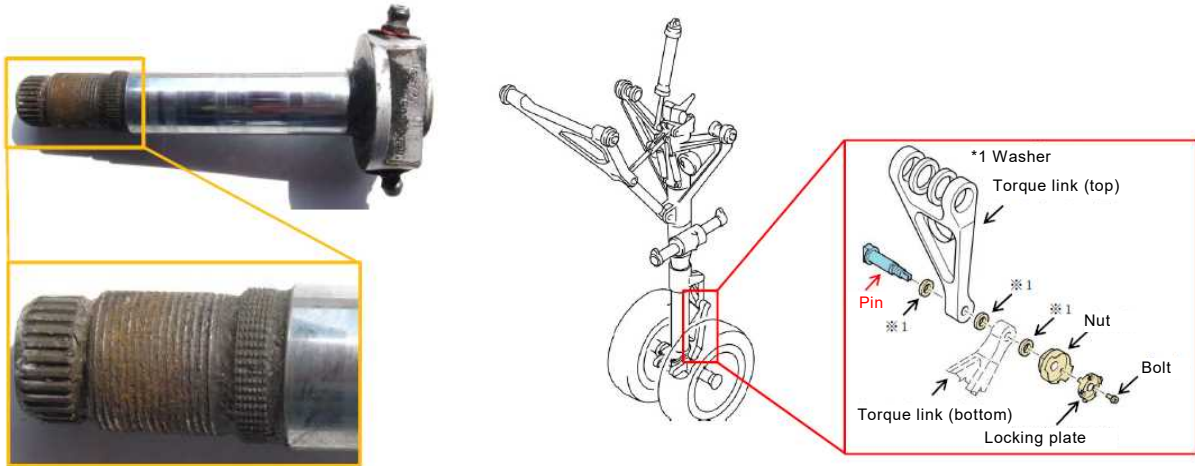
Photo of pin

- The pin connecting the top and bottom torque links on the nose landing gear fell off and was found on the runway.

- The nut, locking plate, washer and bolt fastened onto the landing gear along with this pin has not been found at Fukuoka Airport or Kansai International Airport, where the aircraft departed.
- The state of the pin that fell off the landing gear is as shown in the attachment. (See attachment)
