Chapter 5 Marine accident and incident investigations

1 Marine accidents and incidents to be investigated

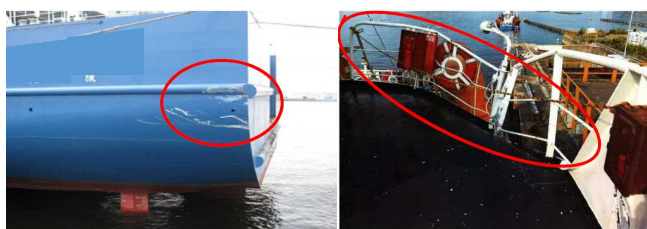
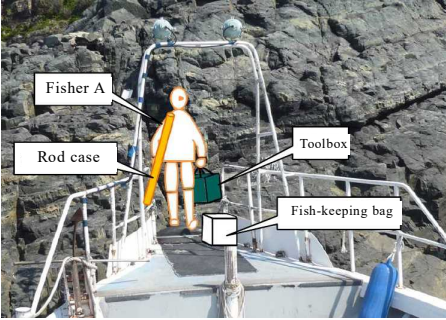
Summary	<p>The vessel, with the skipper on board, was accommodating fishing passengers (fishers) on rocky ground near the northwest coast of Futaoijima island, Shimonoseki City, Yamaguchi Prefecture (called San no Hana). A fisher tried to transfer from the rocky ground to the vessel's bow, but fell into the water and died.</p>

Probable Causes	<p>It is somewhat likely that this accident occurred as follows. Near the northwest coast of Futaoijima island, the vessel was accommodating a fisher by pressing the vessel's bowhead against San no Hana. The fisher tried to transfer from San no Hana to the vessel and stepped on the tire mounted to the bowhead. At that moment, the vessel received a wave with a height over about 3m from the port side, which moved the hull to the starboard side. The fisher lost his balance and slipped from the position where he started his transfer down to a dip and then fell into the water.</p> <p>It is somewhat likely that the reasons why the vessel received that high wave from the port side were as follows. The skipper was late to notice that wind speeds and wave heights in the vicinity of San no Hana exceeded the vessel return standards, and the skipper was accommodating the fisher under conditions exceeding the standards.</p> <p>It is probable that the reason why the skipper was late to notice that wind speeds and wave heights in the vicinity of San no Hana exceeded the vessel return standards was that he neither stood by in the Futaoijima island fishing port nor patrol around the rocky ground.</p> <p>Regarding the fact that the fisher ended up losing his balance, slipping from the position where he started his transfer down to a dip, and falling into the water, it probably had something to do with the fisher transferring from San no Hana to KASUGAMARU, with his luggage in both hands.</p> <p>It is somewhat likely that the inability of the vessel to rescue the fisher in the water had something to do with the following.</p> <ol style="list-style-type: none"> (1) The vessel, usually only with the skipper on board, had no one else who could help rescue the fisher. (2) Because the vessel was in shallow water near San no Hana and there were higher-than-3m waves, the skipper had to rescue the fisher who fell in the water while maneuvering the vessel to prevent it from running ashore. (3) Because the fisher had his luggage in both hands even after falling into the water, he could not hold the lifebuoy the skipper threw to him tightly. (4) Because the vessel was not equipped with a ladder, the skipper could not rescue the fisher on board using a ladder. <p>It is somewhat likely that the death of the fisher was attributable to the following.</p> <ol style="list-style-type: none"> (1) When falling in the water at an air temperature of about 7°C and a water temperature of about 16°C, the fisher left the lifebuoy several times, resulting in exhaustion and a decrease in body temperature. (2) It is probable that because the floating vest the fisher wore had sufficient buoyancy, he was floating in a backward inclining position with his face above the seawater after falling in the water. However, because he was drifting against higher-than-3m waves and rough return waves in the shallow water, he was prone to taking in seawater.

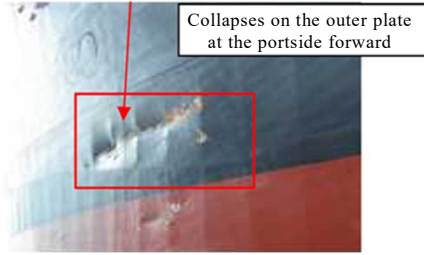
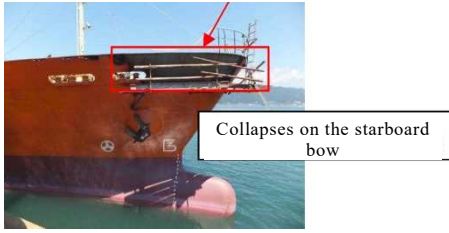
<p>Probable Causes</p>	<p>It is probable that, when the storm warning was issued in SETO NAI KAI, including off the north coast of Shikoku, due to incoming Typhoon 5, the Vessel A dragged anchor while it was anchored with a single anchor, waiting at Takuma Port for its cargo. Master of the Vessel A, instead of evacuating to a safe area, heaved up the anchor and returned to the anchoring area at 275° of and about 1,500m from the Mitamaiwa light beacon, which was directed by an agency of the Vessel A, to reset the anchor, but that didn't work. While the anchor was lifted, the Vessel A became un-maneuverable and drifted; as a result, it collided with the the Vessel B.</p> <p>It was probable that Master of the Vessel A returned to the position 275° of and about 1,500m from the Mitamaiwa light beacon, which was directed by an agency of the Vessel A, to retry anchoring instead of evacuating to a safe area because he didn't understand anchoring, by itself, would not provide a sufficient escape from the adverse weather.</p> <p>It was probable that the Vessel A dragged anchor because, even though Master of the Vessel A received information about the predicted stormy weather due to incoming Typhoon 5, he didn't know the required length of anchor chain extension nor measures against strong wind and continued to be anchored with single anchor.</p> <p>In the area crowded with many other anchored ships, Master of the Vessel A had retried to anchor the Vessel A, but he was unsuccessful. So, he used the engine from dead slow ahead to slow ahead, in a low load operation. It is probable that as a result, the Vessel A lost control of its attitude and became un-maneuverable.</p>

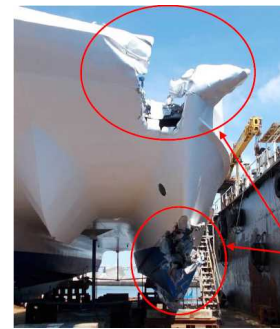
December 20, 2018	July 26, 2017 Hanshin Port Kobe District 6 Kobe Airport east approach light beacon	Passenger ship SORA Contact with an approach light beacon
	Summary	<p>The vessel, with the master, the chief engineer, and 29 passengers on board, departed from the Kaijo Access Terminal of Senshu Port, heading north for a pier at the Kobe Airport Kaijo Access Terminal in Hanshin Port Kobe District 5. Then the vessel collided with the Kobe Airport east approach light beacon in Hanshin Port Kobe District 6.</p> <p>On the vessel, four passengers were severely injured, and 21 passengers and two crew members suffered minor injuries. The hull suffered collapses and other damage to the portside bow area. The Kobe Airport east approach light beacon suffered abrasions to the support legs.</p>	
	Probable Causes	<p>It is probable that this accident occurred in the following situation. At night, the beacon of the Kobe Airport east approach light beacon E2 was difficult to see due to the illuminating lights at Port Island's container terminal in the background. The vessel was heading north in Hanshin Port Kobe District for a pier at Kobe Airport Kaijo Access Terminal in Hanshin Port Kobe District 5. The master was watching only visually without monitoring the radar installed on the port side of the steering stand and the GPS plotter with overlaid radar images. The master did not notice that the vessel was heading for the Kobe Airport east approach light beacon, then the ship collided with the beacon.</p> <p>It is probable that the reasons why the master was watching only visually without monitoring the radar installed on the port side of the steering stand and the GPS plotter with overlaid radar images were as follows. (1) The master was chatting with the chief engineer. (2) He had been able to see in the past the light of the Kobe Airport east approach light beacon E2 when approaching the lighthouse.</p> <p>By leaving ship steering to the chief engineer, the master was handling his smartphone. The master kept chatting with the chief engineer, and he was watching only visually without monitoring the radar installed on the port side of the steering stand and the GPS plotter with overlaid radar images. Paying less attention to return the vessel into the reference route, the master navigated the ship on the west side of the reference route without displaying it on the GPS plotter with overlaid radar images. Furthermore, the chief engineer transferred ship steering to the master without sharing information about the light beacon E2, and he was checking records in the engine logbook without watching the bow direction. It is probable that such behavior shows a lack of discipline in the vessel's wheelhouse, which was attributable to the occurrence of this accident.</p> <p>One of the reasons why the discipline in the wheelhouse was not maintained was that OM Kobe Co., Ltd. had not defined and disseminated the specific details of the standard arrangement of mariners on watch duty that the Safety Management Rule requires to be stipulated. At the same time, there was not enough safety education and training to learn the</p>

<p>importance of ship navigation. Those include watching with the help of the radar installed on the port side of the steering stand and the GPS plotter with overlaid radar images, sharing the same information among crew members, and navigating along reference routes as much as possible. Based on this information, it is probable that the safety management of OM Kobe Co., Ltd. was not working effectively, which was attributable to the occurrence of this accident.</p> <p>There were many injuries, including those who suffered severe injuries. It is probable that many passengers did not wear seat belts.</p> <p>The collision caused the passengers to be thrown in the bow direction, hitting themselves against the front chairs. It is somewhat likely that the chairs that came off the floor contributed to this magnitude of human damage.</p>	
	Report	<p>http://www.mlit.go.jp/jtsb/ship/rep-acci/2018/MA2018-12-1_2017tk0010.pdf http://www.mlit.go.jp/jtsb/ship/p-pdf/MA2018-12-1-p.pdf (presentation material) See Page 52 of “Feature 2: Summaries of Major Marine Accident Investigation Reports (case studies)”</p>

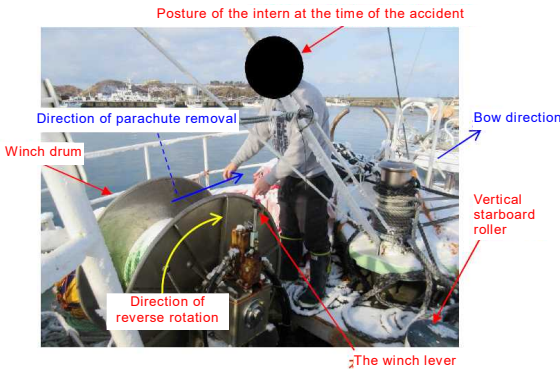
11	Date of Publication	Date and location	Vessel type and name, accident type
	December 20, 2018	July 31, 2017 Off the east-northeast coast of Rebun Island, Rebun Town, Hokkaido	Fishing vessel EIFUKUMARU Injury of a crew member
	Summary	<p>The vessel, with the skipper, deckhands, and a technical intern on board, was fishing for squid off the east-northeast coast of Rebun Island, Rebun Town, Hokkaido. The technical intern was caught in a winch drum and was severely injured.</p>

Probable Causes	<p>This accident occurred when the vessel was lifting a parachute sea anchor at night off the east-northeast coast of Rebun Island. It is probable that the technical intern had his right hand caught between the winch drum and the parachute.</p> <p>It is somewhat likely that the reason why the technical intern had his right hand caught between the winch drum and the parachute was that he rotated the winch drum rapidly in the winding direction while gripping the parachute with the right hand.</p> <p>The technical intern had been on board the vessel for about ten days before this accident in which he rotated the winch drum rapidly in the winding direction. The technical intern was unable to communicate well with other people in Japanese, and the skipper was instructing and coaching him in Japanese with gestures. The technical intern was not proficient in the operation to remove the wound parachute from the winch drum. As such, it is somewhat likely that the technical intern was not fully aware of the danger of the operation.</p> <p>Not knowing the provisions in Article 28 of the Rules for Seafarers Labour Safety and Health, the skipper had the technical intern conduct the operation to remove the wound parachute from the winch drum. It is probable that this situation was attributable to the occurrence of this accident.</p>

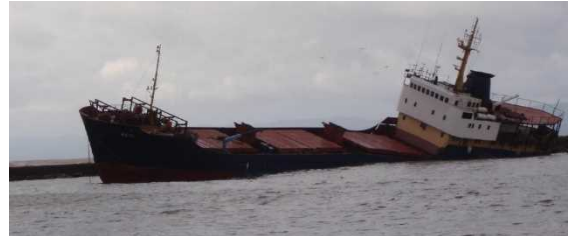
Summary	<p>While moored at Public Berth No. 1, Toyama Section, Fushiki-Toyama Port, the Vessel received the effects of wind and waves occurring with the approach of Typhoon No. 21. Her mooring rope broke and she drifted within the port. Subsequently she attempted to proceed toward the port's exterior using her engine, however ship maneuvering became difficult and, she ran aground on tetrapods on the east side of the Toyama West Breakwater on the opposite bank of the berth.</p> <p>The Vessel's engine room and other areas flooded and she became a total loss. However, there were no fatalities or injuries among her crew.</p>
Probable Causes	<p>It is probable that, while the Vessel was moored at Public Berth No. 1, near the port's entrance of Toyama Section, Fushiki-Toyama Port at night, under conditions in which Typhoon No. 21 was approaching, she drifted within the port because her mooring ropes broke and subsequently, although she attempted to head outside of the port using her engine, she came under the effects of the wind and waves, ship maneuvering became difficult, and she drifted and ran aground on tetrapods.</p> <p>It is probable that the Vessel's mooring ropes broke because she received the effects of the wind and waves that expedited the hull's motion for the reason that she was using mooring ropes with reduced strength that resulted from fatigue degradation and age degradation, and consequently load that exceeded the strength of the mooring ropes being used was applied to them.</p> <p>It is somewhat likely that, although he added additional mooring ropes, the Master's use of multiple mooring ropes of different diameters together and mooring of the Vessel with ropes made slack contributed to the breaking of the mooring ropes.</p>

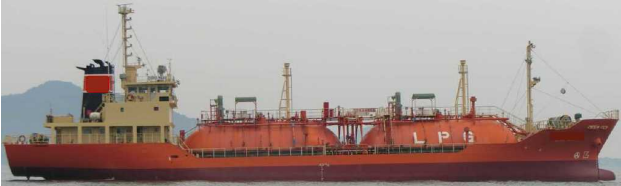
Suo-Oshima Town, Yamaguchi Prefecture	
Summary	The vessel, with the master and eight other crew members on board, was heading west-southwest for Tokuyama Kudamatsu Port, Yamaguchi Prefecture. Off the east coast of Okikamurojima, Yamaguchi Prefecture, the vessel found the oil box of the controllable pitch propeller swinging and oil leaking from the same place. As an emergency measure, the vessel stopped its main engine and cast anchor in Agenosho Bay, Yashirojima, Yamaguchi Prefecture. The vessel had the intermediate shaft broken. The ship also had one of the four mounting bolts for the oil box of the controllable pitch propeller broken, and the other three bolts were loosened.	
Probable Causes	<p>It is probable that the incident occurred in the following situation. The vessel was heading west-southwest at night off the east coast of Okikamurojima for Tokuyama Kudamatsu Port. The vessel had the intermediate shaft broken, and the box of the controllable pitch propeller was swinging, and hydraulic oil was leaking from the box. In Agenosho Bay, where the vessel cast anchor, the vessel lost control as the controllable pitch propeller became uncontrollable.</p> <p>It is probable that the intermediate shaft broke for the following reason. A crack propagated due to vibration, aging, and other reasons from a place that is difficult to check from the outside. The swinging box of the controllable pitch propeller was attributable mainly to the broken intermediate shaft that was swinging. It is somewhat likely that the insufficient strength of mounting bolts and nuts also contributed to this accident.</p>
