Chapter 4 Railway accident and serious incident investigations

2 Procedure of railway accident/serious incident investigation

3 Statistics of investigations of railway accidents and serious incidents

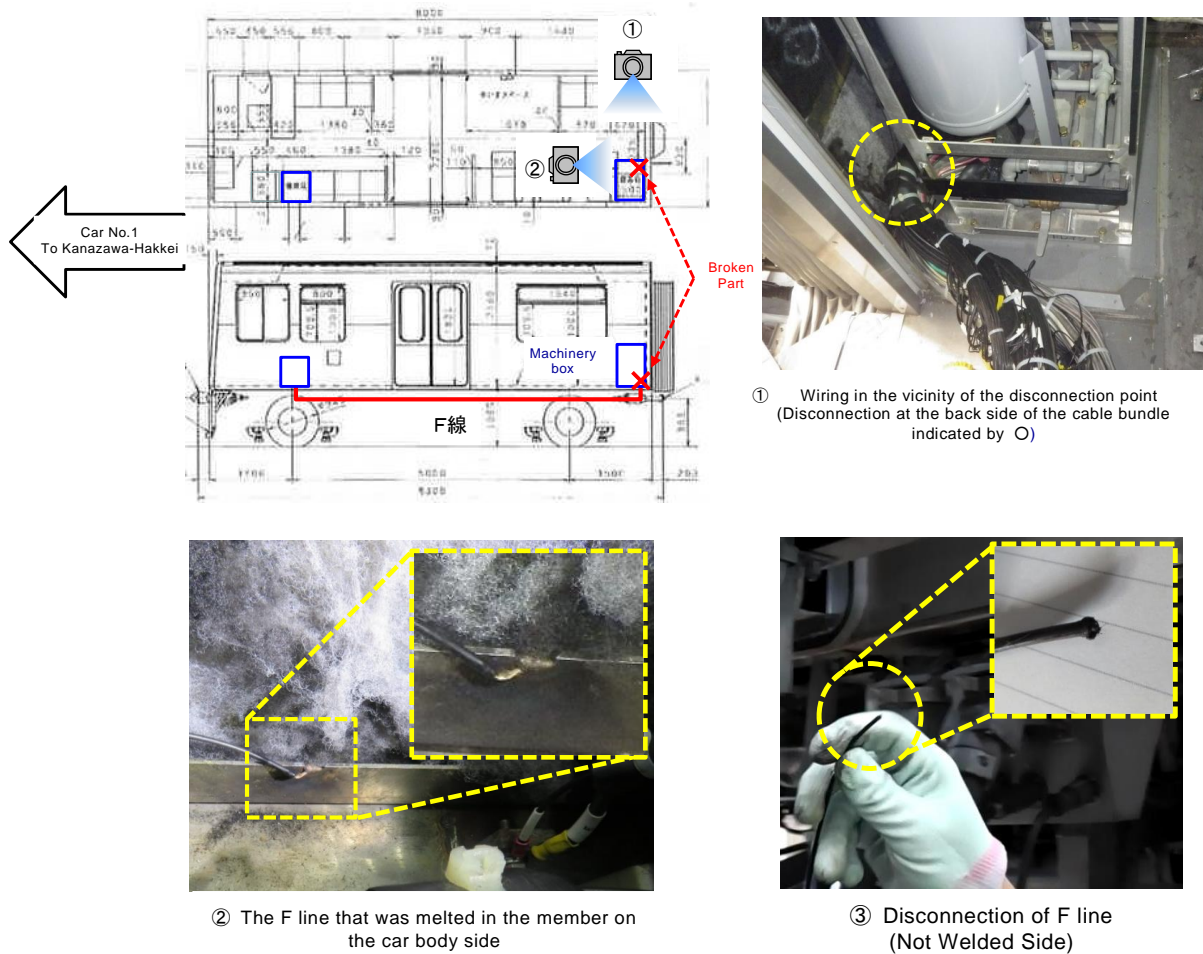
Figure 1 Disconnection of F line

(2) Lines F and R were routed through the entire 5 - car train, and the disconnection of Line F was found near the rear end of the first car (on the connecting side with the second car), and one of the disconnection parts was welded to the member on the car body side.

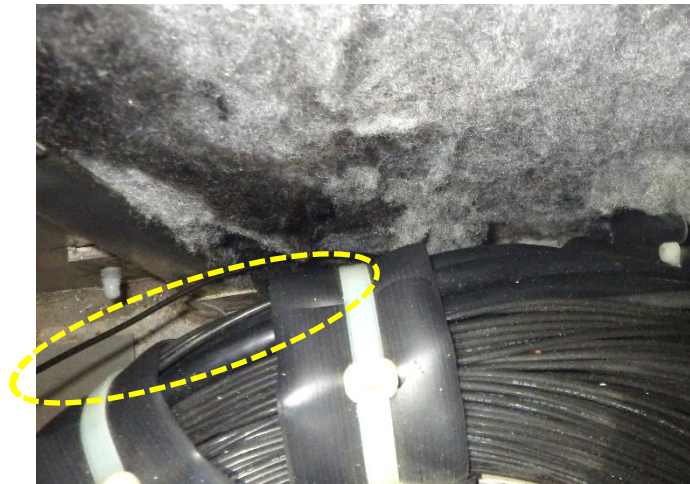
Figure 2 F line out of bundle

(3) Only one of the F-lines were separated from the bundle of bundled cables.

* With regard to Content 1 (3) of the Factual Information, in the subsequent investigation, the F line one of the 4 cable bundles. It was confirmed that the cable was in the cable bundle at the bottom. (February 27, 2020 interim report)

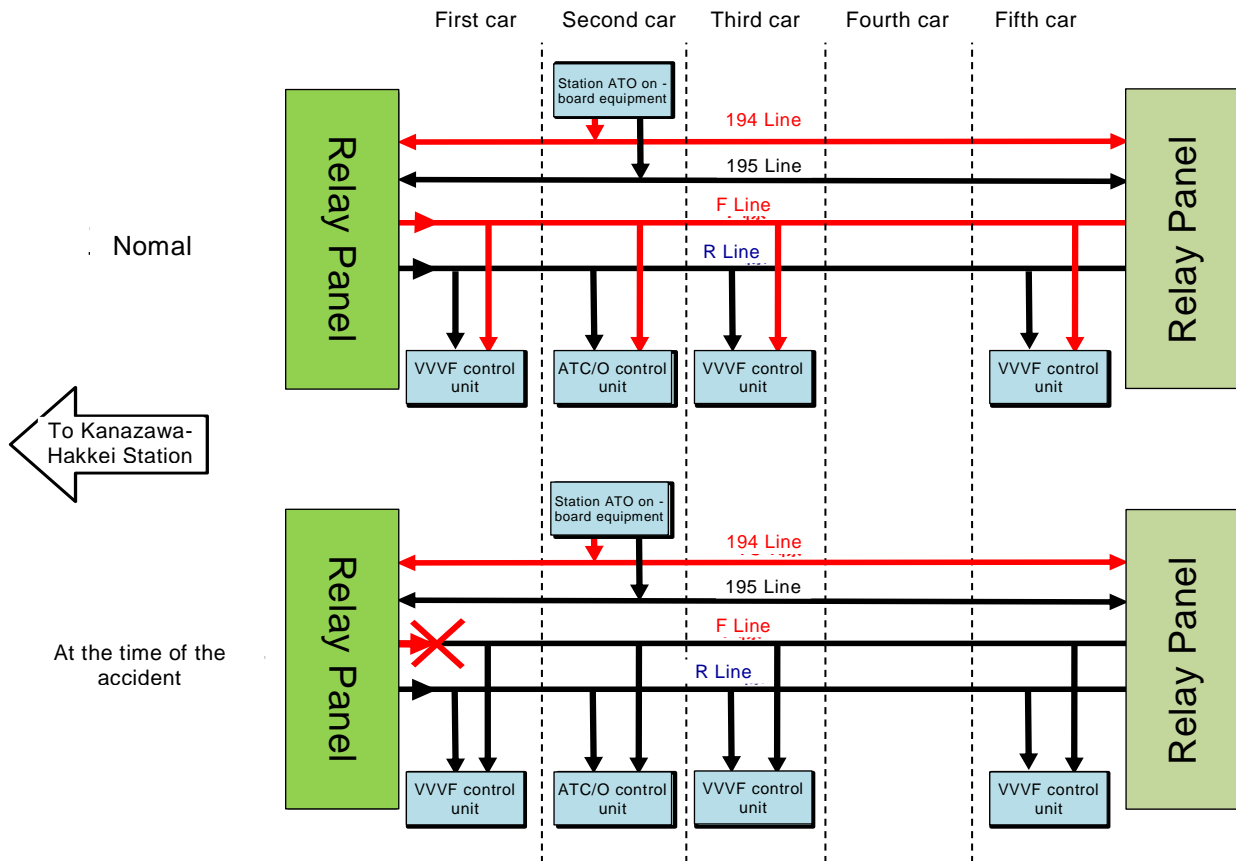
Figure 3 : Schematic diagram of vehicle related wiring (red line indicates pressurization when traveling direction is down)

(4) The traveling direction is set by the on-board equipment of the station ATO, and a voltage (100 V) is applied to the F line or R line through a relay to transmit the traveling direction to the VVVF controller. However, the condition of the F line was not transmitted to all the VVVF controllers due to the disconnection of the F line.

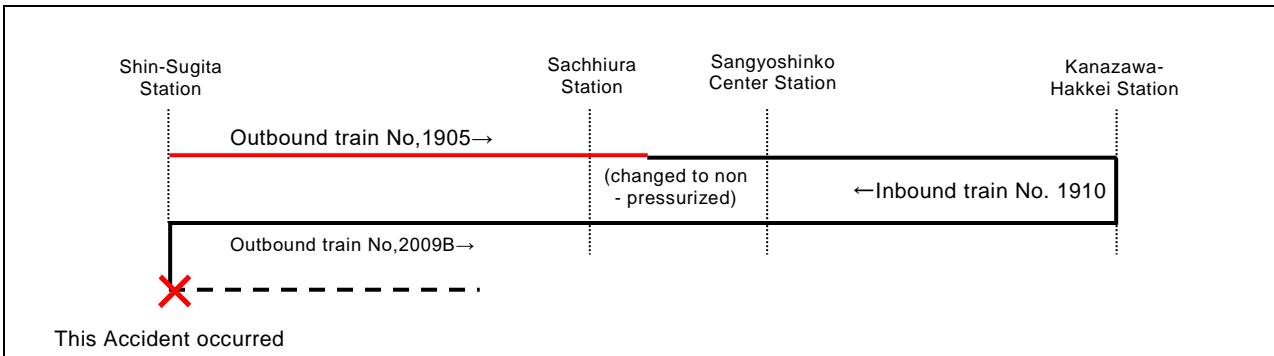
Figure 4 Pressing Condition of F Line (Red Line Indicates Pressing of F Line)

- (3) While the outbound train (No. 1905) was running (between Sachiura Station and Sangyoshinko Center Station), the voltage on Line F changed from pressurized to non - pressurized. The next inbound train (No. 1910 (the inbound train just before the accident occurred)) was running in the correct direction because voltage was applied to the open R - line.

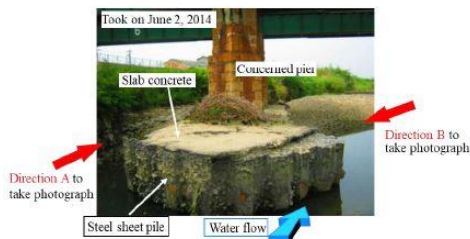
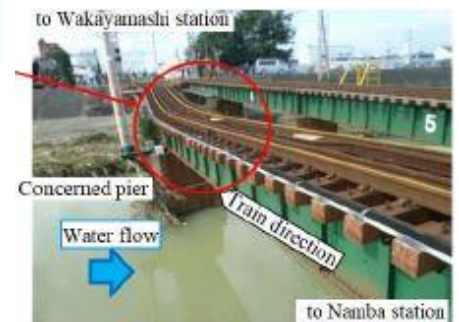
The damages had started from the part of the soldier beams and lagging structure using the log piles and the wooden plates, where it was fragile compared to the steel sheet piles, as the riverbed had been subsided and the foot protection had been exposed due to the erosion by the flowing water after 2008.

The side surface of the footing had been exposed by the deterioration of the washed away cobble stones, etc., between 2012 and 2014.

Probable causes : It is highly probable that the accident occurred as the 2nd axle in the rear bogie of the 3rd vehicle had derailed to right because the train was running on the track on the bridge significantly deformed by the subsided and tilted pier, after that, the derailed axle restored in the level crossing while passed as being derailed.

It is probable that the pier had subsided and tilted because the ground in around the pier was scoured in wide area by the swollen river water at the time of the occurrence of the accident, while the function to protect the piers from scouring had already been deteriorated before the occurrence of the accident, such as the subsided riverbed in around the pier caused by the concentration of the river water due to the change of the water route, damages of the foot protection as the scour protection work, etc.

It is probable that the deterioration of the function to protect scouring was related with that the measures such as the repair, reinforcement, etc., of the foot protection were not implemented, because the evaluation for the unusual status were not implemented sufficiently, even though the unusual status of the foot protection of the pier was recognized in the inspection of the piers.

It is required to judge the healthiness by comprehending the unusual status of the scour protection works such as the status of the riverbed and the foot protection, etc., from the viewpoints to maintain the function of the scour protection works against the swollen water, for the piers which the significant reduction of the natural frequency was not found at that time.

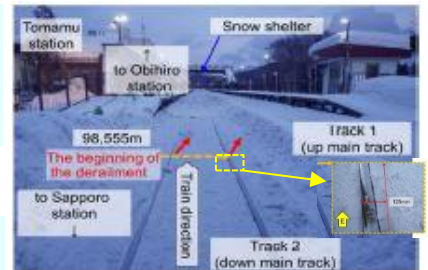
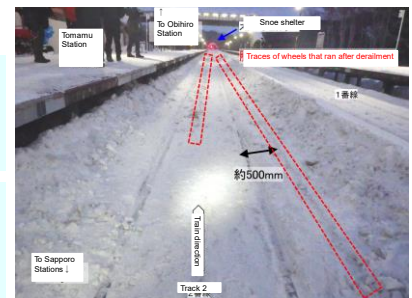
Probable cause: It is probable that the accident occurred as the flange of the right wheel of the 1st axle in the front bogie of the 3rd vehicle climbed over the right rail and derailed at the place where large amount of ice and snow were stacked on the track, while the train was passing the straight track section in the premises of the station, and after that the train restored in the turnout while passing in the status as derailed. It is somewhat likely that the 1st axle in the front bogie of the 3rd vehicle of the train derailed because the side beam of the front bogie of the 3rd vehicle was pushed up over the ice and snow stacked on the railway track, at the same time, the wheel flange was raised up by the hard ice and snow which had existed in around the flangeway. It is somewhat likely that large amount of ice and snow had been stacked on the railway track in around the place where the derailment accident occurred, related with a large amount of snow fall and stacked snow in the previous day of the concerned accident, and that the snow removal works had not been implemented for 6 days before the occurrence of the accident.

It is considered necessary to remove snow from railway tracks at a higher frequency in consideration of the conditions of snowfall, snow accumulation, and accumulated snow on the site, and to judge the appropriate timing, scope and method.

When removing snow, it is especially necessary to pay attention to the ice and snow formed higher than the rail surface on the outside of the track gauge in the railroad section where freight trains run, considering the side beam position of freight cars.

Since it is necessary for the driver to take corrective action immediately after detecting a derailment, it is desirable to develop and popularize a device that can notify the driver of the occurrence of a train derailment.

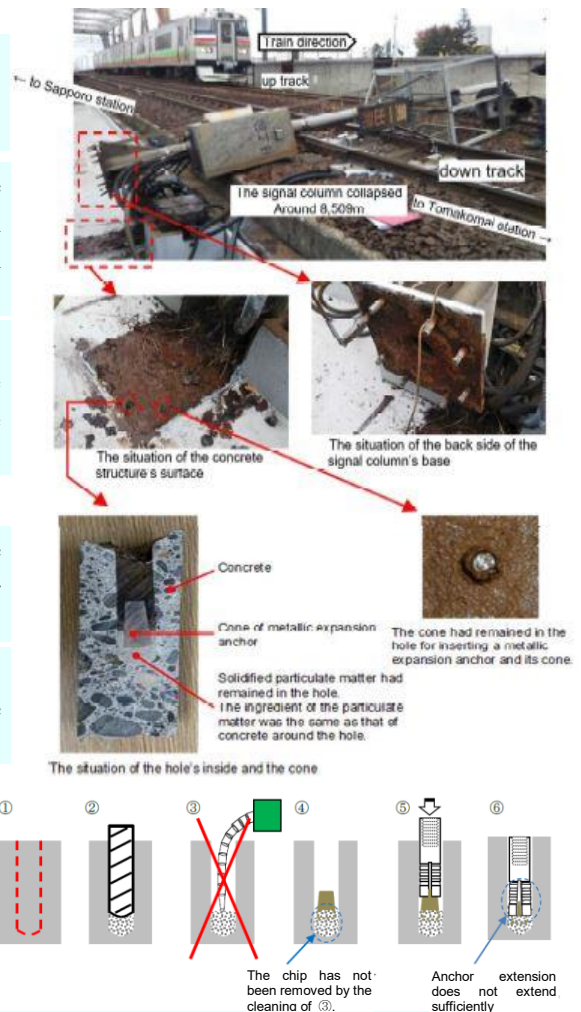
Therefore, it is somewhat likely that the signal column had collapsed because the external force exceeded the tolerance of the metal extension anchor fixing the signal column of the home signal, as the anchor of the metal extension anchor was loosening gradually, caused by vibration due to running trains on the viaduct in addition to the effects of the external force such as windstorm, earthquake, etc., in the period of about 38 years from planting, in the status that the metal extension anchor supporting the signal column had been insufficient endurance against tensile force, in cooperation with the wind pressure of about 20 m/s instantaneous wind speed on the collapsed day.

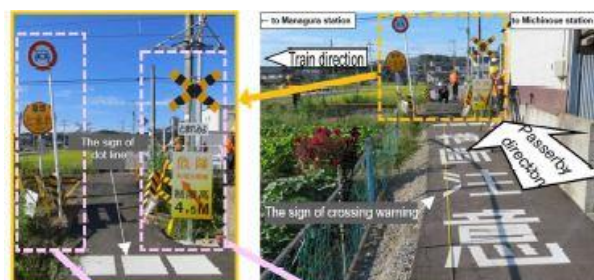
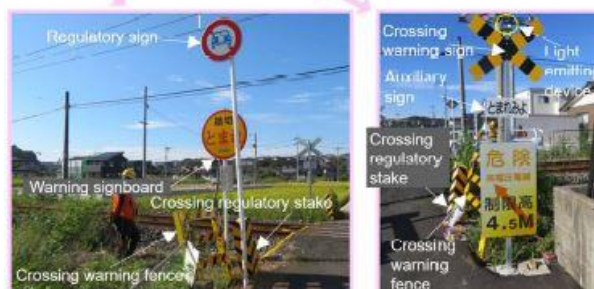
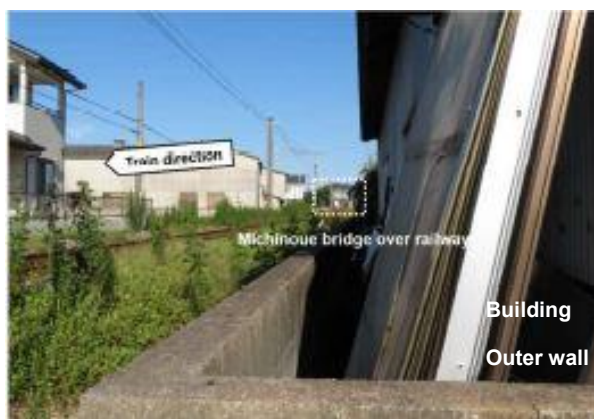
A bicycle with a child entered a class 4 level crossing and collided with a train.

It is somewhat likely that, from the child's point of view, it was not possible to easily recognize that "the warning sound did not sound and the crossing gate did not descend, but the train might be dangerous if it approaches and crosses over." Therefore, it is considered probable that sufficient measures were not taken in terms of facilities in consideration of the child's point of view and in terms of education concerning the existence of the class 4 level crossing.

- Necessity of the traffic safety education on the class 4 level crossing based on the viewpoint of the children.
- Necessity of the measures in the region where the population is increasing.

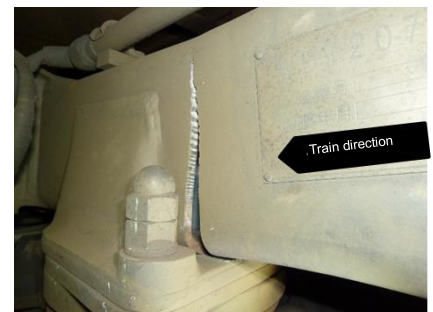
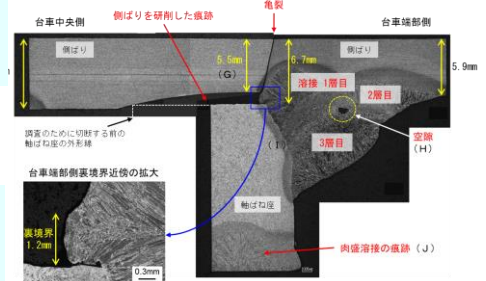
It is probable that on the previous day, the crack had developed to the extent that it affected the rigidity of the side beam, and that the crack had further expanded to the extent that the side beam was deformed during the operation on the day and affected the bogie components.

Probable Causes: It is highly probable that the concerned serious incident occurred because the gear type flexible shaft coupling displaced exceeding the allowable range and damaged due to deformation of the bogie frame caused by the crack which had generated in the side beam of the bogie frame of the vehicle and had expanded by fatigue.

The crack had generated in the side beam of the bogie frame of the vehicle because it is somewhat likely that the split had generated in around the back boundary of the slot welded part where the crack had originated when the welding work had implemented. In addition, it is highly probable that the crack had generated related with the followings.

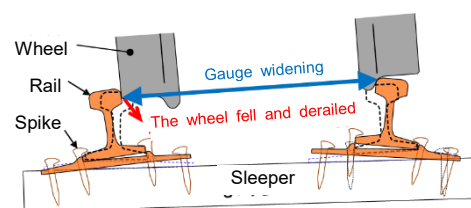
Image of a derailment caused by gauge widening

The causes of train derailment accidents are diverse. One of them is the "derailment on the track due to an increase in the gauge widening." This is a phenomenon in which the gauge widening, which is the distance between the left and right rails, has abnormally increased from the basic dimension (for example, 1067 mm for narrow rails, which are often used on domestic conventional lines), causing the wheels to fall and derail within the gauge widening.
