Chapter 5 Marine accident and incident investigations

1 Marine accidents and incidents to be investigated

2 Procedure of marine accident/incident investigation

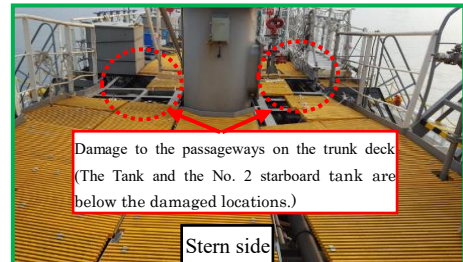
(Damage to the Tank)

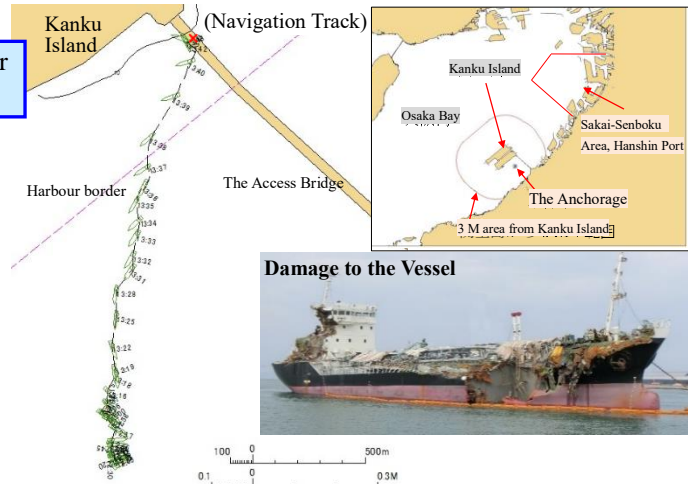
Damage to the Vessel

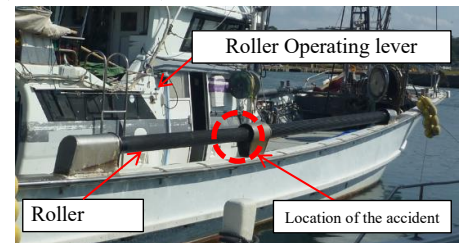
(Situation when injured)
