## Chapter 5 Marine accident and incident investigations

## 2 Procedure of marine accident/incident investigation

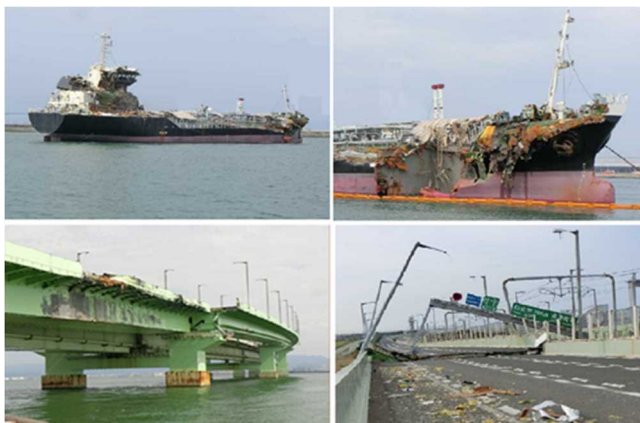
The deck on the starboard bow of the Vessel was crushed, and the road girder of Kansai International Airport Access Bridge was bent, broken, and scratched. The railway girder was collapsed, the rail was warped, and the gas pipe was broken. However, no crew members were injured.

In this accident, the HOUNMARU continued single anchoring at the east side of the Oil Tanker Berth ("the Anchorage") located on the southwest side of the Senshu Port in Osaka Prefecture, where Kansai International Airport Access Bridge is located about one nautical miles north of the southeast of the 'Kansai International Airport First Stage Airport Island' ("the Kanku Island") for the purpose of typhoon

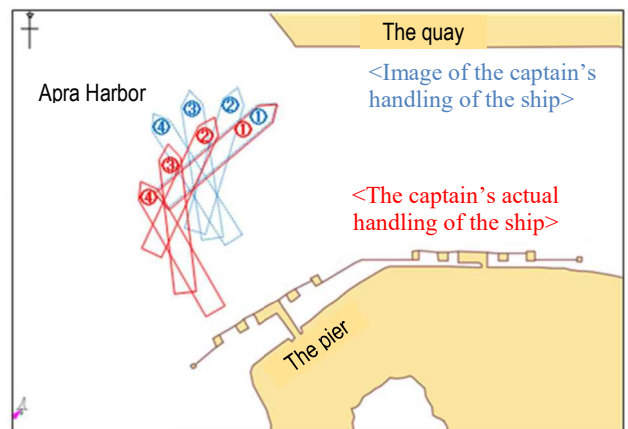
Difference between the captain’s image of his handling and the actual movement of the ship

It is likely that the captain wanted to hold a leading position in the undocking and turning of the ship and recognized that navigation officer C was a newcomer in training. All these factors likely led to his prioritizing his own judgements over the suggestions advice by the pilot and navigation officer C, which likely caused his continuation of tilting the joystick fully sternward.

**Probable cause:** It is probable that, during the ship’s left turn in an area west of the quay, the captain in an attempt to facilitate the turn tilted the joystick fully sternward although intending to tilt it fully in the starboard direction. He continued tilting the joystick fully sternward unaware of his mistake causing the ship to reverse with its bow rotating leftward when the stern collided with the pile dolphin of the pier.

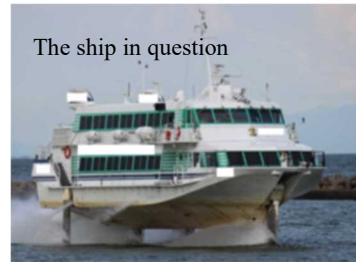
Seats of the ship (at the time of the accident)

At around 12:15, when the ship was navigating westward while increasing its speed, the captain observed white floating objects in the water near the port bow, so he took immediate action to drop the ship's hull to surface and steered full starboard, while the chief engineer began throttling down toward full stop.

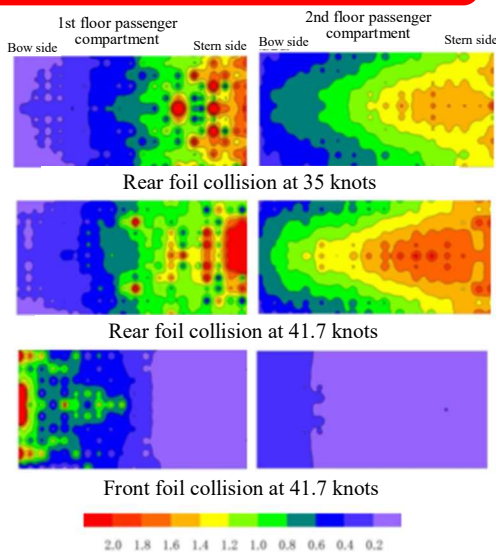
Speeds and upward acceleration for each collision point

Impact on the ship at around 12:16

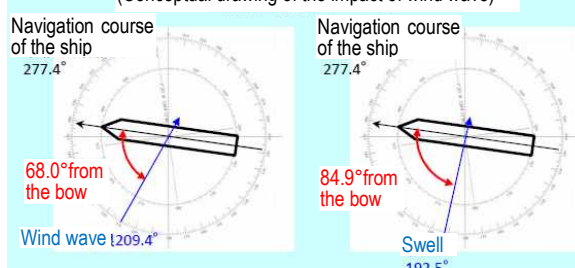
The ship was struck by winds and occasional blasts blowing diagonally from the front and by lateral waves.

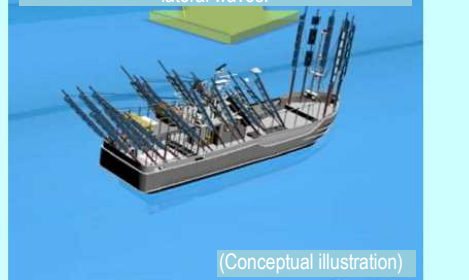
(Conceptual illustration)

(Mechanism resulting in the capsizing)
