Major activities in the past year

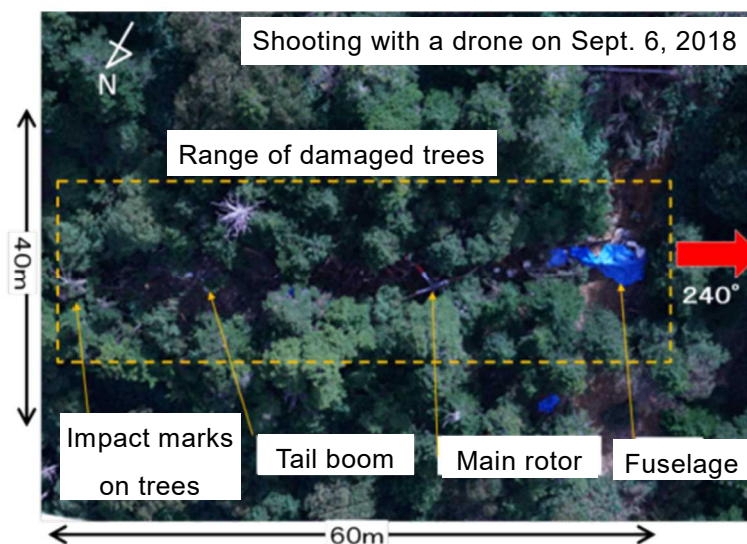
On-site photographing by drone has enabled investigators to easily grasp the distribution of wreckage by capturing a wide image of the site (see Photo 2), visually reveal the mark from a contact point to a stop position on a runway when landing, or depict a flight path of an airframe from a contact position to a crash location with an obstacle, etc. in three dimensions (see Photo 2). In addition, it is also possible to create three-dimensional digital images, which are called orthomosaic images, based on a series of images obtained through a programmed flight using photogrammetric software.

Photo 2. Distribution of wreckage and a trace up to the stop position

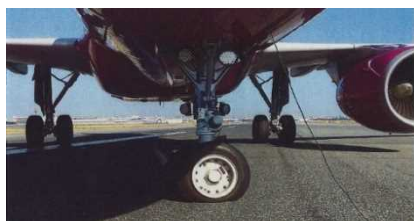
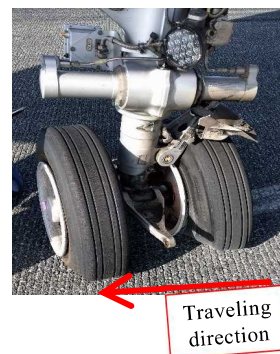
On Saturday, March 24, 2018, a passenger aircraft was forced to stop on the runway with its nose wheel turned sideways at about 90 degrees after landing at Fukuoka Airport.

Consequently, the aircraft was unable to continue taxiing. (See Photo 1)

Photo 1. Serious incident aircraft
(at the time of the serious incident)

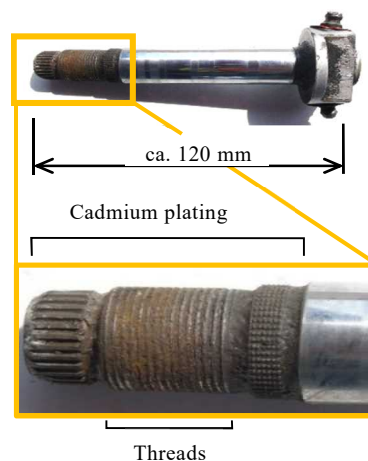
After the accident occurred, the pin was found on the runway, and it was revealed that the threads of the pin were damaged and corroded (see Photo 2). Because the damage and corrosion of the pin threads might have caused it to fall out, and other aircrafts of the same type might have similar potential troubles, the Japan Transport Safety Board provided information on the damage to the pin to the Civil Aviation Bureau. In response to the information, the Civil Aviation Bureau instructed business operators in Japan that operate aircrafts of the same type to inspect the concerned pins. As a result, a corroded pin was found on an aircraft of the same type, and thus, necessary measures were taken to prevent the pin from falling out, etc.

The accident investigation and analysis were carried out to determine the cause of the pin falling out, cooperating with the French aircraft accident investigating authority, the BEA (Bureau d'Enquêtes et d'Analyses: France is the State of Design and Manufacture of the aircraft). As a result, it was revealed that repeated pin installation and removal for inspection damaged the cadmium plating applied to the pin threads to prevent corrosion. Corrosion started and progressed in the damaged cadmium plating, subsequently the threads got damaged, and eventually the pin fell out. It was also revealed that inappropriate work at the contracted maintenance operator

Photo 2. Apex pin

might have accelerated the corrosion progress.

Based on these investigation results, the aircraft manufacturer is to instruct aircraft operators to conduct periodic inspection of the pins concerned, additionally, the aircraft manufacturer is to take measures to prevent such recurrences by clarifying such as the maintenance manual, and developing pins with improved corrosion resistance as permanent measures (see Chapter 3 (page 45)).

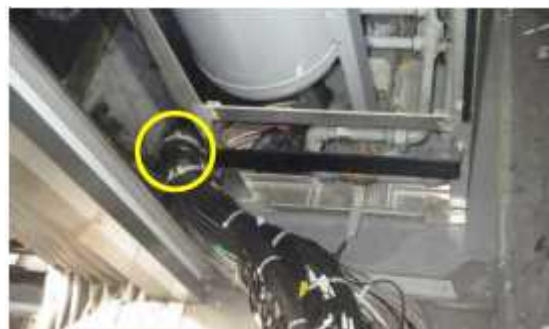
Wired status viewed from aisle side, broken in back side of the circled bundle of cables

It is probable that the electric wire to convey the running direction in the Device Room of the train was broken, so the running direction did not change in the control device at the turn-back station. Therefore, the train ran in wrong direction, resulting in collision with the car stop.

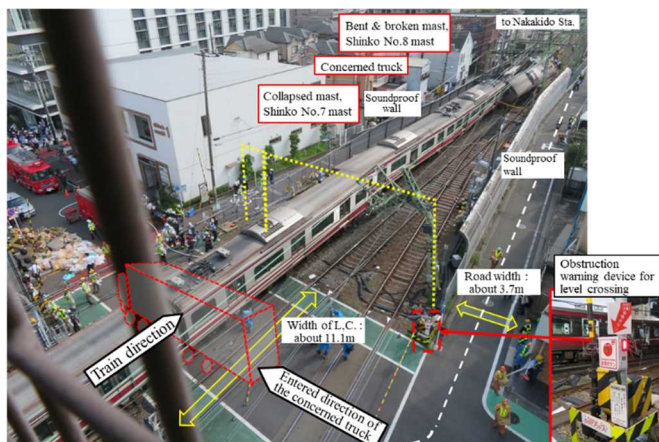
Status of around the accident site

The JTSB concludes that the probable cause of this accident was certain that the truck entered the Level crossing and hindered the route of the train, and the train could not stop before the Level crossing although the obstruction warning signal of the Level crossing had been indicating the stop signal, then collided with the Truck.

As a result, it was revealed that it is likely that the Truck stayed in the Level crossing because it took a long time to pass through due to the narrow width of the road. In addition, it was revealed that the brake operation of the train involved with the installation position of the obstruction warning signal, obstructed view, and so on, delayed noticing of the stop signal of the obstruction warning signal, and the rules for handling the brake when the stop signal was indicated were not clearly stated, and so on.

The accident investigation report published describes not only the analysis result above but also measures considered to be necessary for preventing the recurrence of such an accident, e.g., taking measures to prevent automobiles from wrongly entering narrow roads that are hard to pass, providing the appropriate number of obstruction warning signals at appropriate positions, and more (see Chapter 4 on page 73).

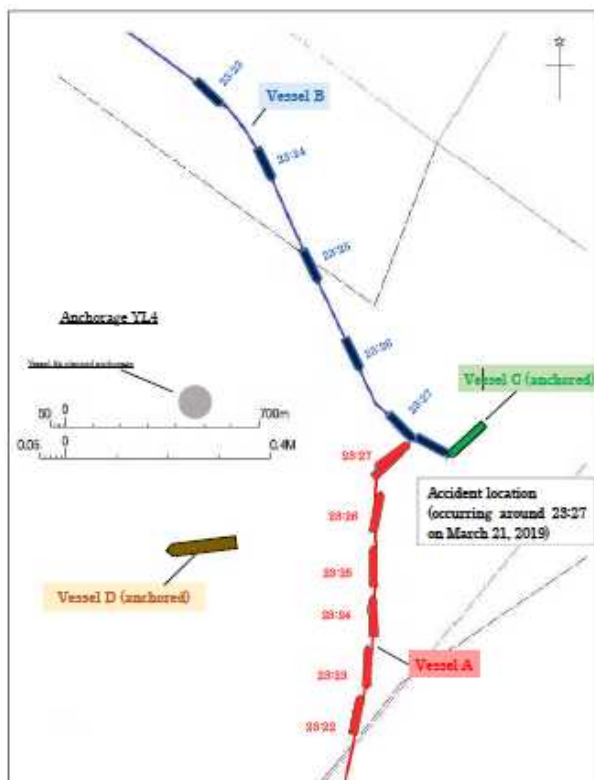
Vessel C and another anchored vessel, and the danger of collision was rising, Vessel A and Vessel B collided because Vessel A intended to pass Vessel B port-to-port and Vessel B intended to pass Vessel A starboard-to-starboard, and subsequently Vessel B collided with Vessel C.

Estimated navigation routes

As a result, it was revealed that it is probable that Vessel A could have prevented the accident by taking such measures as promptly reducing speed, without expecting Vessel B to make a starboard turn, and Vessel B could have prevented the accident by taking such measures as promptly reducing speed, without attempting to navigate near Vessel A's bow.

Based on these investigation results, the Japan Transport Safety Board made safety recommendations to the management companies of Vessel A and Vessel B to instruct including the captains to take measures to avoid collision by promptly reducing speed, etc., while sufficient time is available after confirming maneuvering intentions with the other vessel by engaging in VHF

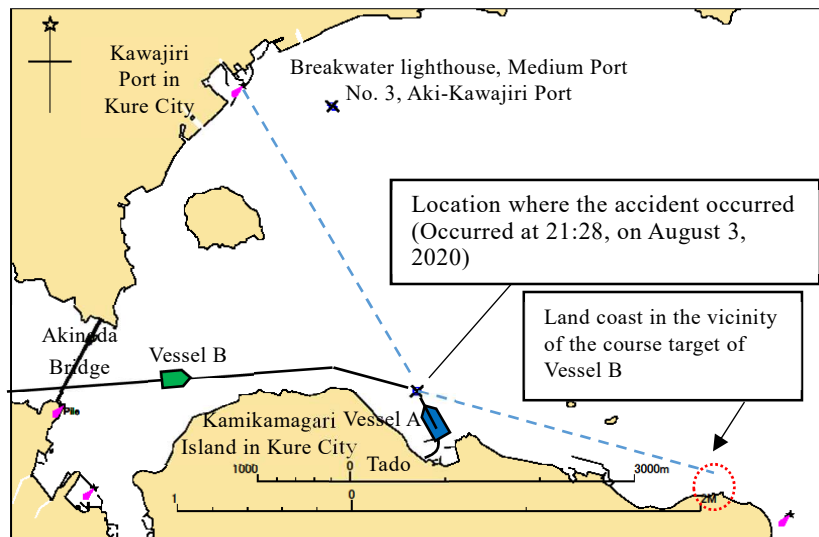
At night, the captain of the pleasure boat kept proceeding on the same course and at the same speed, focusing on setting the course to the breakwater lighthouse, Medium Port No. 3, Aki-Kawajiri Port. The captain of the fishing vessel was assuming that there was no vessel in the starboard direction and kept proceeding with the same course and at the same speed with a blind spot in the starboard bow direction. Therefore, it is probable that they collided without noticing that they were mutually approaching.

Schematic diagram of accident occurrence progress

As preventive measures against recurrence based on the investigation result, the Japan Transport Safety Board offered opinions as follows: (1) during navigation captains shall keep their eyes on the surroundings by the methods such as using a radar, without assuming that there are no other vessels around and without focusing on a specific direction only, (2) keep watching, covering any blind spots in the bow direction by standing up or moving horizontally and (3) persons who get on board small vessels shall always wear a life jacket on exposed decks.
