Chapter 3 Aircraft accident and serious incident investigations

Aircraft accident investigation reports published in 2021

Aircraft serious incident investigation reports published in 2021

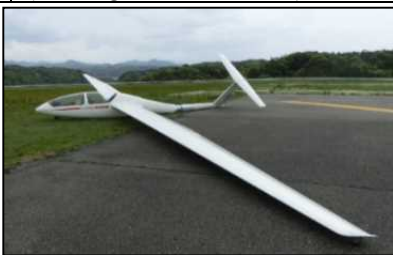
2	Date of publication	Date and location	Operator	Aircraft registration number and aircraft type
	February 18, 2021	April 29, 2019 At Iwami Airport	Privately owned	JA2500 Glaser-Dirks DG-500M (Motor glider, two-seater)
	Summary	The aircraft attempted to land with its main landing gear remained retracting in gliding condition because the engine was not restarted in flight with a total of two people on board including a pilot and a passenger. Then it hit the ground surface and suffered damage to the airframe.

Probable causes	It is probable that this accident occurred because the right wing tip contacted with the ground surface when the aircraft was making a right turn for a landing, it hit the ground surface while losing its balance and suffered damage to the airframe. Regarding the fact that the right wing tip contacted with the ground surface, it is probable that because the engine and the propeller which were unable to stow produced a large drag and the wind condition was a headwind, the Aircraft entered the Airport at a low altitude while losing much altitude.

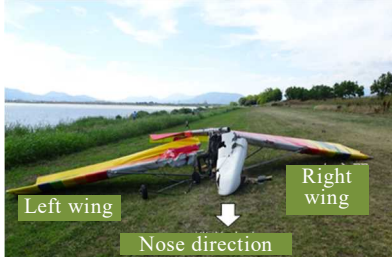
Report	https://www.mlit.go.jp/jtsb/aircraft/rep-acci/AA2021-3-2-JE0205.pdf (In Japanese only)			
7	Date of publication	Date and location	Operator	Aircraft registration number and aircraft type
	April 22, 2021	June 9, 2020 In Shiroishi Town, Kishima District, Saga Prefecture	Privately owned	JR0862 Sanyo Tekko EX-03C PUFFIN-LT447 (Single-seat ultralight plane))
	Summary	<p>The aircraft crashed at Kita-Ariake temporary airfield during the jump flight.</p> <p>Only a pilot was on board and died.</p> <p>The aircraft got heavily damaged with no fire.</p>

Probable causes	<p>It is probable that this accident occurred because the propeller blade got damaged after starting the takeoff run, subsequently some scattered fragments collided with the rear strut of the left wing, then the strut buckled and also the left-wing front joint was separated, which caused the aircraft to crash.</p> <p>Regarding the damaged propeller blade, there may be a possibility of external damage due to a collision with foreign matter or potential internal damage, and influence in association with the processing to change the propeller diameter, however, none of them were identified.</p> <p>Regarding the separation of the left-wing front joint, it is probable that an inappropriate assembly and maintenance of the aircraft as well as the buckled strut were involved.</p>

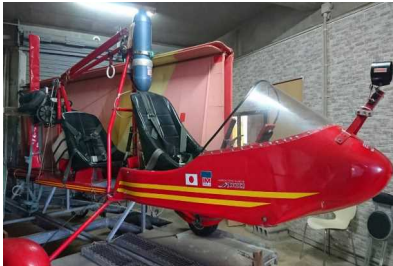
mainly responsible for maneuvering the aircraft. PM is an abbreviation of Pilot Monitoring mainly responsible for monitoring flight status of the aircraft and cross-checking of PF's maneuvering and undertakes other nonoperational tasks.		
	Report	https://www.mlit.go.jp/jtsb/eng-air_report/JA01JC.pdf		
10	Date of publication	Date and location	Operator	Aircraft registration number and aircraft type
	July 29, 2021	January 3, 2020 In Miyako Island, Okinawa Prefecture	Privately owned	JR0251 Maxair Drifter XP-R503L (Two-seat ultralight plane)
	Summary	When the aircraft conducted a forced landing on the road in the vicinity of Gusukubenagama, Miyako Island, Okinawa Prefecture, its left wing collided with trees at the side of the road, and then fell to the ground. The airframe got heavily damaged and the passenger got severely injured.

Probable causes	During the flight, the engine speed did not increase, and the thrust required for continuous flying was not achieved. For that reason, it is probable that the aircraft started to descend, consequently colliding with trees before reaching the destination for the forced landing, fell to the ground and the airframe got damaged, and thereby the passenger got severely injured.

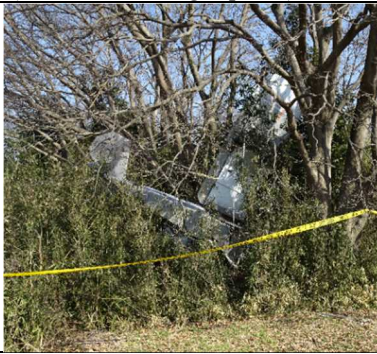
12	Date of publication	Date and location	Operator	Aircraft registration number and aircraft type
	October 28, 2021	February 20, 2021 In Moriya City, Ibaraki Prefecture	Privately owned	JR1734 Rans S-7 Courier R503L (Two-seat ultralight plane)
	Summary	The aircraft crashed into trees while flying the traffic pattern of the airfield of Ogashiwa, Moriya City, Ibaraki Prefecture. The aircraft got heavily damaged but the pilot was not injured.

Probable causes	It is probable that this accident occurred because of the change in the aircraft's angle of flight in response to the flap control and the inappropriate control in response to the speed reduction causing the aircraft to stall and decrease in altitude, which caused it to crash into the trees.		
Report	https://www.mlit.go.jp/jtsb/aircraft/rep-acci/AA2021-6-2-JR1734.pdf (In Japanese only)

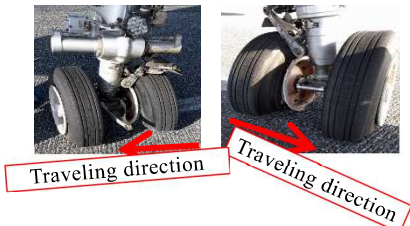
Report	https://www.mlit.go.jp/jtsb/eng-air_report/93-8550_JA216J.pdf			
3	Date of publication	Date and location	Operator	Aircraft registration number and aircraft type
	February 18, 2021	March 24, 2018 At Fukuoka Airport	Peach Aviation Limited	JA805P Airbus A320-214 (Large aeroplane)
	Summary	<p>The aircraft was forced to stop on the runway with its nose wheel turned sideways after landing at Fukuoka Airport as a scheduled flight 151 of Peach Aviation Ltd. Consequently, the aircraft was unable to continue taxiing.</p>

Probable causes	<p>In this serious incident, it is highly probable that the aircraft was unable to continue taxiing with its nose wheel turned sideways about 90° because during</p>

<p>landing roll, the pin that connected the upper and lower torque links was disconnected, and it had lost control of the nosewheel steering.</p> <p>It is probable that the pin disconnection occurred because the mechanical strength of the threads was deteriorated by corrosion developed on the pin threads, the pin assembly could not withstand the loading transmitting from the torque links to the nut during steering operations, and the nut was torn.</p> <p>Regarding the corrosion development on the pin threads, it is probable that the cadmium plating was damaged and the corrosion resistance was reduced because installations and removals of the pin and nut were repeatedly conducted after the aircraft production, and the torque links were misassembled.</p> <p>In addition, it is somewhat likely that during reinstallation at the heavy maintenance check on the aircraft, the lubrication of the pin threads was not sufficient and the torque links were misassembled, which contributed to the acceleration of the corrosion development on the pin threads.</p>

Safety Actions	<p>(1) Design manufacturer of the aircraft</p> <ol style="list-style-type: none"> 1. Following this serious incident, the Aircraft Maintenance Manual was reviewed. As a result of this review, the Aircraft Maintenance Manual was updated by making the cleaning procedures in the detailed inspection on the pin much clearer, and adding the inspection method regarding corrosion. Besides, the pin installation procedures were updated to ensure that the grease application method and region were clarified. In the revised manual, it is required to clean carefully and dry all the pin threads and splines, and to completely fill the threads and splines with reapplied grease. 2. To the A320 family operators, the "Technical Follow-Up" was issued to provide the information on this serious incident in detail and the revised Aircraft Maintenance Manual. In addition, the Service Bulletin was issued to recommend the operators to perform an initial inspection of the pin threads and recurrent A320 fleet inspections subsequently. 3. As a terminating action, the pin and nut with improved corrosion resistance will be developed on future. <p>(2) The Company</p> <p>After the serious incident, the Company performed inspections on the pin condition of their A320 fleet, and replaced the pin suspected corrosion. Although inspections on the pin threads and reapplication of grease used to be performed every six to ten months to monitor the status of the applied grease, after receiving the Service Bulletin mentioned as above, the inspection procedures were established in accordance with this Service Bulletin.</p> <p>It was decided that the pin inspection was established as an item for witness inspection by the Company's inspector in case of outsourcing the heavy maintenance check to other company.</p>

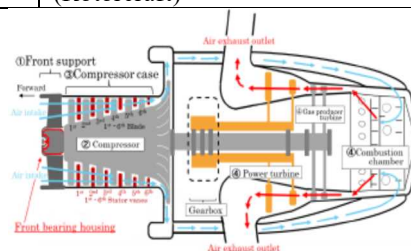
Report	https://www.mlit.go.jp/jtsb/eng-air_report/JA73AB_JA885A.pdf		
8	Date of publication	Date and location	Operator	Aircraft registration number and aircraft type
	May 27, 2021	June 19, 2019 Over an area near Aikawa Town, Aiko District, Kanagawa Prefecture	Toho Air Service Co., Ltd.	JA6697 Aerospatiale AS355F2 (Rotorcraft)
	Summary	<p>The aircraft took off from Tokyo Heliport for press and news coverage. While flying over an area near Aikawa Town, Aiko District, Kanagawa Prefecture, the No.1 engine (left engine) was shut down. The helicopter made a preventive landing on a riverbed of the Nakatsu River in Aikawa Town.</p> <p>During an inspection after landing, it was confirmed that fragments of the No. 1 engine penetrated the engine case.</p>		
	Probable causes	<p>It is highly probable that fracture of the 2nd stage blades of the engine (left engine) compressor during the flight, which resulted in damage to the subsequent stages blades and stator vanes, etc., and those fragments penetrated the compressor case.</p> <p>It is probable that fracture of the 2nd stage blades of compressor was caused by damage due to corrosion, which reduced the robustness of the blades.</p>

Safety Actions	<p>Safety actions taken by the operator</p> <p>On June 20, 2019, the operator decided to conduct occasional inspections for the same type of helicopters in operation as temporary safety actions for this serious incident, and confirmed there were no anomalies in the overall airframes and engines.</p>

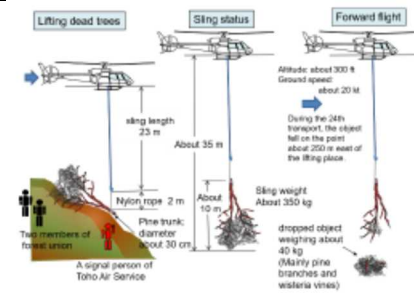
Report	https://www.mlit.go.jp/jtsb/eng-air_report/JA6697.pdf		
9	Date of publication	Date and location	Operator	Aircraft registration number and aircraft type
	July 29, 2021	December 4, 2020 In Higashi-Matsushima City, Miyagi Prefecture	Toho Air Service Co., Ltd.	JA504D Airbus Helicopters AS350B3 (Rotorcraft)
	Summary	<p>The helicopter while transporting withered pine weevils trees by cargo sling dropped some of the dead trees on a fallow field in Miyato Island, Higashi-Matsushima City, Miyagi Prefecture. There was no damage to the helicopter, or injury to persons on board or on the ground.</p>

Probable causes	<p>In this serious incident, during the flight at low speed, it is highly probable that some of the dead trees dropped on the fallow field due to the wind pressure including downwash because the measures to prevent the slung dead trees from dropping were not sufficient.</p>		
Safety Actions	<p>On December 9, 2020, the company additionally stipulated in the Toho Standard Operating Procedure the methods for packaging and the procedures to suspend the slinging work to prevent dropping, made it public within the company and implemented the safety education.</p>

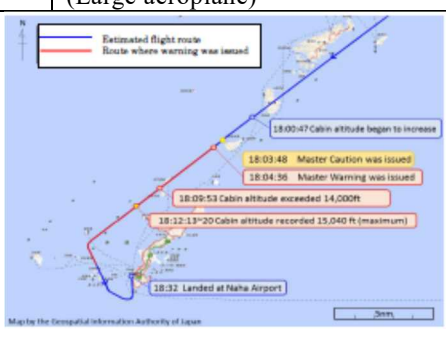
Report	https://www.mlit.go.jp/jtsb/eng-air_report/JA504D.pdf			
10	Date of publication	Date and location	Operator	Aircraft registration number and aircraft type
	August 26, 2021	February 20, 2020 At FL250 about 92 km north-northeast of Naha Airport	Silver Air Corp.	N829RA Bombardier BD-700-1A10 (Large aeroplane)
	Summary	<p>The aircraft took off from Tokyo International Airport as a charter flight. While the aircraft was flying at FL400 to Tan Son Nhat International Airport (the Socialist Republic of Vietnam), the instrument indicated loss of cabin pressurization. The flight crew member of the aircraft declared an emergency and made an emergency descent until the aircraft reached an altitude of approximately 10,000 ft. The Pilot in Command changed its destination to Naha Airport and the Aircraft landed at Naha Airport.</p>

Probable causes	<p>The JTSD concludes that the probable cause of this serious incident was the shutdown of both PACKs of the Aircraft during the flight at FL400, which resulted in loss of cabin pressurization. Concerning the shutdown of both PACKs, it is highly</p>

probable that the flight crew member was going to operate the switches of fuel recirculation system but erroneously pushed both PACK switches to position "OFF" without noticing.		
	Safety Actions	<p>Safety actions taken by the Company after the serious incident</p> <p>The following safety actions were taken for all crew members who operate the same type of aircraft.</p> <ol style="list-style-type: none"> (1) Strict adherence to checklists and procedures during all phases of flight, especially in climb out and cruise, as was identified in this incident. (2) It was informed that it is important for a PIC to emphasis on Crew Resource Management (CRM^{*1}) and crew communication is vital and will be briefed and emphasized during all phases of flight. (3) Review of fuel recirculation procedures on aircraft with manual fuel recirculation action, such as N829RA, crew shall do a thorough review of the fuel recirculation system to include limitations of such actions. (4) Re-emphasis the challenge and response items to various phases of the checklist to ensure proper cockpit switchology. <p>*1 "CRM" refers to the effective use of all available resources: human resources, hardware and information, in order to accomplish safe and efficient operations. (AIM-JAPAN)</p>

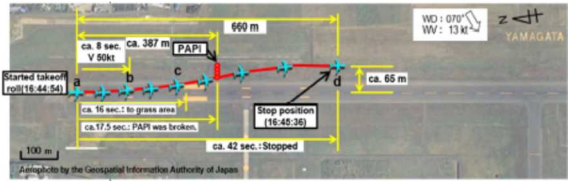
Report	https://www.mlit.go.jp/jtsb/eng-air_report/N829RA.pdf		
11	Date of publication	Date and location	Operator	Aircraft registration number and aircraft type
	October 28, 2021	April 23, 2019 At Yamagata Airport	Fuji Dream Airlines Co., Ltd.	JA11FJ Embraer ERJ 170-200 STD (Large aeroplane)
	Summary	<p>The aircraft started takeoff roll to fly from Yamagata Airport to Prefectural Nagoya Airfield with a total of 64 people, consisting of the pilot in command, three crew members, and 60 passengers, then ran off while veering to the left, and stopped in the grass field.</p>

Probable causes	<p>The JTSB concludes that the probable cause of this serious incident was that because the aircraft could not change its direction while trying to control the nosewheel steering with the pedal mode when it started takeoff roll, the aircraft was disabled to move on its own when it stopped in the grass field after running off the side of the runway while aborting the takeoff.</p> <p>Regarding the reason why the pedal mode could not control the nosewheel steering, it is highly probable that because there was an abnormality in the microswitch inside the handle, the steering mode stayed in the handle mode.</p> <p>The cause of the microswitch failure could not be determined even in the detailed investigation.</p>

Safety Actions	<p>(1) Measures taken by the Company</p> <ol style="list-style-type: none"> a. The Company issued an Operating Information^{*1} "Response when occurring an abnormality in the steering system," and has informed the flight crew members the outline of the steering system and the response at the time when an abnormality would occur in it. b. The Company provided the flight crew members with the training for a rejected takeoff at low speed in the periodic training of the 2019 fiscal year. <p>(2) Measures taken by the Manufacturer</p> <p>The manufacturer has revised the normal procedure in the AOM^{*2} related to the operational check for the flight control system as below. (Revised on November 6, 2020)</p> <ul style="list-style-type: none"> · Added the verification of the displayed status of the EICAS message "STEER
