## Chapter 4 Railway accident and serious incident investigations

### 3 Statistics of investigations of railway accidents and serious incidents

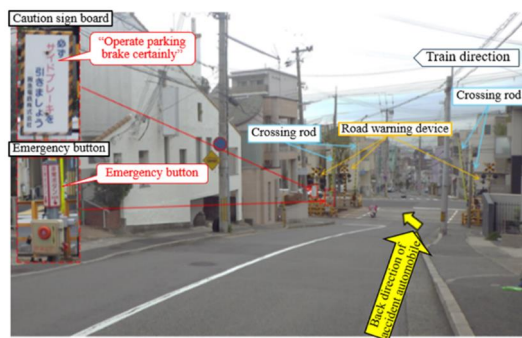
1	Date of publication	Date and accident type	Railway operator	Line section (location)
	February 17, 2022	November 23, 2020 Train derailment	Hankyu Corporation	Takaha level crossing, class 1 level crossing equipped with crossing gate and road warning device, between Rokko station and Mikage station, Kobe Line, Hyogo Prefecture
	Summary	<p>The train was running between Rokko station and Mikage station at the velocity of about 85 km/h, the driver of the train noticed the light motor truck entering Takaha level crossing, class 1 level crossing, so that applied the emergency brake immediately, the train collided with the light motor truck, and all two axles in the front bogie of the first vehicle derailed to left. The light motor truck had been going down the slope as no one was boarded.</p> <p>One passenger was injured in this accident.</p>		
	Probable causes	<p>It is highly probable that the train derailed because an unattended light motor truck backed the sloping road, and entered Takaha level crossing in the status as the crossing rod lowered responded to the approaching train, and collided with the approaching train.</p> <p>As for that the train had derailed, it is probable that left wheel of the first axle ran onto the rail and derailed due to the impact of the light motor truck which collided with lower left front part of the train, in addition, some parts of the light motor truck was caught between left wheel of the first axle of the front bogie of the first vehicle and rail, furthermore, left wheel of the second axle ran onto the rail and derailed due to the impact acted by these parts and the vibration acted by the derailed wheel.</p> <p>It is probable that the light motor truck had backed because the driver of the light motor truck left from the light motor truck in the status that the measures required to keep the stopping status of the light motor truck had been insufficient, although the stopped place was the sloping road.</p>

Safety actions	<p><b>(1) Measures Taken by the Company</b></p> <ol style="list-style-type: none"> <li>In December 2020, the company requested the city of Kobe in charge of road management to take safety measures, such as installing warning signs to indicate the gradient of Takaha Kita Route 2. In addition, in May 2021, the company requested the installation of warning signs on roads connecting to the level crossings with the alignment and gradient similar to those of the road.</li> <li>In October 2021, as a measure to reduce damage to railway facilities in the event of an accident, the company installed protective fences near the damaged instrument boxes and signal pole ladders.</li> <li>In December 2020, the company replaced the warning sign “Be sure to pull the parking brake” with a new warning sign to warn drivers coming down the sloping road.</li> </ol> <p><b>(2) Measures taken by Kobe City</b></p> <p>In July 2021, in response to the request of (1)1, they installed a warning sign indicating “there is a steep slope ahead”.</p> <p><b>(3) Measures taken by the Nada Police Station of Hyogo Prefecture</b></p> <p>After the accident, not only that various traffic guidance regulations have been strengthened near Takaha level crossing, but also the area has been designated as a priority application area of the Parking Warden Activity Guidelines to share information with parking wardens*<sup>1</sup> and strengthen monitoring of abandoned vehicles*<sup>2</sup>. In addition, in April 2021, an alert flyer was prepared as a warning message when parking and leaving a car on a sloping road with the aim to remind the driver to apply the parking brake, put the gear in the manual car, move the change lever to P (parking) in the automatic car, and use wheel stoppers, not only to display it on the website, but also to hand out to people on the streets during the national traffic safety campaign period.</p> <p>*1 A “parking warden” is a person who patrols the area based on the Parking Warden Activity Guidelines to check abandoned vehicles and attach the identification mark under a corporation entrusted by the chief of the police station.</p> <p>*2 An “abandoned vehicle” means a vehicle which is recognized as being illegally parked (in case of light vehicles, attached with a structure and device for being towed, and with the gross vehicle weight exceeding 750 kg) and which is unable to be driven immediately because of the absence of the driver.</p>

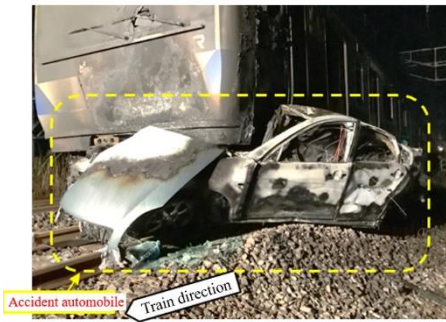
Probable causes	<p>It is highly probable that the running train collided with the automobile which entered the track and was stopping on the railway track, and right wheels of all two axles of the front bogie of the first vehicle ran onto the rail and derailed to right side of the track, because the automobile got into the space between lower left part of the front surface of the first vehicle and the railway track.</p> <p>It is probable that the automobile had been enter the railway track because the automobile broke through the net fence and enter the railway track and became stuck, because the driver of the automobile mishandled the steering wheel in the situation that the driver could not drive calmly in order to escape from the pursuit by the police.</p>		
	Safety actions	<p><b>Measures taken by Road Administrator</b></p> <p>After the accident, at the request of the company, the road administrator who has jurisdiction over the net fence took the following measures before June 3, 2021 at the location where the automobile entered.</p> <p>(1) The damaged net fence was repaired.</p> <p>(2) A guardrail was installed on the net fence side of the prefectural road 141.</p>
