Case 1

Crash during cargo transport with underslung external cargo caught in trees or rocks into the mountain slope

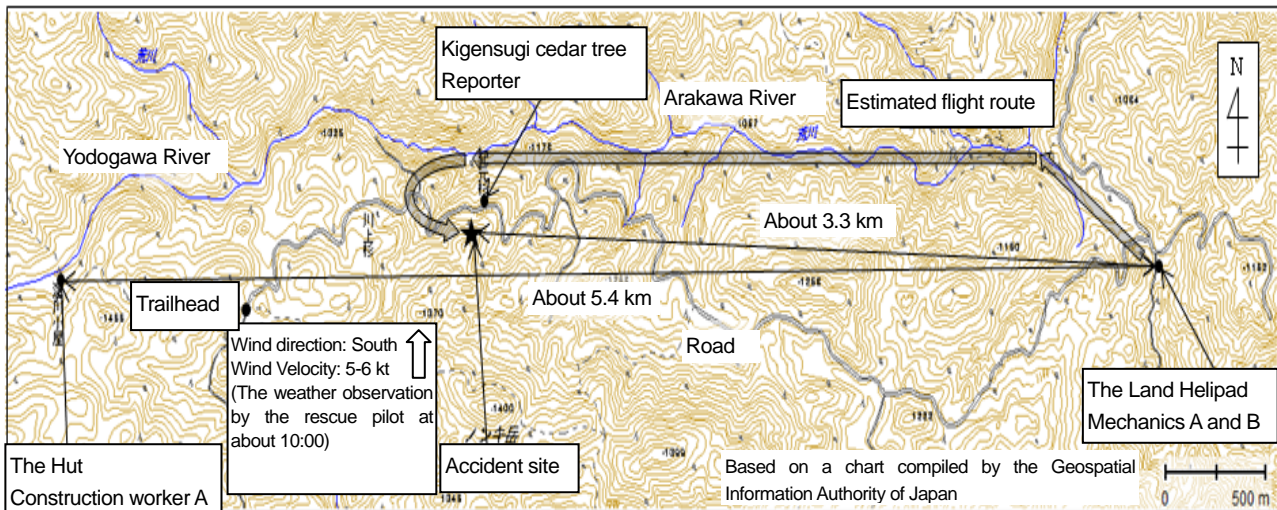
Estimated Flight Route

It is probable that the flight route was along the valley of Arakawa and Yodogawa River due to the following reasons:

- ▶ The Reporter stated that he had heard the helicopter flying back and forth when he was near Kigensugi cedar tree, and had seen it flying in the valley to the north of the Kigensugi cedar tree in the direction of the Hut.
- ▶ It is probable that due to the following advantages the pilot chose to fly in the valley rather than over the mountain ridge for the route of helicopter short distance shuttle flights for cargo transport, as he was aware of the absence of linear obstacles (such as wires and cables) and was fully familiar with the geographical features.
 - ▶ A flight at low altitude will shorten the length of the route and provides the helicopter with better margin of usable power (cargo sling capability), which lead to less time and fuel consumption.
 - ▶ Flying over a river provides bigger AGL altitude.

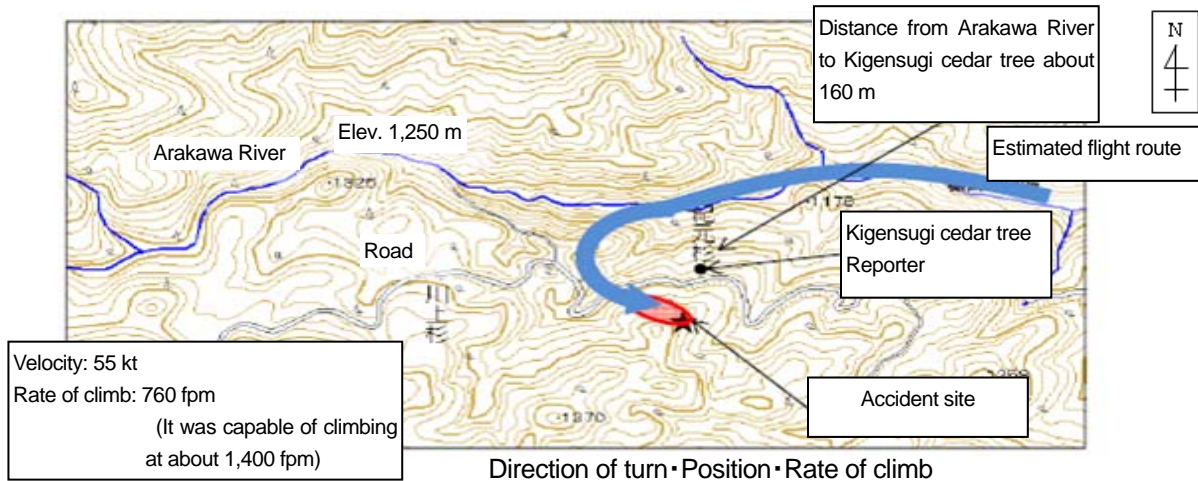
It is probable that the squeezed opening between the lowered cloud base and the surface made it difficult for the helicopter to continue the flight near the cargo unloading sites in the vicinity of the Hut at the time of the accident.

It is probable that the weather conditions over the accident site were such that the cloud base was 100 m above the site-small opening between the ground and the cloud base.
