Persons on board were injured as a result of hard landing during a high descent rate

Summary: On Friday June 29, 2012 at 12:54 local time (UTC+9 hours), a Bell 412EP, owned by Chubu Regional Bureau, Ministry of Land, Infrastructure, Transport and Tourism (operated by contracted Company A) experienced a hard landing when attempting to land at upstream of Nagashima Dam temporary helipad, Kawanehon-cho, Haibara-Gun, Shizuoka Prefecture. The pilot suffered serious injuries, and one of the passengers suffered minor injuries. There were eight persons on board, consisting of the pilot, two crews and five passengers. The helicopter was slightly damaged, but there were no outbreak of fire.

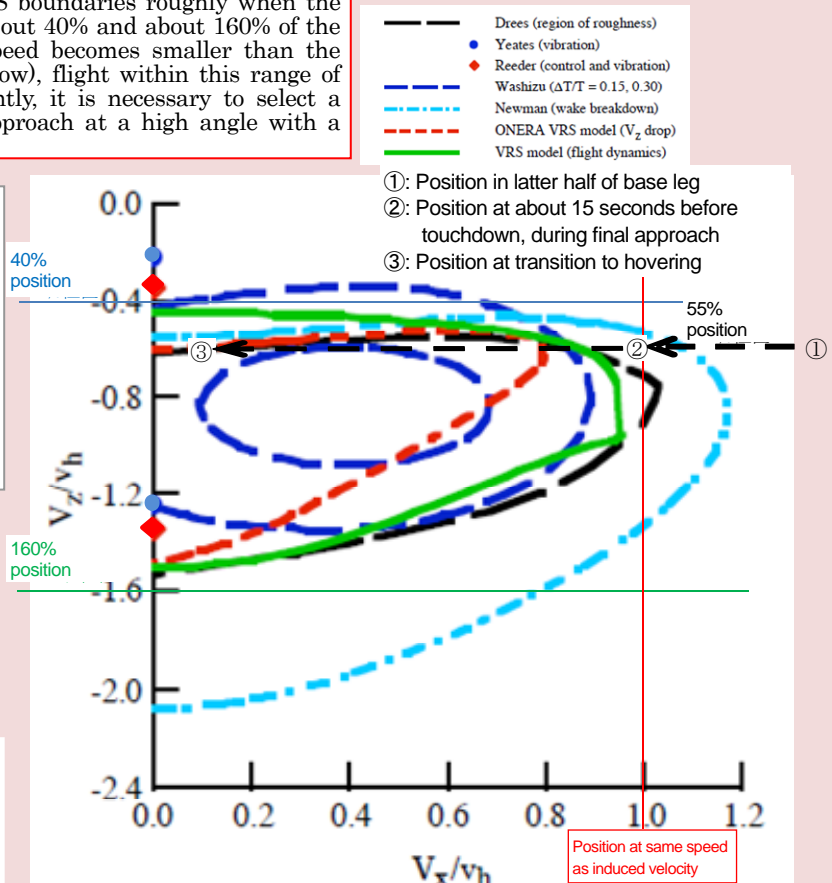
Figure: Relationships with VRS Boundaries

It is probable that the cause of the hard landing was not a lateness in the pulling of the CP, on the contrary, there existed a condition in which the power output was increased but there was no increase in main rotor (MR) lift, suggesting the occurrence of VRS (*3).

At 37 seconds before touchdown during the latter half of the helicopter's base leg, its forward airspeed was about 30 kt and its descent rate was about 1,300 ft/min. Therefore, the ratio of the helicopter's descent rate to its induced velocity (about 2,360 ft/min: about 23kt) becomes -0.55, and the ratio of the forward airspeed to the induced velocity becomes 1.3, which are **outside of the VRS boundaries** as indicated by ① in the figure.

At about 15 seconds before touchdown the descent rate was about 1,300 ft/min and the forward airspeed was about 22 kt, their ratio to the induced velocities become about -0.55 and about 0.96 respectively, which are **near the entry point of the VRS boundaries** as indicated by ② in the figure.

It is probable that the helicopter's forward airspeed continued to decrease during its high descent rate because it was attempting to land on steep approach path under tailwind conditions.

Avoiding a descent at 700 ft/min or greater with a forward airspeed of 25 kt or less.
