Case 6

Fire occurrence from rear hold during power transmission lines inspection flight led to a forced landing, followed by flames and destruction of the helicopter

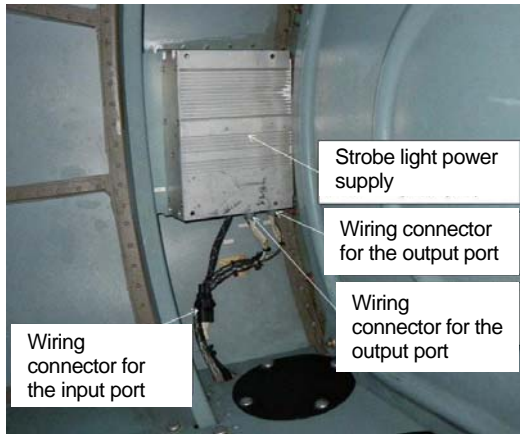
The strobe light power supply (*1) was installed at the back of the right side in the rear hold with its input and output wiring extending from the main body of the power supply to the floor. The wires were not protected by rigid housing or similar goods from contact with the embarkation.

The airworthiness standards applicable to the helicopter type require for wiring in a compartment not to be damaged by the movement of cargo in the compartment, and their breakage or failure will not create a fire hazard.

Regarding a fire in the rear hold, it could not be identified the ignition source; nevertheless it is possible that a fire occurred from the wiring connected to the strobe light power supply, which was installed in the rear hold, and that it spread to inflammables placed around the power supply.

This is because the wiring was not designed and structured so that it was fully protected so as to prevent it from being damaged due to the movement of embarkation and preclude a risk of occurring a fire even if it was damaged or destroyed.

The EASA should make it mandatory to modify the rear hold of the Eurocopter AS 350 series so that electrical equipment and its wiring are fully protected.

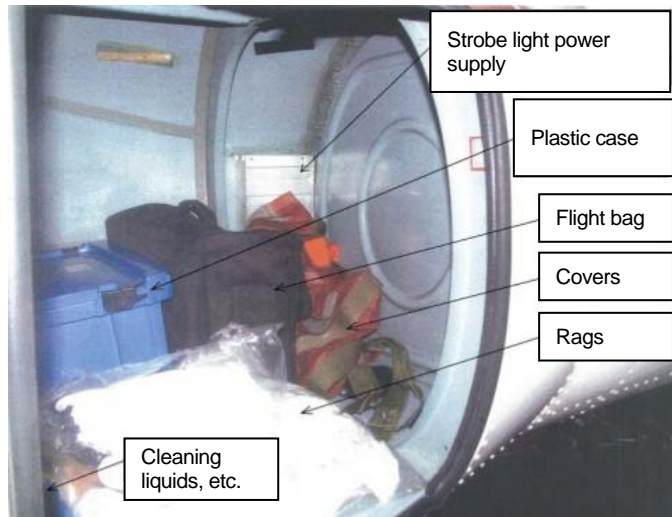
The rear hold was filled with so many inflammable items such as extra oils, plastic cases, documents, flight bag, covers, rags and cleaning liquids that are almost no room to stand, and they were not covered with a floor tie-down net to prevent them from moving. However, it was confirmed no abnormality by the flight mechanics during the preflight inspection.

Condition of embarkation in the rear hold (Reproduced based on the mechanic's memory using the type of helicopter)

It is highly probable that wiring came into contact with embarkation when the latter was moved inside or brought into or out of the hold.

It is probable that the embarkation moved unrestrictedly if the airframe was vibrated or accelerated violently. It is highly probable that the fire spread to these items after it occurred.

It is also possible that since the embarkation was not covered with nets to prevent its movement, embarkation in the rear hold damaged the wiring, which was not fully protected from damage due to the movement of the embarkation.

When having embarkation in the rear hold of Eurocopter AS350B3, Company A should take measures to prevent its movement as provided in the Flight Manual in order to prevent an unforeseen event due to the movement of embarkation. In addition, when transporting items that fall into the category of explosives and other goods, the company should confirm the content of the pronouncement and meet the standards specified therein.
