Case 1 of wrong approach to a runway, etc. (Aircraft serious incident)

The aircraft made an attempt to land on a closed runway while approaching Kansai International Airport, and then made go-around

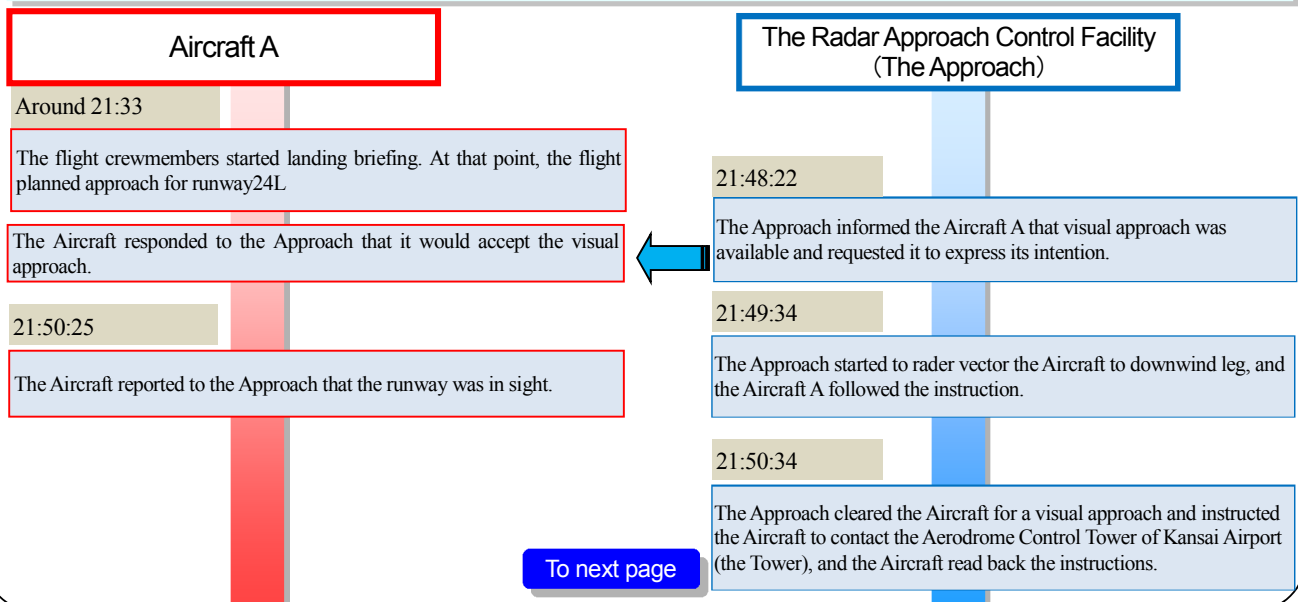
Background of events up until the serious incident

The Aircraft A reported to the Tower that it had entered the downwind leg.

The precision approach lighting system (PALS), the sequenced flashing lights (SFL), and the precision approach path indicator (PAPI) of runway 24R were turned on.
*The explanation of each lights are the next page.

The Captain said, "Three reds, one white."*1

The Tower pointed out that the Aircraft was approaching 24R, and asked whether it was possible to make a left turn to approach 24L.

The Aircraft A reported to the Tower that the Aircraft would make a go-around because the Aircraft was unable to approach 24L.

*1 It is considered highly probable the Precision Approach Path Indicator (PAPI) was seen as "red, red, red, white" (a slightly low entry altitude)

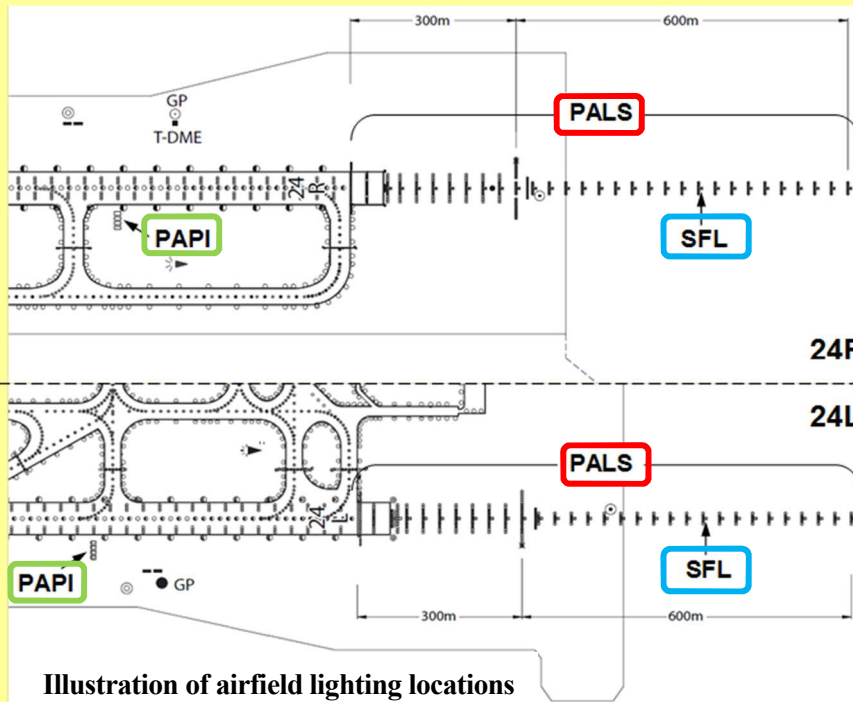
Illustration of airfield lighting locations

The rights to control the lighting console including the operation of the PALS and PAPI had been transferred from the Tower to the lighting staff at the time of this serious incident. Furthermore, the lighting staff was allowed to omit the prior notification to controllers. Therefore, it is considered highly probable that the lighting staff turned on the lights without notifying controllers in advance.

The PALS and PAPI on 24R were turned on when the aircraft was flying on the downwind leg in the traffic pattern

It is considered probable that the fact that the PAPI was on while there were no visual references on the sea was a contributing factor that the Captain and the First Officer to believe 24R as 24L.

- Kansai Airport Office: In regard to the Extinction of the approach lighting system and the precision approach path indicator on closed runways” and “Thoroughgoing observance of the Agreement with the lighting staff”, thoroughgoing observance of the Agreement with the Aerodrome Lighting Department was re-confirmed.
- Arrangements of Air Traffic Control Division, Air Traffic Services Department of Civil Aviation Bureau (at that time): Regarding the lighting control of closed runways, the controller in charge should determine the timing of the lighting of the precision approach path indicator and approach lighting systems on closed runways for a proper period with consideration of the air traffic condition of the airport.
