## Digest of the Analyses of Railway Accidents

### For the prevention of derailment accident "Points of management of the track maintenance"

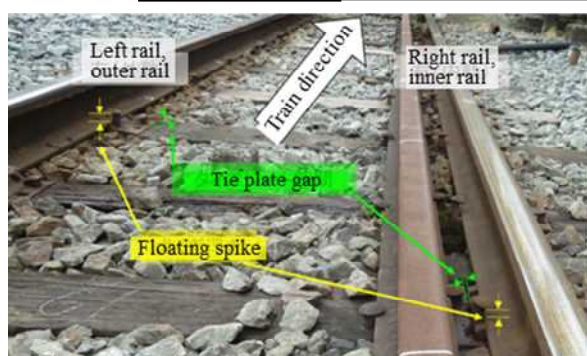
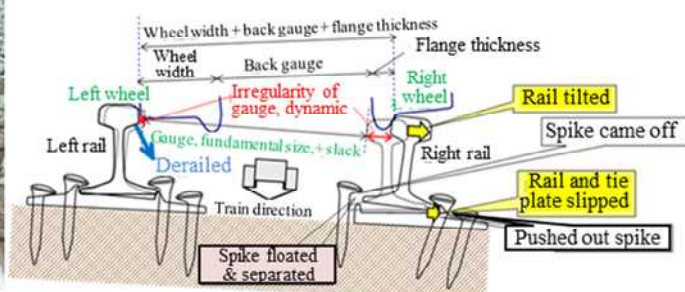
#### Supposed running status when derailed in this accident

Decreased margin against derailment to inside gauge.

At about 21:26 Outer rail side wheel fell to inside gauge and the train derailed.

**Probable causes :** It is probable that the train, while passing through the 200 m radius right curve, left wheels on the front and the rear bogies fell to inside gauge due to largely widened gauge, the front bogie derailed to right although the rear bogie restored by the guard rail, in the first vehicle.

As for that the gauge had widened largely, it is likely that the gauge had widened dynamically due to the rail tilting, etc., caused by the lateral force when train was running, because the defects of rail fastening devices had been continued in the curved track, and related by that the margin against derailment to inside gauge had been decreased due to relatively large slack in the curved track.

- Check the corrosion of sleepers and the loosened spikes, etc.
- Implement re-hammering or additional hammering of spikes, replacement of sleepers or the installation of the gauge tie, *i.e.*, metal to hold the gauge, etc.
- Establish the system that can implement the above two items certainly.
- Maintain in high priority when defects of sleepers, etc., continued or existed in steep curve with large slack.
- Pay attention to the inner rail side same as for the outer rail side in the management of sleepers and rail fastening devices in the curved section.

- Replace to the concrete sleepers, etc., which is superior in the durability and easiness of maintenance compared to the wooden sleepers.

- Changed to the concrete sleepers and replaced the ballast as the measure to improve the drainage.

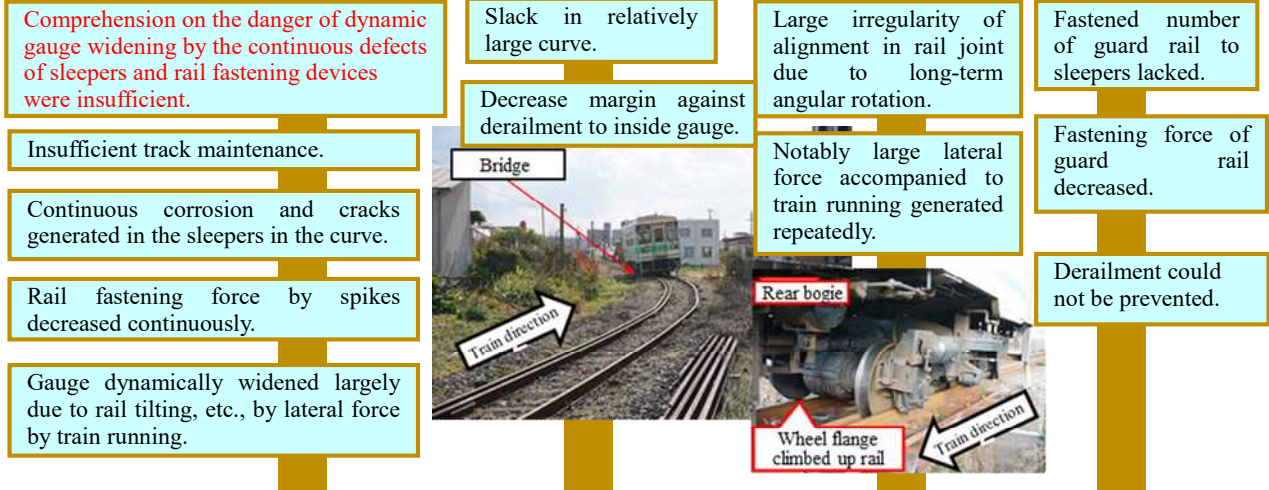
At about 11:00 Inner rail side wheel fell to inside gauge and the train derailed

**Probable causes :** It is probable that left wheels in the first and the second axles in the rear bogie derailed to inside gauge, right side of the left rail, *i.e.*, inner rail, because the gauge had widened largely while the train was passing the 160 m radius left curve, in this accident.

There was the possibility that the gauge widened dynamically by the rail tilting, etc., due to lateral force accompanied to the train running, because the rail fastening force by the spikes had been decreased by the effects of the continuous collision and cracks generated in the sleepers in the curve.

It is likely that the rail fastening force had decreased by corrosions and cracks generated in the sleepers continuously, related by that the company had not been comprehended the danger to cause derailment accident by the dynamically widened gauge due to the continuous defects of sleepers and rail fastening devices, in the inspection for track materials, etc., and the track maintenance responded these situations had not been implemented promptly.

- (1) Review the maintenance standard values
  - Establish the handling when exceeded the maintenance standard value, and to take measures certainly according to it.
  - The maintenance standard value of the gauge shall be increased or decreased corresponding to the slack.
- (2) Proper installation of guard rail, etc.
  - The guard angle shall be installed properly by using tie plate for the section where installed the guard rail, etc.
  - Or study the replacement to the guard angle considering the easiness of the maintenance.
- (3) Inspection of guard rail, etc., and measures when noticed the traces
  - Add the existence of contacted trace with wheel in guard rail, etc., as requiring care item in the periodic inspection, etc.
  - When the trace was found, confirm the existence of abnormality and take measures if there is abnormality.

- (1) Replacement of sleepers and realignment of track
  - Replaced 100 wooden sleepers and spikes to new ones in the section included the accident site, enforced track by supplied ballasts and tamping, realignment of track.

- (4) Replacement to the guard angle
  - Replaced the guard rail already installed in the accident curve to the guard angle.
- (5) Used the concrete sleepers

- Replaced to concrete sleeper every one of two wooden sleepers, in the curves scheduled to be maintained next to the accident curve.

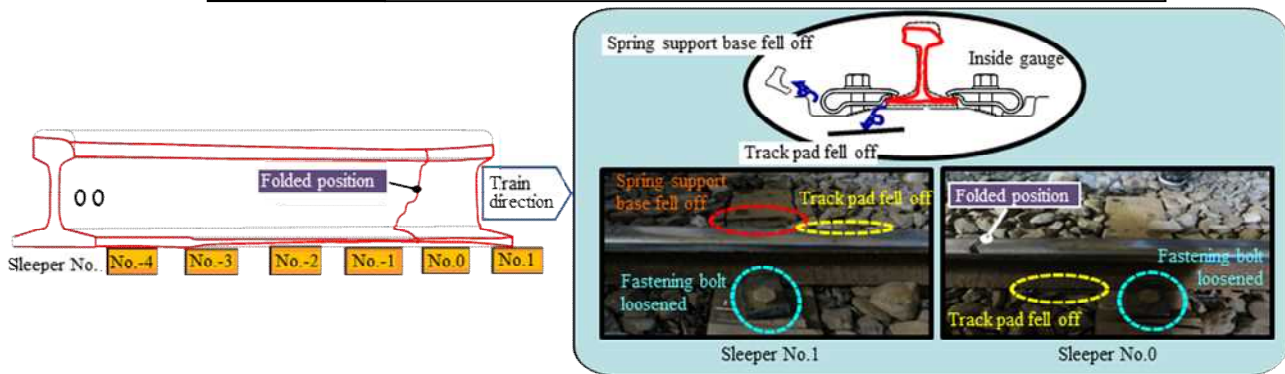
The status that cross-section of rail had been decreased remarkably by corrosion could not noticed.

Missed to find crack in the rail.

Missed to find continuous looseness of rail fastening bolt and removed track pads, in the track where relatively large irregularity of cross level had been existed.

Rail, outer rail, was folded and damaged.

Derailment coefficient increased due to decrease of outer rail side wheel load and increase of lateral force.

At about 19:25 Outer rail side wheel ran over the rail and the train derailed.

**Probable causes :** It is likely that left wheel in the third axle in the rear bogie of the train ran over the rail and derailed, because the wheel load decreased significantly and the derailment coefficient had increased while the train was running in the circular curved section in the tunnel, based on the followings.

- (1) The outer rail side lateral force which is generated steadily in the curved track, increased further due to the existence of relatively large irregularity of alignment.
- (2) The loosed fastening bolts of the rail fastening devices and the falling off track pads had been existed continuously, in the track where relatively large irregularity of cross level to promote to decrease wheel load had been existed.
- (3) The left rail, the outer rail, had been folded and damaged when the rear bogie of the train passed.

- (1) On the measures for the folded and damaged rail
  - On the places of leaking water from tunnel, manage properly as to concentrate to confirm the corroded status of rail, including the replacement of rails according to the necessity. It is effective to suppress leak of water from tunnel, and to introduce rust proof treatment which apply antiseptic to rails.
  - Conduct systematic replacement of rails when the corrosion of rails had been deteriorated.
  - Replace rail as soon as possible when deterioration of corrosion of rail was in danger. When replacement was difficult, watch carefully the change of the rail by on-foot patrol and reinforce the rail according to the necessity.
- (2) Implementation of the careful track inspection.
  - Implement careful inspection so as not to overlook continuous looseness of the rail fastening devices and the falling off track pads.

- (1) Replacement of the decrepit rails in the tunnel section.
  - Total 25 rails in five tunnels were judged to be replaced in the status inspection including the rail bottom, and completed to replace all designated rails.

- (2) Certain implementation of track inspection in the tunnel section.
  - Adopted bolt cap with white one line and paint of fitting mark with a marker, in order to find looseness of bolts visually and easily.

- (3) Measures against folded and damaged rails in the tunnel sections.
  - Newly installed the point to measure the corroded status of rails in the place of water leakage in tunnel section, and implemented the status check of rails by the on-foot patrol, etc.

- (4) Measures against the folded and damaged rails in the open section.
  - Reinforced the rails which the flaw was found on the rail head, according to the necessity.

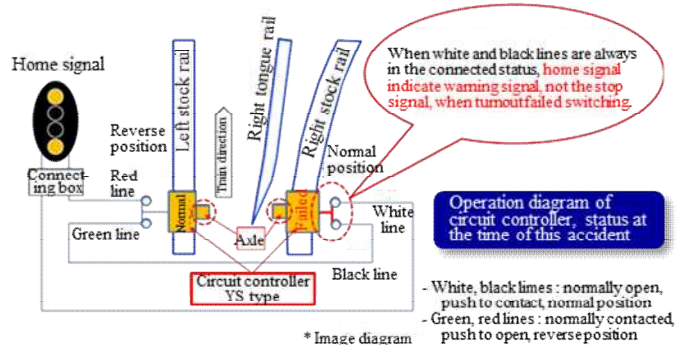
**(1) Defect of switching of the turnout**

It is likely that the switching load exceeded the switching force of the spring switch, due to the increase of the coefficient of friction between the tongue rail and the floor board, caused by **the lack of lubrication to the floor board in the point part of the turnout.**

**(2) Signal indication of the home signal**

It is highly probable that the home signal did not indicate the stop signal but indicated the speed restriction signal even though the turnout had been in the status of the defect of switching, because **the insufficient contact of the tongue rail could not be detected caused by that the contact point of the micro switch in the circuit control device to detect the defect of switching of the turnout did not switched and in the status as being conducted.**

**Probable causes :** It is probable that right wheel flange of the first axle of the front bogie of the first vehicle went into the space between right stock rail and right tongue rail, and derailed to right, and the rear bogie of the first vehicle and all bogies of the second vehicle had entered to the up main line side different from the designated direction of travel, because right tongue rail of the turnout did not contact to the normal position side and in the status of the defect of switching, when the train entered the straight line side of the turnout obeying to the indication of the speed restriction signal of the home signal, in this accident.

**Required Safety Action :** To comprehend the status that the home signal did not indicate the stop signal but indicated the speed restriction signal even though the circuit control device was in the status as could not detect the defect of contact in the home position side, was the dangerous status with the possibility of derailment, and implement the followings.

- (1) Replaced the spring switch of the accident turnout by the new product.
- (2) Decided the limited speed when passed the accident turnout and No.16 turnout in the premises of B station as 15 km/h or slower, and let the train crews known well, and newly installed the speed limit sign.

- (3) Improved the security level of the circuit control device by making dual system in the home position side of the accident turnout and the No.16 turnout, because the exact signal control could not be implemented. Furthermore, replaced the circuit control device by new one.

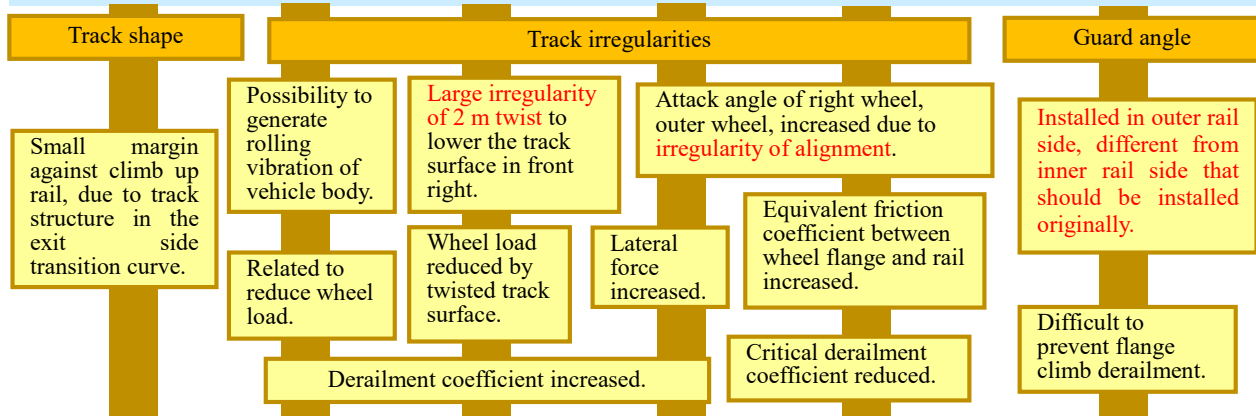
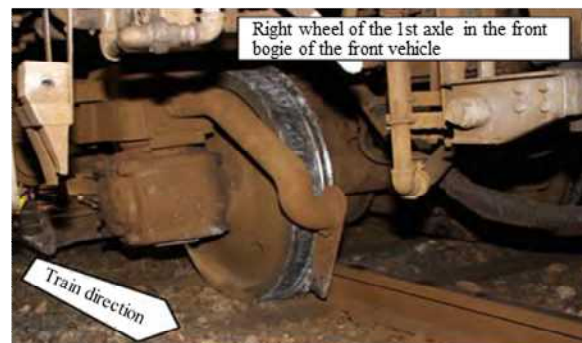
At about 11:58

**Outer rail side wheel climbed up rail and the train derailed in exit side transition curve**

**Probable causes :** It is probable that right wheel in the first axle in the front bogie of the front vehicle climbed up right rail, outer rail, and derailed to right, because the lateral force had increased and the wheel load had decreased for the right wheel, outer rail side wheel, due to the existence of the irregularity of alignment in the direction to shorten radius of curvature and the irregularity of 2 m twist in the direction to lower front right of the track surface, in the exit side transition curve connected to the 200 m radius curve. In addition, it is highly probable that the derailment could not be prevented because the guard angles had been installed in outer rail side, different from the inner rail side where it should originally be installed.
