4. Case Studies of Accidents

Case 1: Improper Piloting

Date and Time of Occurrence: Around 15:25, September 11, 2010

Type: AEROS AEROS2-R912 (weight transfer controlled ultralight plane)

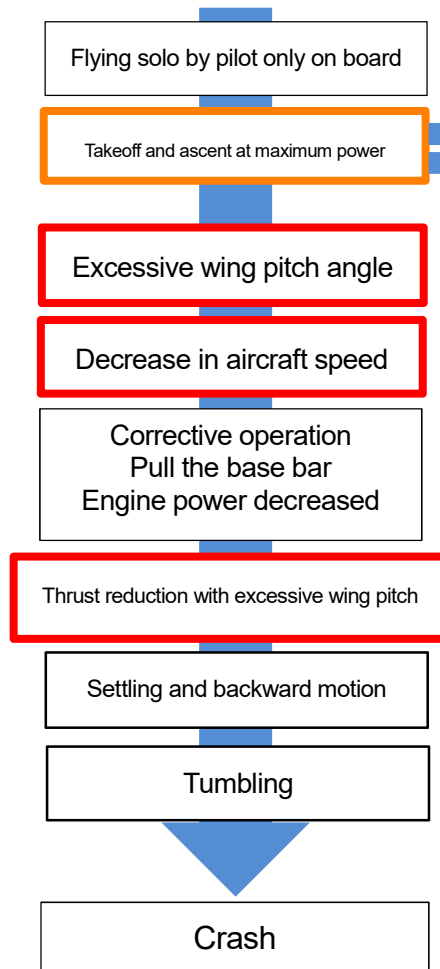
Flight conditions at the time of the accident

【Probable Causes: Improper Piloting】
While ascending at the maximum engine power, the wing pitch became excessive and the speed decreased. The pilot pulled the base bar to correct the decrease in speed and subsequently reduced the engine power, which caused the aircraft to back off and rapidly drop the front of the wings, presumably resulting in tumbling and crashing.

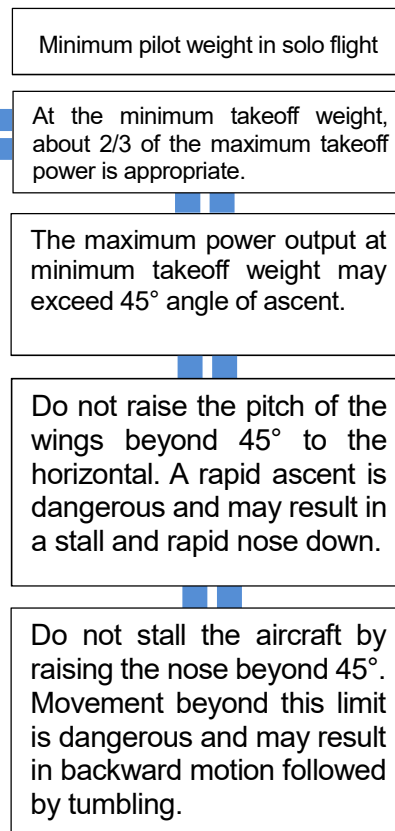
Description in manuals issued by the manufacturer

- It is presumed that the pilot, not fully understanding the meaning of the limitations and warnings in the manual issued by the aircraft manufacturer regarding the pitch angle and engine power for a single-passenger flight, took off and ascended at the maximum power that is restricted for use in a single-passenger flight.
 - In the case of a weight-transfer controlled ultralight plane, the tendency to turn the entire aircraft upward generally increases in response to growing thrust.
- Since the accident aircraft had an increased thrust due to the engine conversion, it is believed that the crew was unaware that this would result in excessive wing pitch angles.

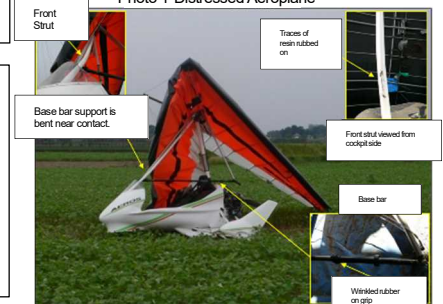
Photo 1-Distressed Aeroplane

Summary of the Accident: While ascending after takeoff from Temporary Airfield A with only the pilot on board, the aircraft went into a tumbling* and crashed due to thrust reduction under conditions of excessive wing pitch angle. The airframe was severely damaged and the pilot was seriously injured.

【Factors: Lack of Knowledge, Skill, and Experience】
