JTSTB (Japan Transport Safety Board) DIGESTS

No. 40 (Issued in February 2023)

Digest of Marine Accident Analyses

For Prevention of Accidents Caused by Dozing Watchkeepers on Cargo ships and Tankers

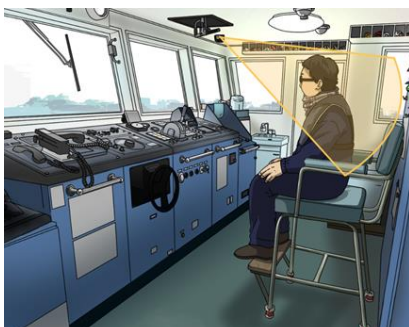
There were some inappropriate recommendations to point the sensor upwards to avoid detecting a dozing operator.

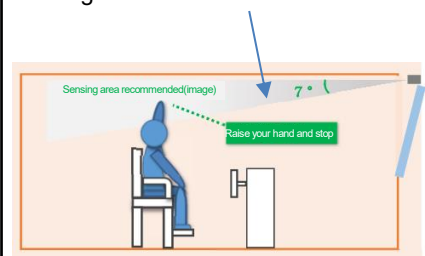
Sensing area recommended by the manufacturer.

Position and angle at which the person cannot stop the alarm without raising a hand

It is likely that **BNWAS did not likely raise the alarm because the sensor pointed lower than the manufacturer's recommended position and detected the body and leg movements of Master B, who dozed.**

- Operators should **have crew members take leaves at appropriate intervals** to let them perform their bridge watchkeeping duty properly and in good condition and **instruct them to get out of their chairs and into the open air to dispel any drowsiness** if they feel drowsy while on duty.
- Shipowners, masters and bridge watchkeepers of vessels equipped with a BNWAS **should not overconfidently depend on the system, endeavour to prevent sleep operation, thoroughly check the system working at departure and under sail, adjust the sensor conditions such as its mounting angle, and set the time (the alarm inactivation time) to be short as possible.**
