Case 1

A crew member who inhaled chloroform gas while checking the condition inside a cargo tank became unable to breathe and died of hypoxia

Outline: While the chemical tanker which departed from Komatsu Wharf in Sakai-Senboku Quarter Section 7 of Hanshin Port was sailing north toward Osaka Quarter Section 1 of the Port, the second officer was found lying inside No.1 cargo tank on the port side at around 12:29, February 7, 2012. Although rescued, he became unable to breathe due to toxic gas inhalation and died of hypoxia.

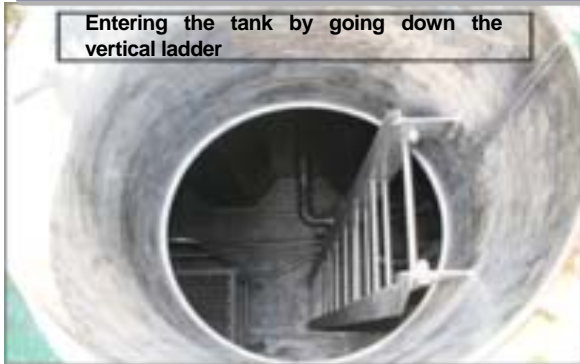
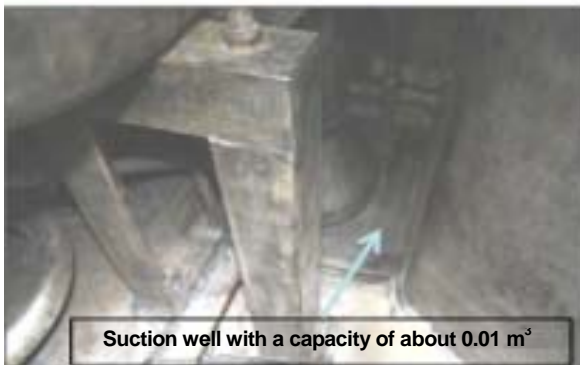
Inside portside No.1 cargo tank

According to the findings that there was a smell of toxic gas inside the cargo tank and a residue of washing water inside the suction well at the time of the accident, it is considered somewhat possible that when sending air, a residue of washing water in the piping was pushed out to return inside the cargo tank.

"Suction well"

A hollow section placed on the quarter side of a cargo tank, designed to absorb cargo and washing water efficiently, which is normally equipped with a tube for absorbing cargo and washing water.

- (3) As stated in the coastal tankers safety guidelines and P & A manuals, operation procedures for such categories of work as checking the existence of washing water, removing washing water by stripping, if any, and tank cleaning by drying or gas-freeing should be organized in a plain form so that their crew can understand them easily and check them for confirmation. Such operation procedures should be posted at an easily viewable location close to their working sites.

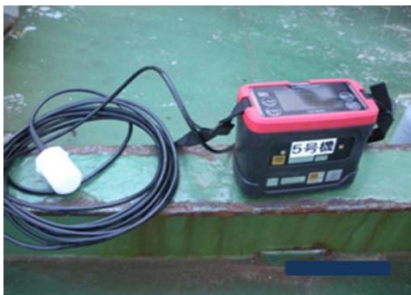
Portable measuring instrument

2. According to the findings that although Company A explained to the master and C/O about the inability of the portable measuring instrument to measure noninflammable and fire-resistant gas concentration, the crew of the Vessel thought that it could measure the concentration of not only oxygen but also all types of gas including noninflammable ones, it is considered probable that the explanation by Company A was not enough for the crew to understand correctly about the ability of the instrument.

3. According to the findings that in spite of being aware of the requirement to use devices like gas detectors for measuring the concentration of noninflammable and fire-resistant gases, Company A thought that replacing a gas detectors for each cargo tank would be time-consuming and laborious, and instructed the crew of the Vessel to judge the existence of noninflammable and fire-resistant gases by a decrease in oxygen concentration instead of by using gas detectors, it is considered probable that Company A did not give instructions conforming to the notices prescribing standards for transporting dangerous goods by vessels or regulations like coastal tankers safety guidelines.

- (1) The companies should instruct their crew never to fail to implement oxygen and gas concentration measurement when entering enclosed space. They should also visit their vessels on a regular basis to make sure that oxygen and gas concentration measurement has been properly implemented.

- (2) It should be assured that each master has been making a record of implementing oxygen and gas concentration measurement, as well as a record of how many gas-detecting tubes have been purchased, consumed and left unused in case of using gas detectors to measure gas concentration. They should also visit their vessels on a regular basis to make sure that oxygen and gas concentration has been properly measured, by checking records of measurement implementation and gas-detecting tube usage.
