# JTSCB Digests

JTSCB(Japan Transport Safety Board)

## Digest of Marine Accident Analyses

### For prevention of “Fatal and Injury Accidents Caused by Oxygen Deficiency or Gas Poisoning”

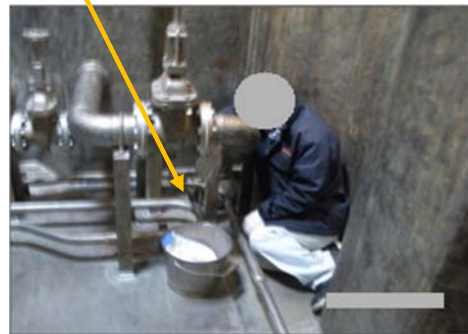
Situation when the chief engineer found 2/O (inside portside No.1 tank)

It is considered probable that there was a danger of a secondary accident.

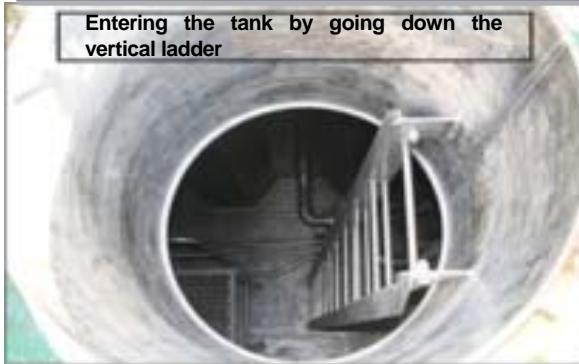
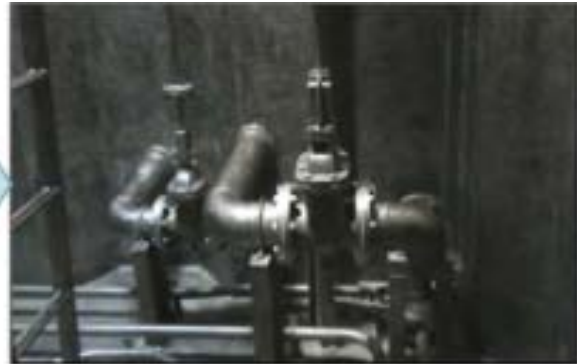
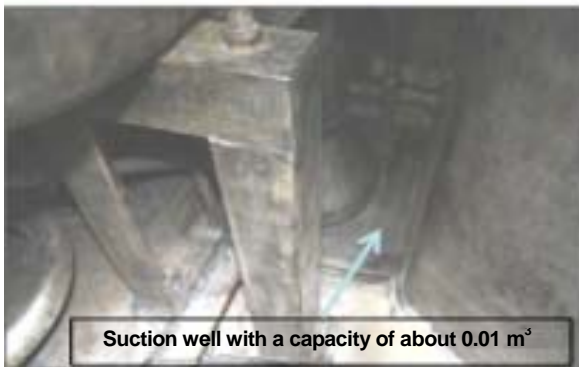
## Inside portside No.1 cargo tank

- ◆ It is considered probable that in spite of replying to C/O's instructions not to enter portside No.1 cargo tank, 2/O did not follow the instructions as he found chloroform washing water remaining in the suction well of the cargo tank, and entered the cargo tank on his own judgment to remove the washing water while C/O went to the accommodation space for getting oxygen and gas concentration measuring instruments (portable and pocketable) (hereinafter referred to as "Both Measuring Instruments").
- ◆ According to the findings that Both Measuring Instruments were not available to 2/O when C/O went for them, it is certain that 2/O did not measure oxygen and gas concentration when entering portside No.1 cargo tank.

- (1) The companies should instruct their crew never to fail to implement oxygen and gas concentration measurement when entering enclosed space. They should also visit their vessels on a regular basis to make sure that oxygen and gas concentration measurement has been properly implemented.

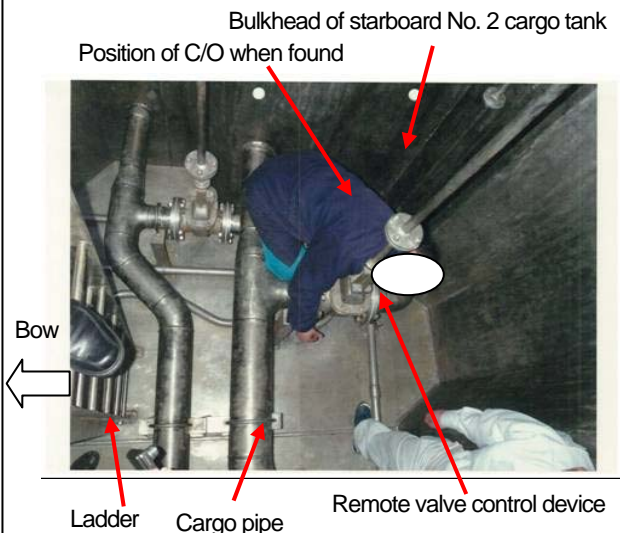
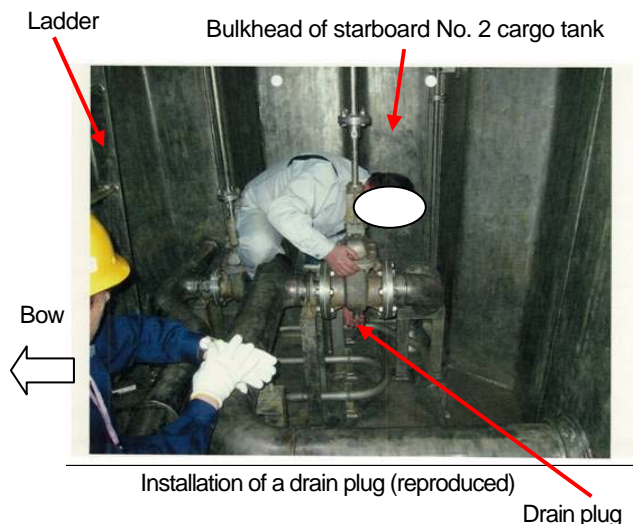
### Reproduction of the Accident Site

C/O entered the Tank wearing the gas mask without measuring oxygen concentration.

According to the findings that although the gas concentration inside the Tank was 16% at around 14:23, C/O stopped moving at around 13:55 soon after picking up the drain plug and fixing it in the drain hole by screwing it three times, it is considered somewhat likely that the gas concentration near the drain hole was not so high as to cause instant death, but to the extent of causing the loss of consciousness in a short time (10% or less).

Accordingly, vessel owners are required to provide the crew of chemical tankers with safety education about the possibility that a state of oxygen deficiency will be caused depending on the nature of cargo to handle, as well as the method of cargo handling, and further to instruct them never to fail to measure oxygen concentration before entering a cargo tank which is feared to turn into a state of oxygen deficiency.

Furthermore, considering that crew members other than C/O and 1/E were unaware when the accident occurred that nitrogen gas was injected into the cargo tank while unloading work was going on, and even C/O may have forgotten it, it is earnestly recommended that stevedores working on the shore side should notify the crew of a chemical tanker properly before injecting gas into a cargo tank to lower oxygen concentration.

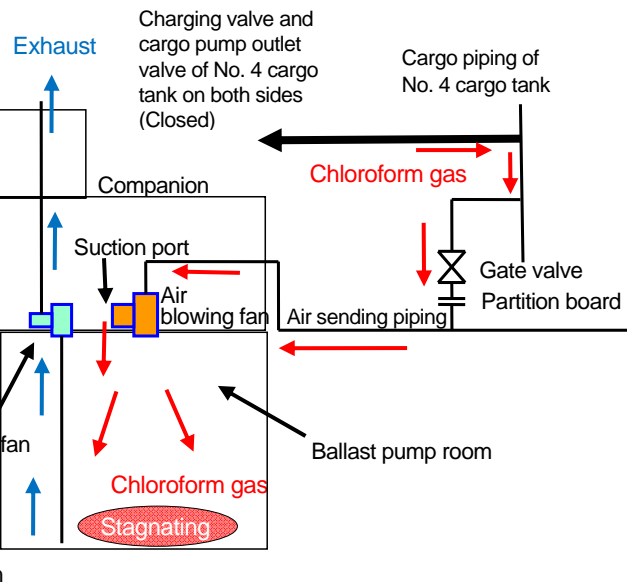
### Inflow Route of Chloroform Gas

After operating the ballast pump in order to pump water into the ballast tank, 1/E opened the partition board and the gate valve which were separating the cargo piping and the air sending piping in No.4 cargo tank on both sides.

- (1) Instruct the crew to ensure that measurement of oxygen concentration and detection of toxic gases should be implemented without fail when entering a ballast pump room, as in the case of entering a cargo tank or a cargo pump room where a toxic gas may exist.
- (2) Be aware of the details of such onboard work as may endanger the crew, establish safety check procedures during work as well as working procedures, and give them instructions on these procedures and ensure observance by them.

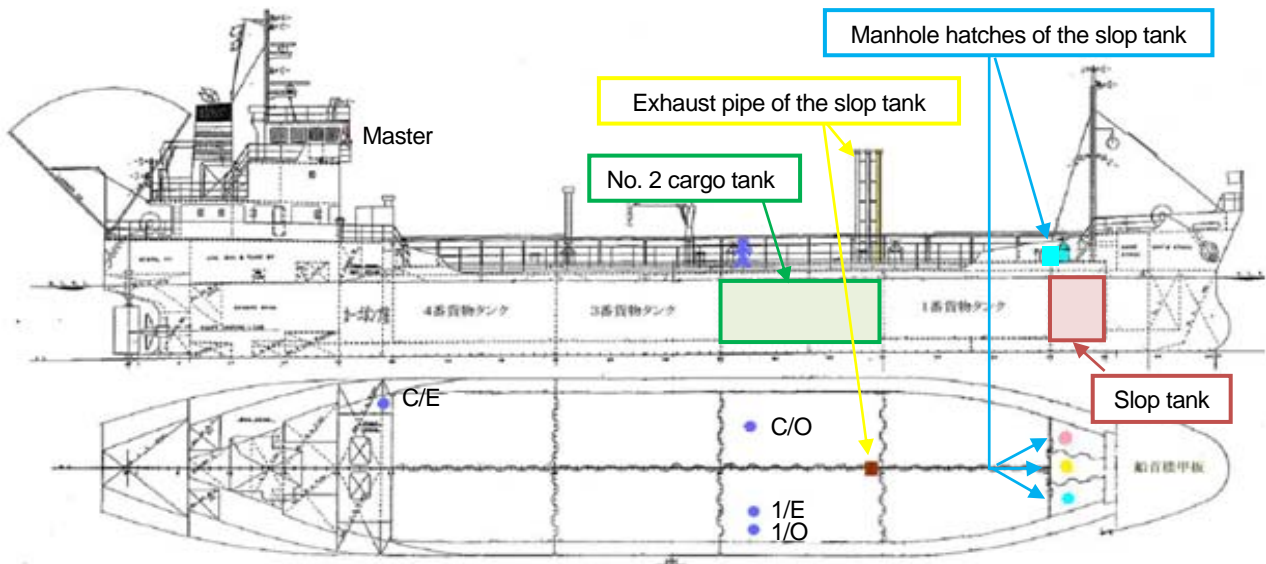
【Location of the slop tank and other facilities, and positioning of the crew when the accident occurred】

**Inside the slop tank, sodium hydrosulfide washing water and acrylic acid washing water caused a chemical reaction, and generated hydrogen sulfide gas, which spouted out of the discharge port of the slop tank's exhaust pipe while making a sound.**

C/O, 1/E and 1/O were rescued and taken to hospital by the staff of Nagoya Coast Guard Office who came for relief, and **C/O and 1/E were confirmed dead. 1/O was hospitalized due to hydrogen sulfide intoxication, and C/E was also hospitalized due to hydrogen sulfide intoxication and chemical pneumonia.**

In order to prevent mixing different types of tank washing water likely to cause a dangerous chemical reaction while recognizing that tank washing water includes cargo residue on board and bears similar properties as cargoes, it is necessary to identify in which case mixing tank washing waters is dangerous, such as by making a chemical interaction chart for dangerous types of cargo when mixed while referring to procedures for handling dangerous goods or material safety data sheet (MSDS). This should be fully disseminated to the crew. It is also necessary to fully disseminate the method of tank washing water treatment and slop tank usage to the crew in the form of a manual in order to ensure that they observe such procedures at all times.

In case a toxic substance like hydrogen sulfide gas is generated by chemical reaction while transporting tank washing water without checking the condition inside a slop tank, the manhole hatch covers of the slop tank should not be opened, and crew members staying near the discharge port of the slop tank’s exhaust pipe should evacuate to the windward side of the discharge port of the exhaust pipe while those staying near the accommodation space should evacuate without delay to the closed accommodation sections.

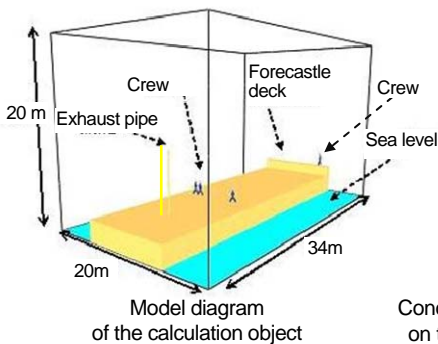
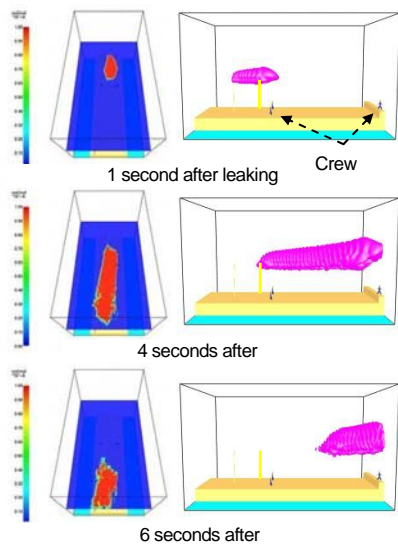
Concentration distribution on the horizontal section      Isosurface changes over time

- ▶ For C/O, 1/E and 1/O, it is proper to consider that the accident was caused by a different reason, and it is considered probable that they inhaled hydrogen sulfide gas which spouted out of each of the slop tank (starboard, port) manhole hatches.
- ▶ For C/E, it cannot be denied completely that part of hydrogen sulfide gas which spouted out of the discharge port of the slop tank's exhaust pipe reached C/E, and it is considered probable that C/E inhaled hydrogen sulfide gas which spouted out of the discharge port and each of the manhole hatches of the slop tank (starboard, port).
