JTSB Newsletter

Special edition
Marine Accidents

Japan Transport Safety Board

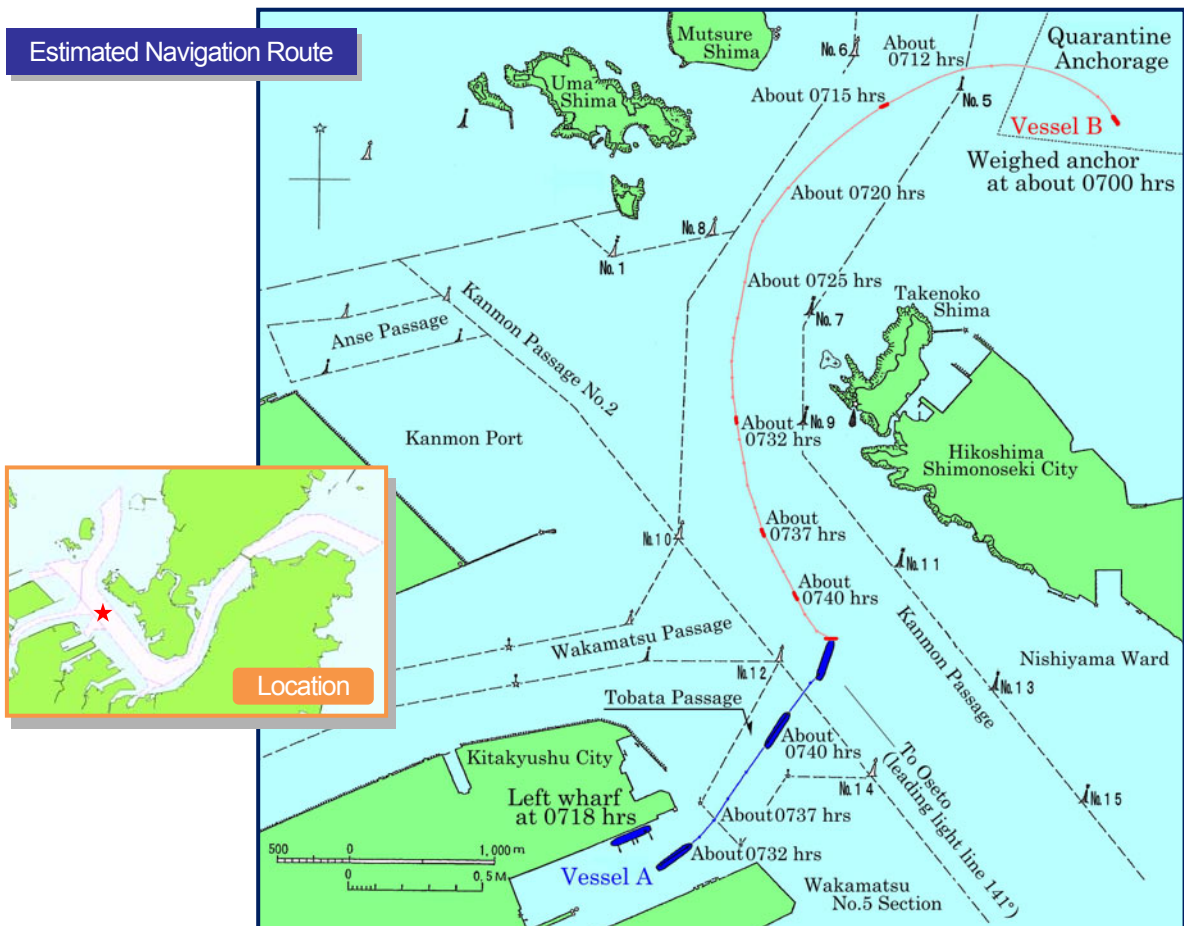
Estimated Navigation Route

On a heading of 019° and at an approximate speed of 7.2 knots, the bow of Vessel A collided with the starboard amidships section of Vessel B.

As a result of collision, she sustained a flooding in the cargo hold, forcing her to list to starboard.

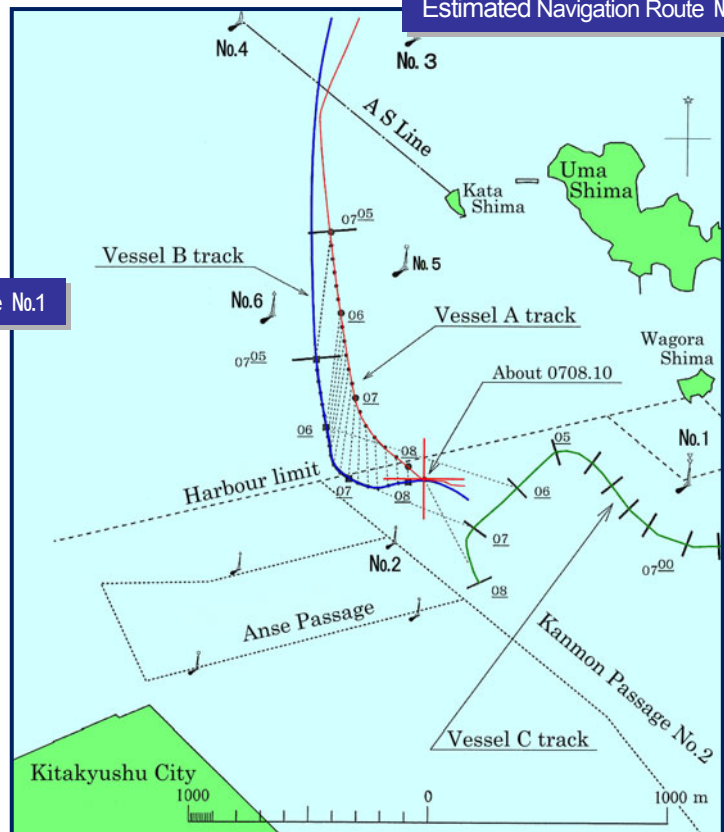
Estimated Navigation Route No.2

With a heading of about 081°, at a speed of about 7.9 knots, she collided with Vessel A.

This accident occurred in the vicinity of the northwestern end of the Kanmon Passage No. 2, in restricted visibility due to thick fog. It is probable that, when Vessels A and B were proceeding southward, in tandem, in the waterway west of Mutsure Shima Island, and Vessel C was sailing northwestward through the Kanmon Passage No. 2, with the intention to enter the Anse Passage, each of them detected, by radar, the presence of the other two vessels, but did not maintain an appropriate radar lookout and continued sailing, without taking notice that they were developing a close-quarters situation, which resulted in the accident.

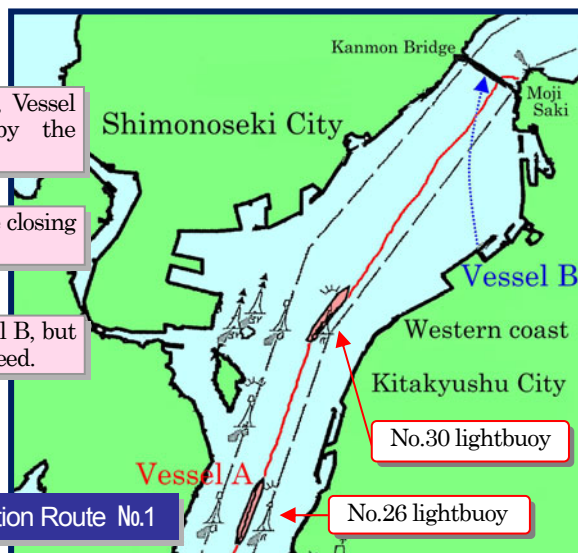
Estimated Navigation Route No.1

She was sailing while closing to Vessel B.

He lost track of Vessel B, but did not slacken his speed.

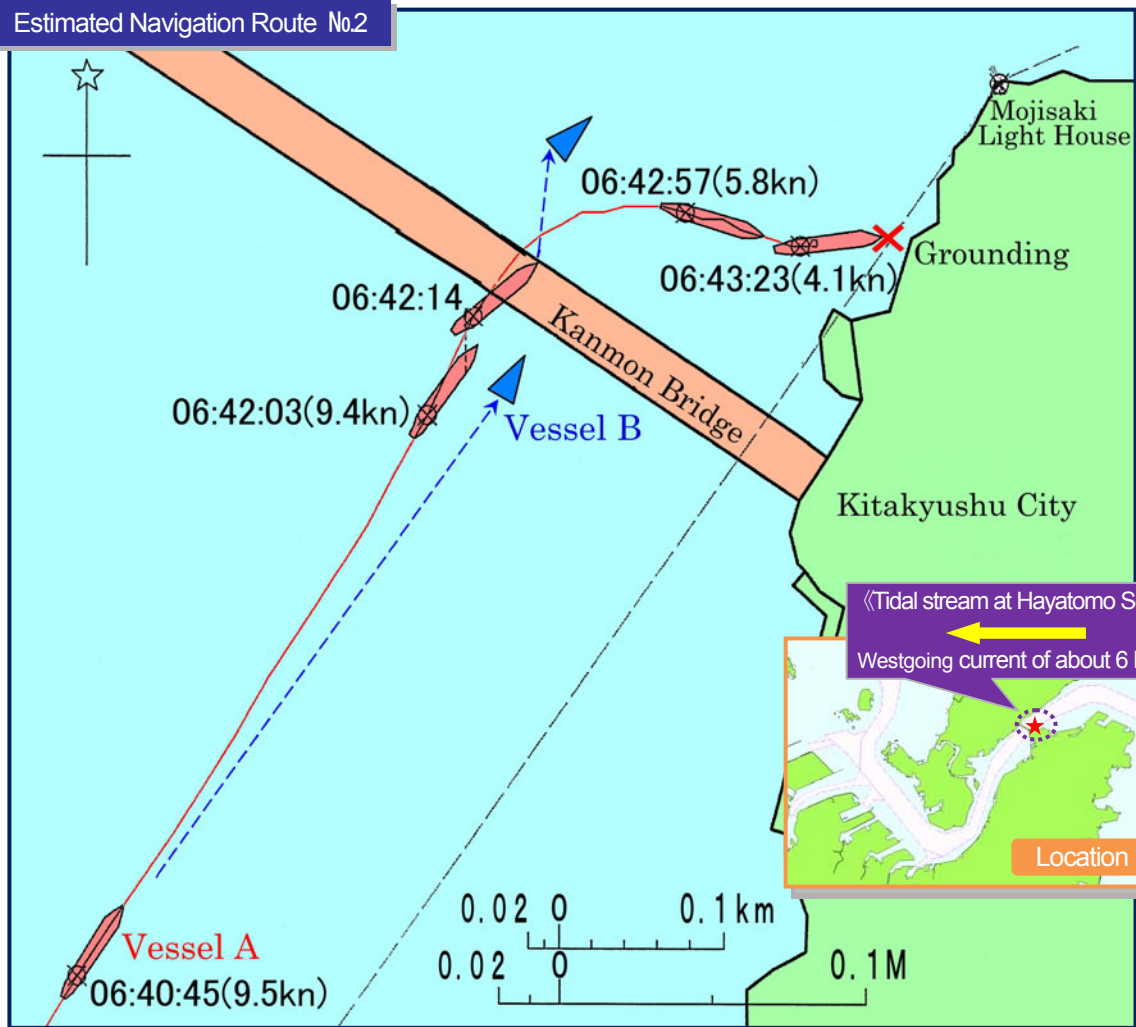
Estimated Navigation Route No.2

It is considered probable that this accident occurred, in the Kanmon Passage in a restricted visibility condition because of thick fog, as follows: While sailing northeastward and, at the same time, closing to Vessel B from behind, Vessel A lost track of Vessel B on the radar screen when her radar image was covered by that of the Kanmon Bridge; whereupon Vessel A did not slacken her speed; as a result, she drew closer and at the moment when lights of Vessel B were sighted, the latter was at a distance of about 50 m off on the port bow of Vessel A; and, in order to avoid collision, Vessel A turned to starboard.

It is considered probable that: As visibility had dropped to below 1,000 m, Vessel A should have taken shelter at an anchorage in a safe area or other means, by complying with the relevant safety management manual; although, after having observed Vessel B on the radar screen, she continued sailing at such a speed as would bring her closer to the other, she should have slackened her speed to a safe one.
