## AIRCRAFT SERIOUS INCIDENT INVESTIGATION REPORT

RYUKYU AIR COMMUTER CO., LTD. J A 8 4 R C

# RUNWAY INCURSION JAPAN AIR SELF-DEFENSE FORCE AIRCRAFT F-15J, 52-8850 & 32-8818, ON RUNWAY 36 ENGAGED BY BOMBARDIER DHC-8-402, JA84RC AT NAHA AIRPORT AT AROUND 20:26 JST, JUNE 14, 2018

June 14, 2019

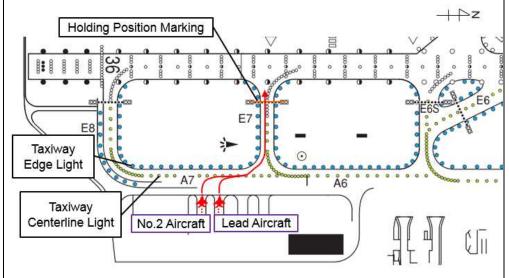
Figure 3: Taxi Route of Lead Aircraft and No. 2 Aircraft

The Lead Aircraft commenced taxiing to E7 taxiway followed by the No. 2 Aircraft. The Formation Leader was perplexed by the taxiway centerline lights which were not installed along his taxi route from A7 to E7, because, in addition to the night time operation, this was his first time to taxi from the the Alert Hangar of the Naha Air Base. Besides, the Wingman could not timely adapted to the darkness immediately after getting out of the well-lighted Alert Hangar; therefore he was taxiing attentively confirming the position of the Lead Aircraft and the taxiway edge lights, which slightly delayed the move of the No. 2 Aircraft after the Lead Aircraft.

- To introduce on-site trainings in the vicinity of the Alert Hangar at night, and to strengthen the educational training associated with ground operations.
