AI2011-6

**AIRCRAFT SERIOUS INCIDENT
INVESTIGATION REPORT**

Japan Transport Safety Board

**QATAR AIRWAYS
BOEING 777-300, A7BAE
ABOUT AN ALTITUDE OF 1,000 FT, 3.8 NM NORTHEAST OF
RUNWAY 24R, KANSAI INTERNATIONAL AIRPORT, JAPAN
AT ABOUT 21:55 JST, AUGUST 30, 2010**

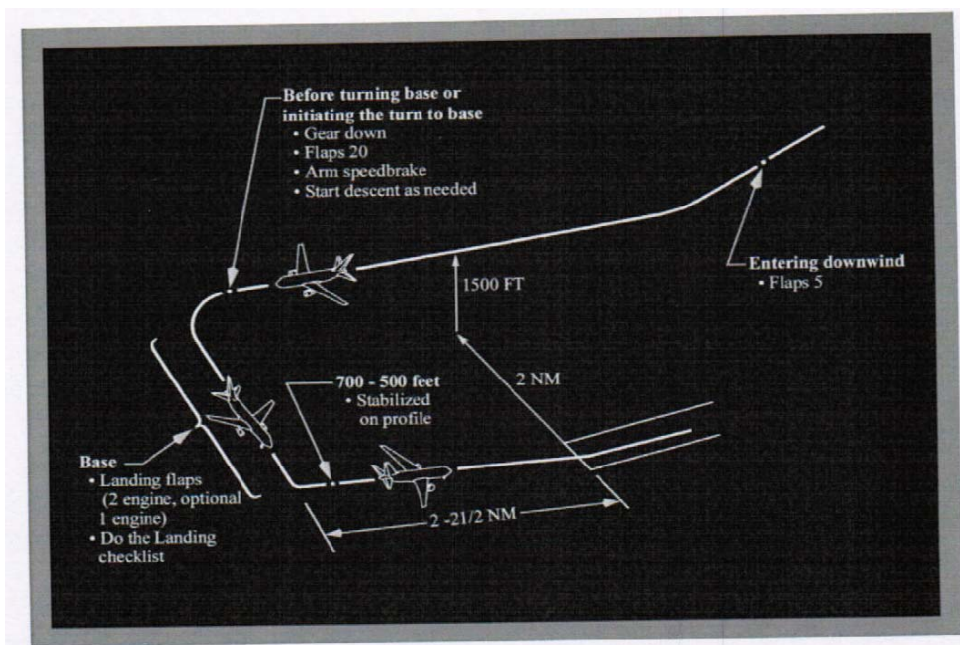
Visual Traffic Pattern

- (5) The First Officer took the traffic pattern wider than the standard width specified in 2.9.4 (2) in order to have leeway to fly. It is considered probable that this was not the direct cause of the false recognition of the runway. However, the traffic pattern was made above the sea, the visual approach was made at night with limited visual reference objects visible, and the downwind leg was close to the standard traffic pattern for 24R. Therefore, it is considered probable that, after the runway once became invisible in the downwind leg, when the Aircraft made the base turn, the First Officer saw a runway and a PAPI close to the position where they were normally seen, assumed it was the right runway, and entered 24R mistakenly.

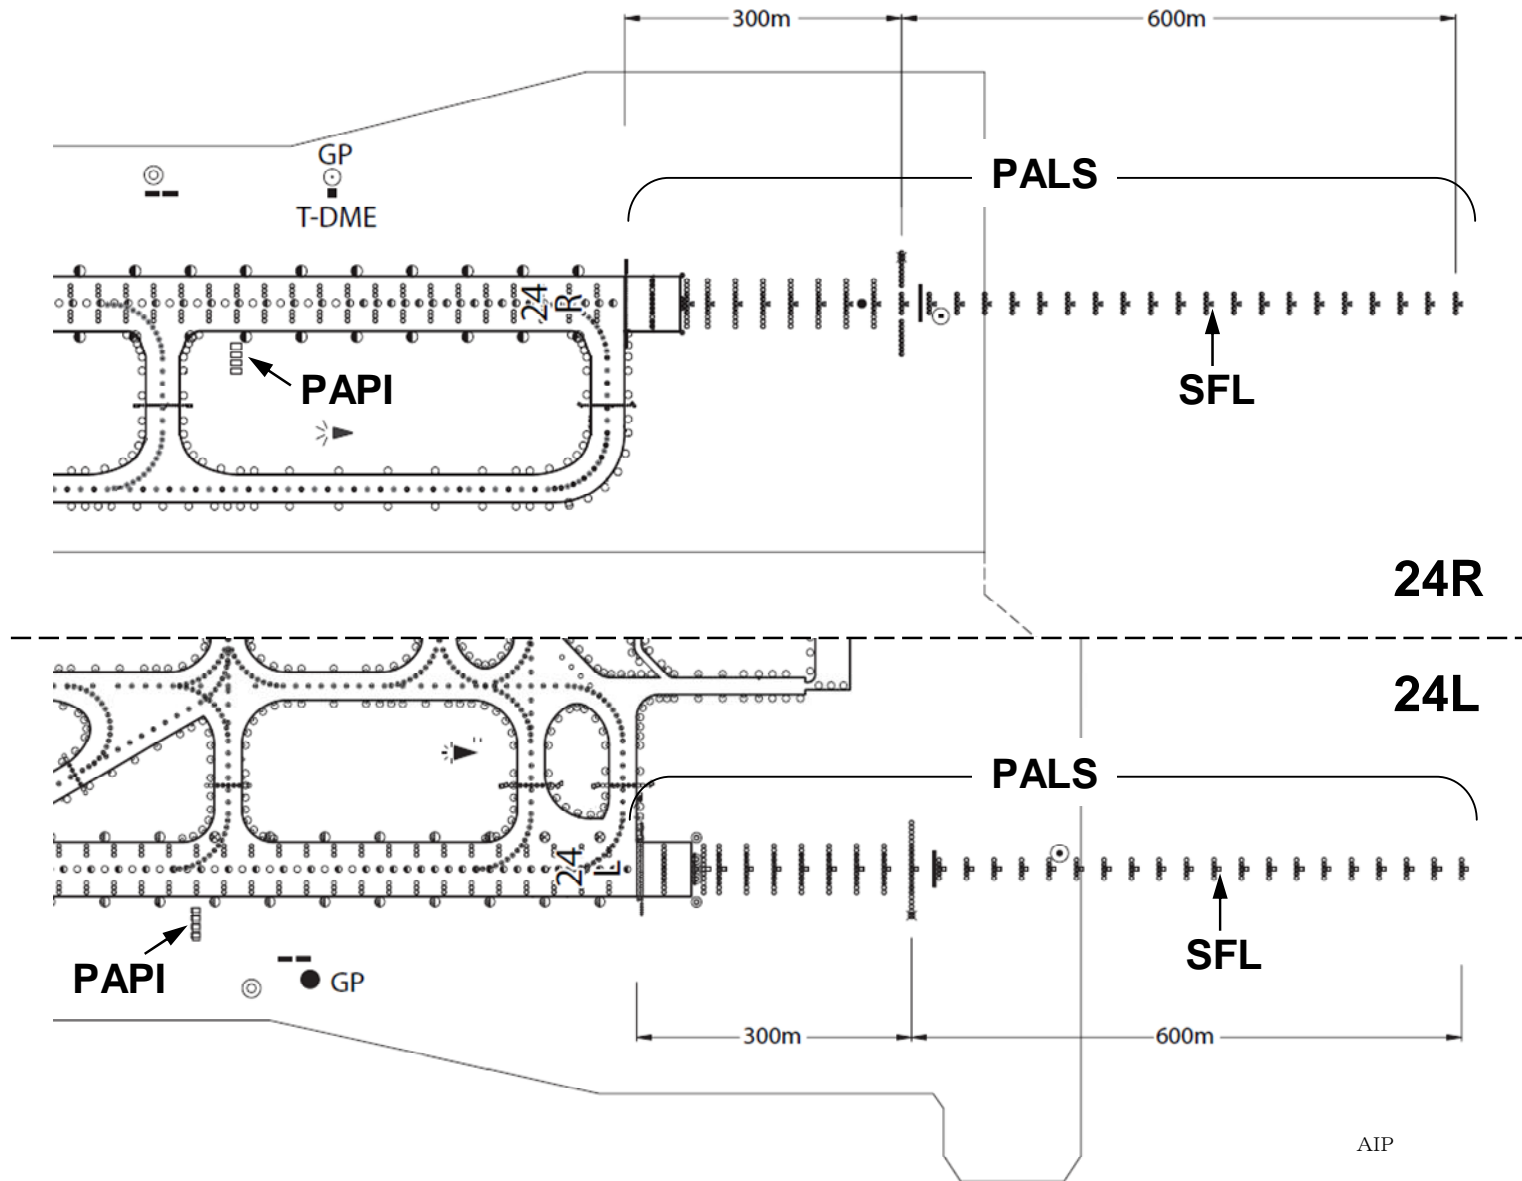
Figure 3 Lighting Arrangements

The SFL was lit between 21:52 and 21:53 and the PALS and PAPI were lit between 21:52 and 21:56.

The runway edge lights and runway touchdown zone lights were turned on in order to secure safety for the maintenance work but the runway centerline lights were turned off.
