AI2015-4

**AIRCRAFT SERIOUS INCIDENT
INVESTIGATION REPORT**

**CHINA EASTERN AIRLINES CO., LTD.
B2332
AIRASIA JAPAN CO., LTD.
JA01AJ**

1. CHINA EASTERN AIRLINES CO., LTD.
AIRBUS A319-112, B2332
 2. AIRASIA JAPAN CO., LTD.
AIRBUS A320-214, JA01AJ
- RUNWAY INCURSION
ON RUNWAY 18 AT NAHA AIRPORT
AT ABOUT 13:24 JST, JULY 5, 2012

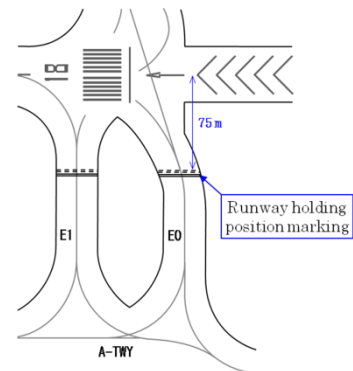
As shown in the figure at right, Taxiway E0 is located between Parallel Taxiway A and the overrun on the north side of the runway. It is connected to the threshold of Runway 18; therefore, Taxiway E0 is mainly used together with the adjacent Taxiway E1 when departing aircraft are entering Runway 18 for takeoff.

In order to indicate the position at which aircraft should come to a stop short of the runway, a runway holding position marking is placed at a point 75 m away from the extension of the runway's center line.

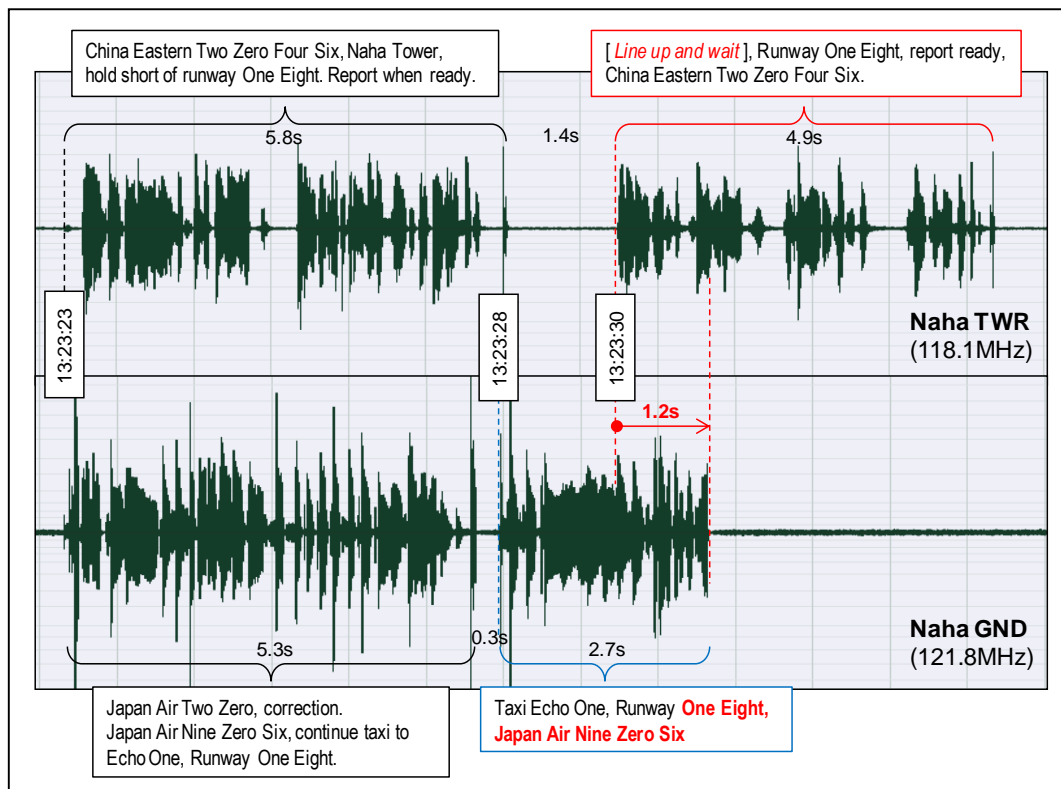
pop noise (noise occurring when sound is cracked by excessive strength of the voice or by blowing into a microphone) are recorded on the voice of the Tower Controller. This noise primarily occurs on consonant sounds, and is particularly prominent in the “Hold short” portion, in the transmission beginning at 13:23:23, which instructed Aircraft A to hold short of the runway.

The readback of this hold instruction from Aircraft A began at 13:23:30. The beginning portion of the readback “Line up and wait” was recorded unclear voice and was very difficult to read. Moreover, as indicated in the figure below, from 13:23:28, immediately after the hold instruction from the Tower was completed, Japan Airlines Flight 906 (hereinafter referred to as “Aircraft D”), which had been instructed on the Ground frequency to taxi to the runway, began to read back the instruction, and the readback from Aircraft A was overlapping the latter half of the readback from Aircraft D for about 1.2 seconds.

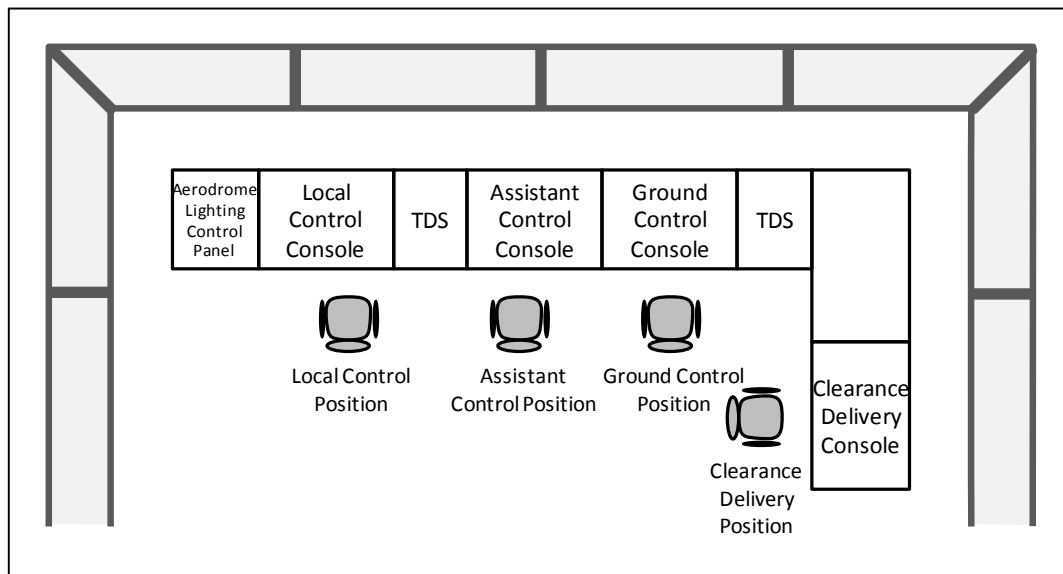
A radio communication unit for selecting the radio frequency used for communications is mounted on each control console except for the Assistant Control Console, and received sound on the selected frequency can be heard by using a headset connected to the control console. The received

sound can also be output from a loudspeaker located on each control console.

While sound from a loudspeaker on a control console is attenuated in volume and deteriorated in clarity depending on the distance from the loudspeaker, sound from a headset, as described in 2.5.3, can be heard from an earpiece inserted into the ear and is anytime at a constant volume and superior in clarity to sound from a loudspeaker; therefore, it is probable that it could be easily

From these points, in order to prevent the occurrence of masking and to make sure communications, it is considered necessary for Controllers responsible for Tower or Ground at Airport Traffic Control Towers, where more than one control position conducting ground-to-air communication are allocated, to listen to sounds through the earpieces by wearing headsets, even if those sounds are output from loudspeakers.

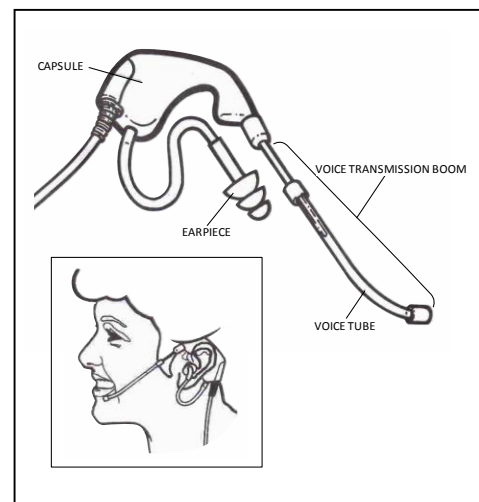
The headsets used by Controllers for their duties at the Naha Airport Traffic Control Tower are ear-hook type and manufactured in the United States of America. They are composed of a microphone contained in a capsule to be hooked over the ear, and a tube known as a “voice transmission boom” extending from the capsule to a sender’s mouth area, within which the sender’s voice travels to the microphone. When the headset is properly worn, the tip of the voice tube, a part of the voice transmission boom, comes sideways against the lips. The received sound is heard through an earpiece connected to the capsule and inserted into the ear.

According to 2.1.3, the Tower Controller stated that she conducted communications without wearing a headset but by holding it in her hand, and that the tip of the voice tube was pointed toward her mouth; therefore, it is highly probable that the pop noise described in 2.5.1 occurred because the breath of Tower Controller struck directly the opening in the tip of the voice tube when she uttered words. The controller also stated that she clearly added “Hold short of Runway 18”; therefore, it is probable that prominent noise was caused when the Tower Controller stressed the “Hold short” portion.

It is probable that if the headset had been properly worn, the tip of the voice tube would have been positioned at a right angle to the Tower Controller’s lips, and this pop noise would not have occurred; therefore, in order to transmit a clear voice when a headset is used, it is considered necessary for Controllers to engage in their duties by wearing the headset as described in the manufacturer’s instruction manual mentioned in 2.5.3.
