AI2009-2

**AIRCRAFT SERIOUS INCIDENT
INVESTIGATION REPORT**

AT ABOUT 18:11 JST OCTOBER 20, 2007

**ON THE FINAL APPROACH COURSE FOR
RUNWAY 24L OF KANSAI INTERNATIONAL AIRPORT**

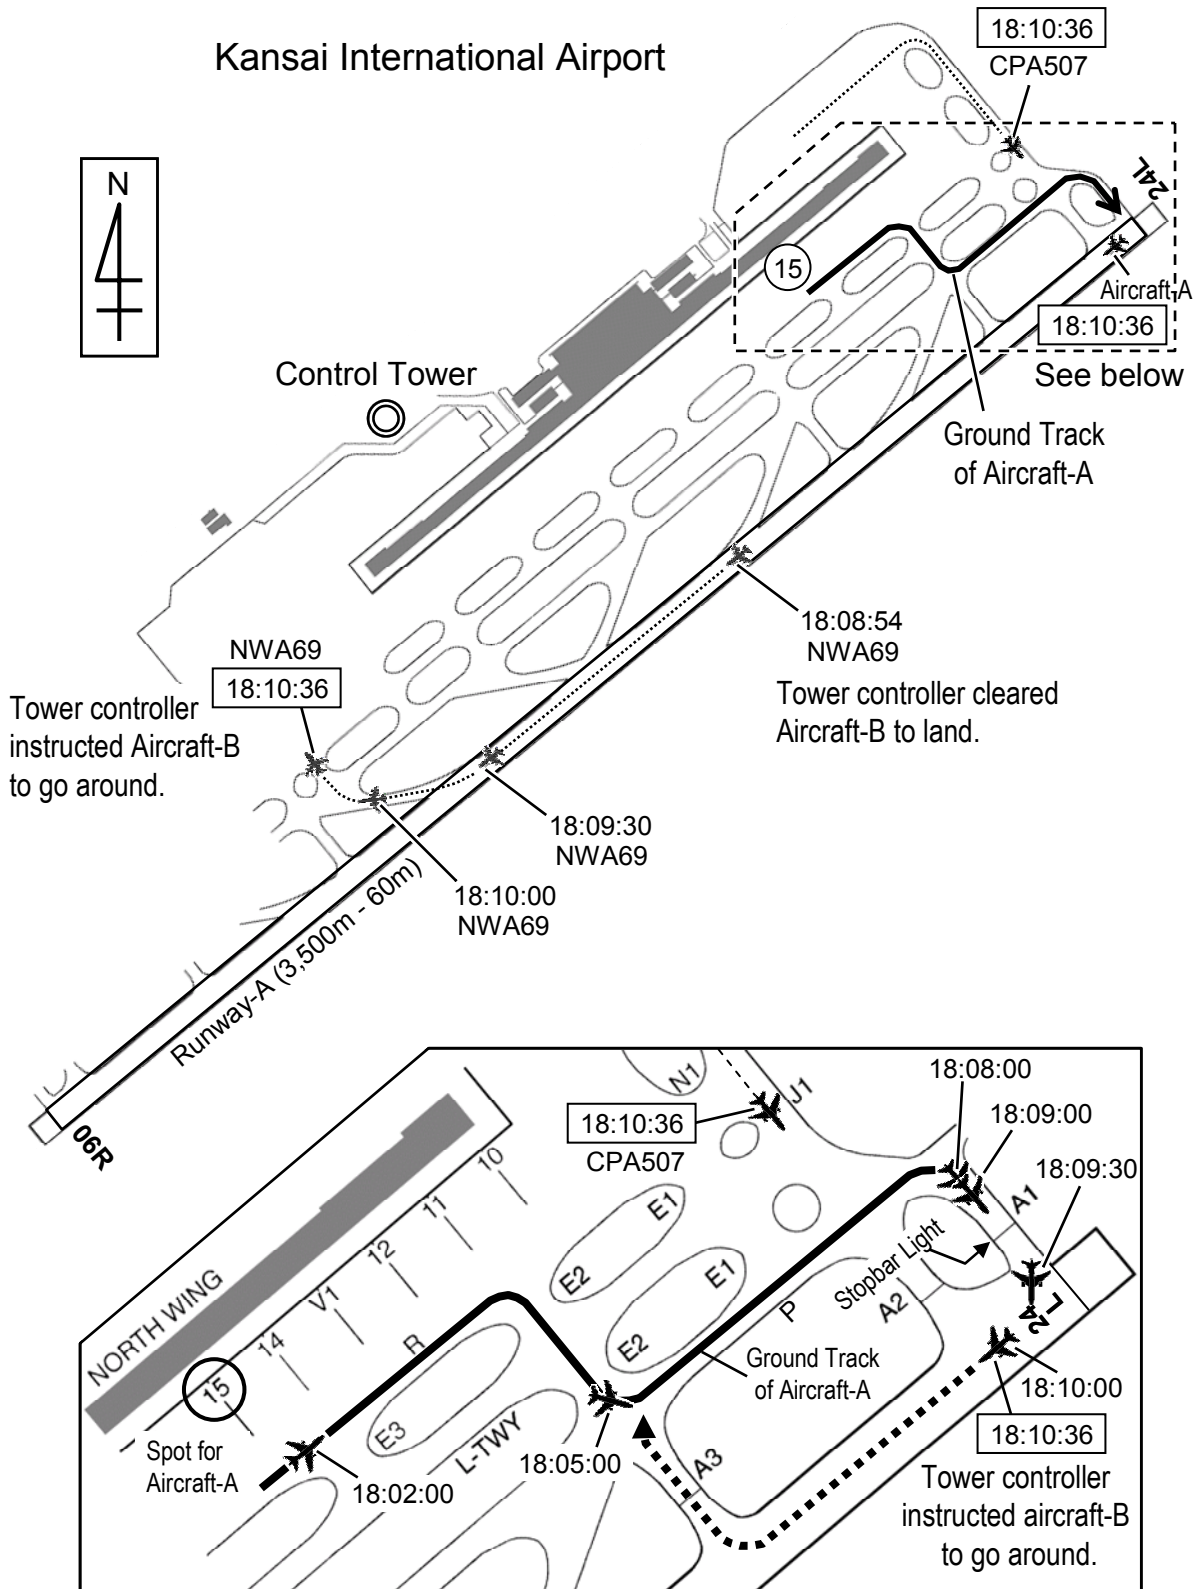
Figure 1 Estimated Track of Aircraft-A

- Around 08m:40s Aircraft-A stopped short of the runway holding position markings on Taxiway A1, and NWA69, which was just before touchdown for landing, passed by.

- 08m:43s The Tower instructed Aircraft-A, “Roger that. Hold short of runway 24L.” The position of Aircraft-B was about 6.5nm away from the 24L threshold at this point.

- 08m:46s Aircraft-A replied to the Tower, “To position 24L.”
- Around 08m:49s Aircraft-A started moving towards 24L.
- 08m:54s The Tower issued a landing clearance to Aircraft-B, transmitting “Revised. Runway 24L, cleared to land,” and reported “Wind 290 at 19, (Boeing) 747 (NWA69) landing roll.” The position of Aircraft-B was about 6.0nm away from the 24L threshold at this point.

- Around 09m:30s Aircraft-A entered the runway.
- Around 10m:00s NWA69 vacated the runway.
- Around 10m:05s Aircraft-A stopped aligning to 24L.
- 10m:07s Aircraft-B confirmed landing clearance with the Tower. The position of Aircraft-B was about 3.3nm away from the 24L threshold at this point.

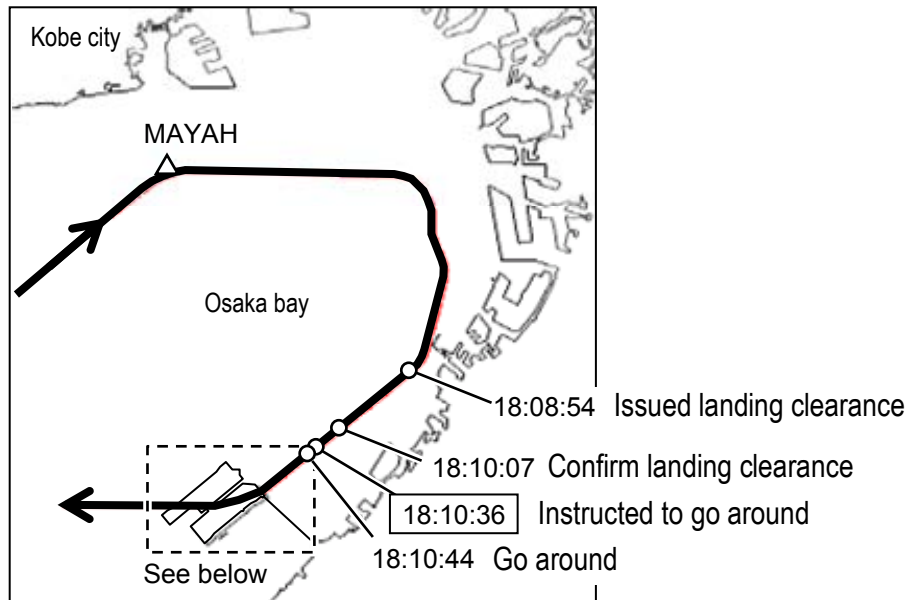
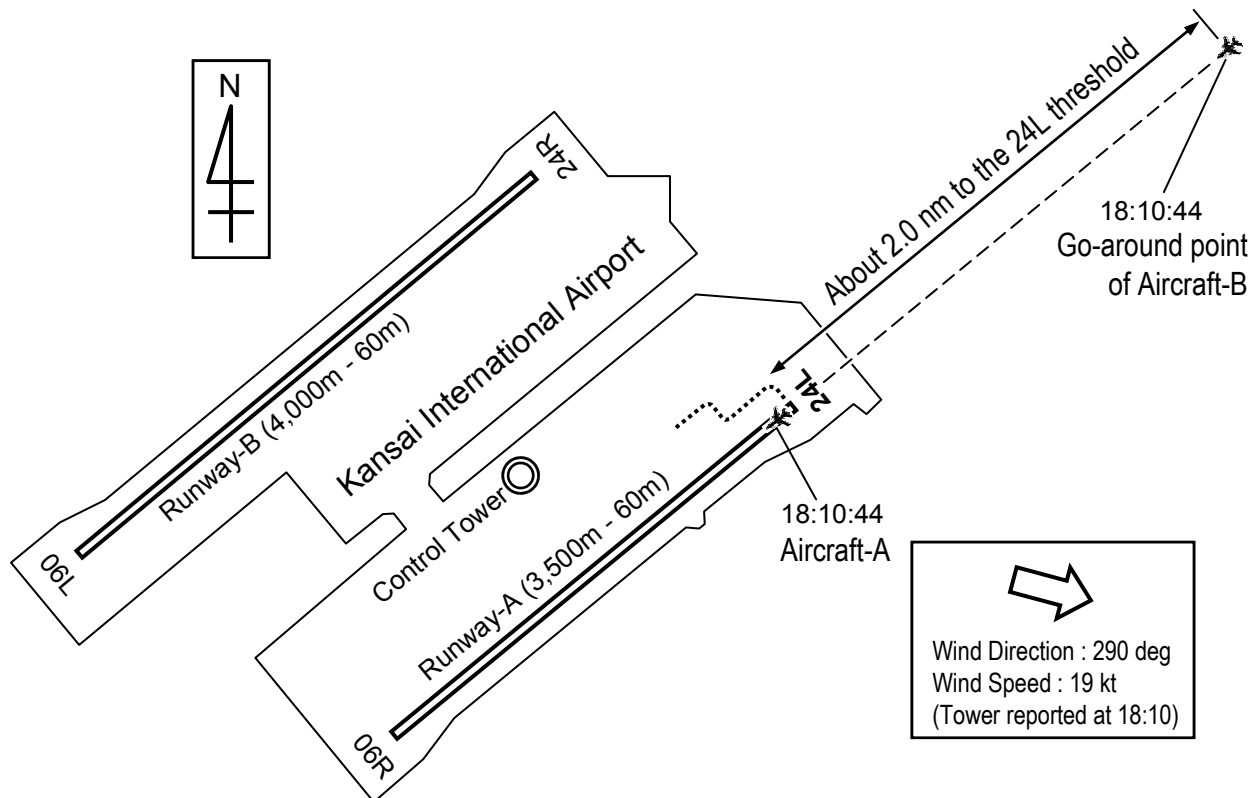
Figure 2 Estimated Flight Route of Aircraft-B

This serious incident³ occurred on the final approach course for 24L of the Airport, about 2.0nm (about 3.7km) from the threshold of 24L, at around 18:11, October 20, 2007.

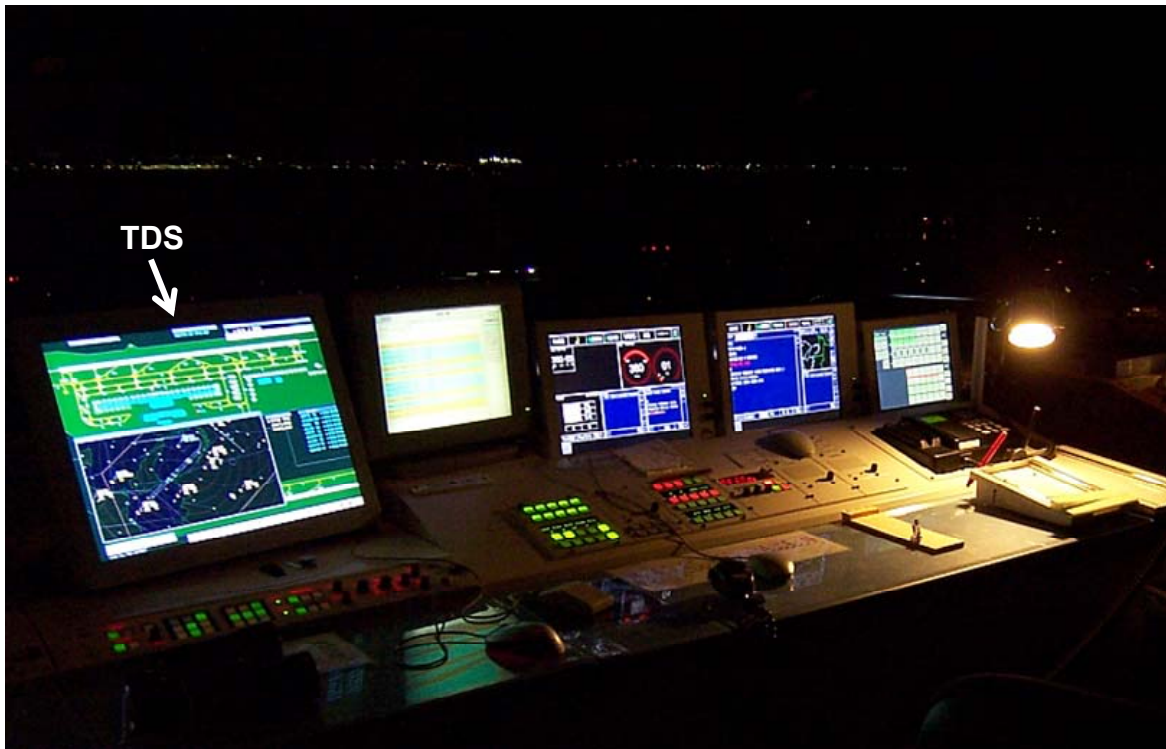
Photograph 1 Control Tower (Runway-A side)

When CPA507, to depart following Aircraft-A, called and I looked at the side of 24L, I noticed that Aircraft-A had entered the runway and I instructed Aircraft-B to make a go-around.
