The response from the FAA to the safety recommendation

SPECIAL AIRWORTHINESS INFORMATION BULLETIN

SUBJ: Flight Controls

SAIB: NM-15-03

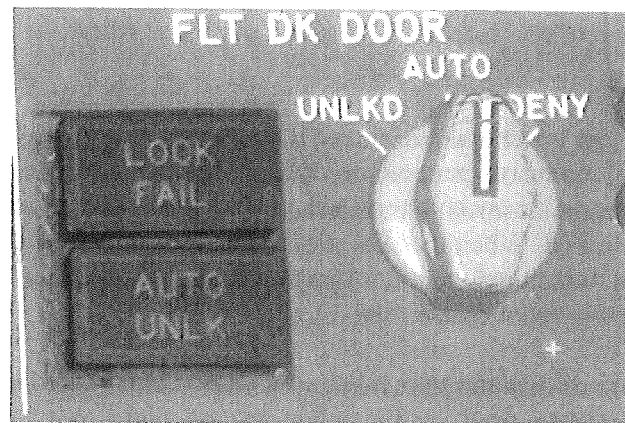
Figure 2 – Flight Deck Door Control Switch

During the investigation of this incident, numerous aisle stand configurations were identified due to the multitude of supplemental type certificate installations and significant variability in the Boeing-delivered configurations. On the incident airplane (Model 737-700), the rudder trim switch is in approximately the same location as the flight deck door control switch on the operator's Model 737-500 airplane. This creates a potential for confusion when pilots transition between aircraft. Positive training on one model can become negative when the pilot transfers to a different model. Although the rudder trim switch (Figure 1) and flight deck door control switch (Figure 2) are different in size and shape (cylindrical vs. blade shaped), and the flight deck door unlock side of the switch must be depressed before turning, the general feel (spring force) to actuate the switches is similar; both are spring loaded to the center position. In this incident, the negative transfer error allowed the pilot to think he had operated the correct control, and the similarity of the control's operation exacerbated the situation.

In response to this incident, Boeing analyzed modifying the shape of the flight deck door control switch; however, they determined the position of the switch is more important than the shape of the switch from a human factors perspective. Position of a switch that affects pilot reach/posture provides better feedback to the pilot than the shape of the switch that the pilot feels. Boeing determined the most important factor to minimize inadvertent activation of the control switches is aisle stand configuration consistency within an operator's fleet.

1. Place the rudder trim switch in the center column as far aft as possible.
2. Place the flight deck door control switch in the far right column (first officer side) aft position.
3. Do not place the flight deck door control switch in the center column.
