**AIRCRAFT SERIOUS INCIDENT  
INVESTIGATION REPORT**

**KOREAN AIR**

**H L 7 2 4 0**

**KOREAN AIR  
AIRBUS INDUSTRY A300B4-600R, HL7240  
AT AN ALTITUDE OF APPROXIMATELY 33,000 FT, OVER THE  
VICINITY OF HIKARI CITY, YAMAGUCHI PREFECTURE,  
JAPAN  
AT ABOUT 19:36 JST, JUNE 23, 2009**

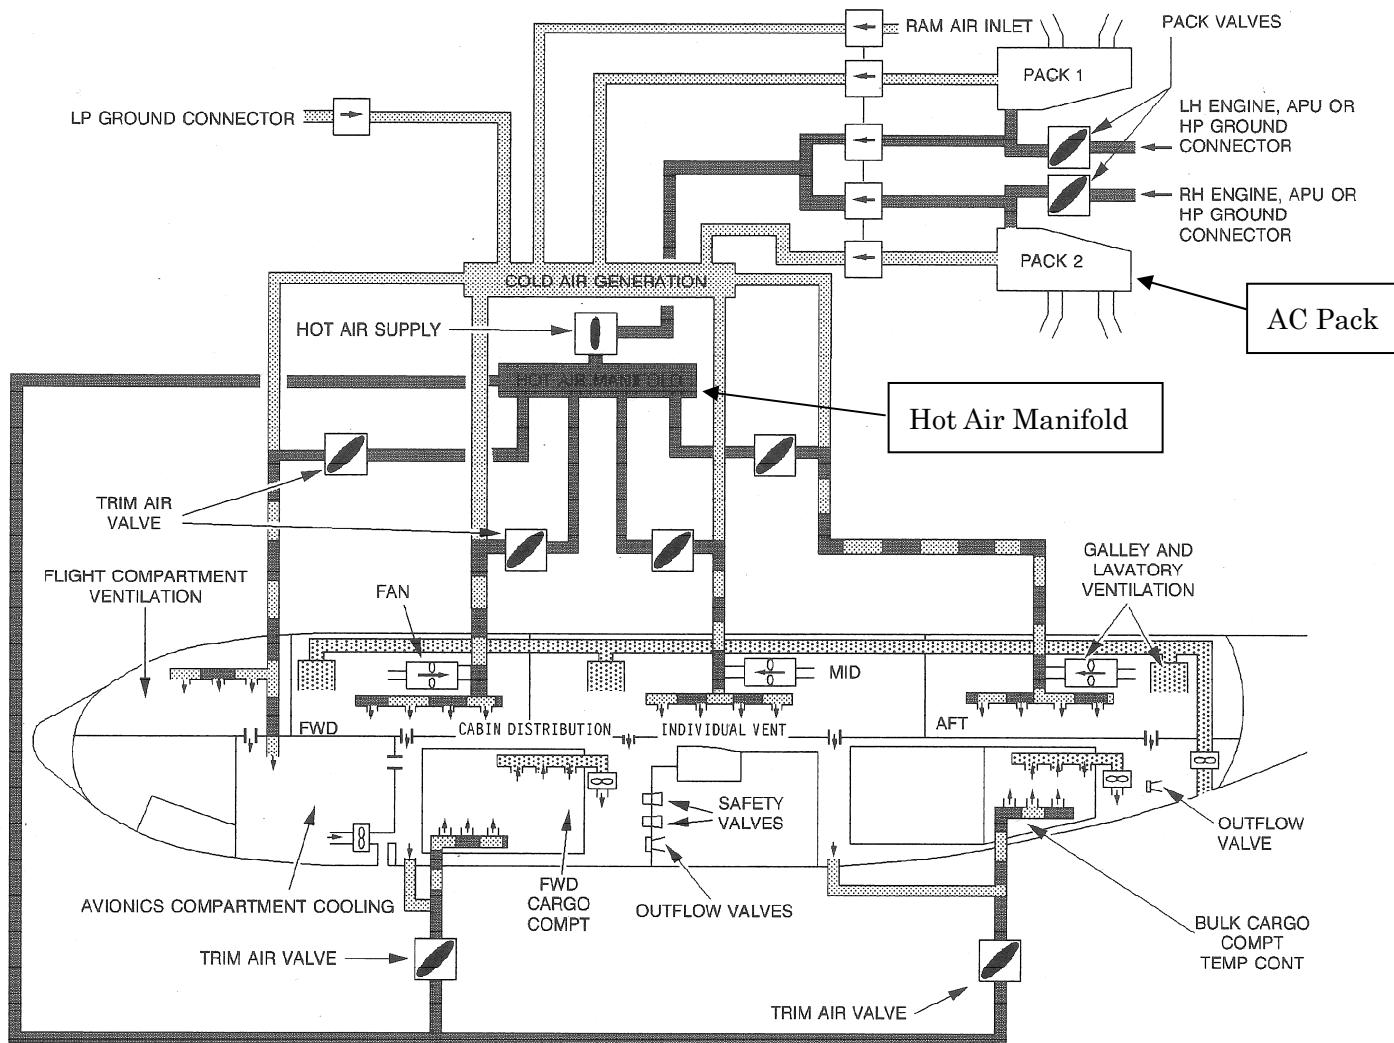
Figure 4 Air-Conditioning, Pressurization and Ventilation Systems

- (2) The emergency ram air inlet system is used only when flying at low altitude without pressure difference. If the air-conditioning system becomes inoperative, the system lets outside air into the aircraft for cabin ventilation. When the system is activated, it opens the ram air inlet door to take in the outside air, while at the same time the cabin pressure controller fully opens the outflow valves as an outlet for cabin air.
