**AIRCRAFT ACCIDENT
INVESTIGATION REPORT**

**T'WAY AIR
HL 8021**

July 30, 2020

FLIGHT ATTENDANT INJURY BY THE SHAKING OF THE AIRCRAFT T'WAY AIR BOEING 737-800, HL8021 OVER HITACHIOTA CITY, IBARAKI PREFECTURE, JAPAN AT AROUND 09:57 JST, MAY 2, 2019

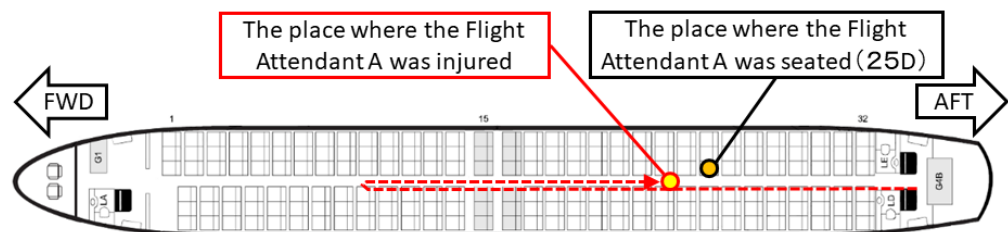
Figure 2: The flight attendant’s position when injured

referred to as “Flight Attendant A”) was ensuring safety from aft galley to around the 10th row in the forward zone. When Flight Attendant A was near the 23rd row in the midst of returning to her seat, the Aircraft suddenly shook severely. After Flight Attendant A felt like floating by the shaking, she lost her balance and severely fell down backward. Flight Attendant A attempted to regain her feet promptly thereafter, however, she was unable to put some muscle due to a strong pain in her right ankle and took an empty seat (25D) in the aft (see Figure 2). There was no indication of echo on airborne weather radar or no turbulence information by PIREP. The descent was being performed by autopilot.

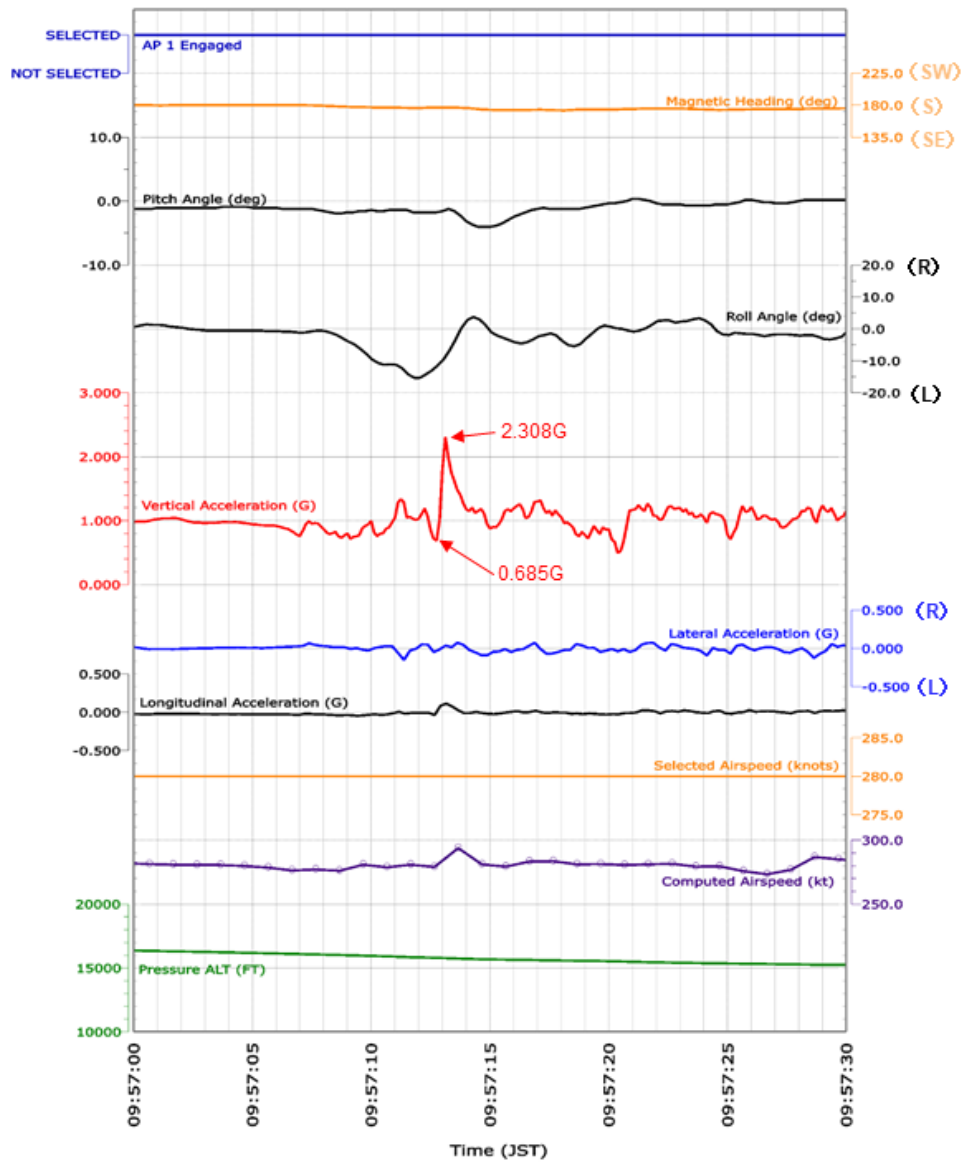
Figure 3: FDR records

According to FDR records of the Aircraft from 09:57:12 until 09:57:14, roll angle changed in the range from 15.3° to the left to 3.7° to the right , and at the same time, vertical acceleration speed instantaneously changed in the range from +0.685G to +2.308G. Lateral acceleration speed at this time changed by 0.048G in the left direction and 0.074G in the right direction. Simultaneously, changes in longitudinal acceleration speed and air speed were also recorded. (See Figure 3)

3.1 Involvement of Weather	Yes
3.2 Involvement of Pilot	None
3.3 Involvement of Aircraft	None
3.4 Analysis of Findings	<p>(1) Shaking of the Aircraft</p> <p>The shaking of the Aircraft at the time of the accident was to correspond to instantaneous changes in vertical acceleration speed and lateral acceleration speed during the period from 09:57:12 until 09:57:14 recorded in FDR, and it is highly probable that the Aircraft was descending in the thin cloud at this time. It is highly probable that the shaking caused Flight Attendant A who was ensuring safety in the cabin to lose her balance after feeling like floating and fall down severely backward, which resulted in her injury by an excessive force applied to the right ankle at that time.</p> <p>(2) Meteorology</p> <p>From domestic significant weather observation chart issued by the Japan Meteorological Agency, on the radar echo, from 5 mm or more to less than 10 mm precipitation per hour was observed near the accident site, and an hourly atmosphere analysis chart indicated Vertical Wind Shears near the accident site. It is probable that there might have occurred atmospheric disturbance near the accident site although there was no report of the PIREP regarding turbulence near the accident site within an hour before and after the accident.</p> <p>(3) PIC's Judgement on Meteorology</p> <p>It is probable that, even if the PIC predicted a chance to encounter a light turbulence, he did not expect to encounter a severe turbulence when passing the thin cloud, because meteorological data confirmed prior to the departure, the display of on-board weather radar and PIREP did not indicate turbulence along the flight route that might affect the flight.</p> <p>When visually recognized the thin cloud, the PIC, considering safety of the passengers, notified the flight attendants by the seat belt fastening chimes that a light turbulence was predicted; however, it is probable that the atmospheric disturbance bigger than the flight crew had expected generated along the flight route.</p>

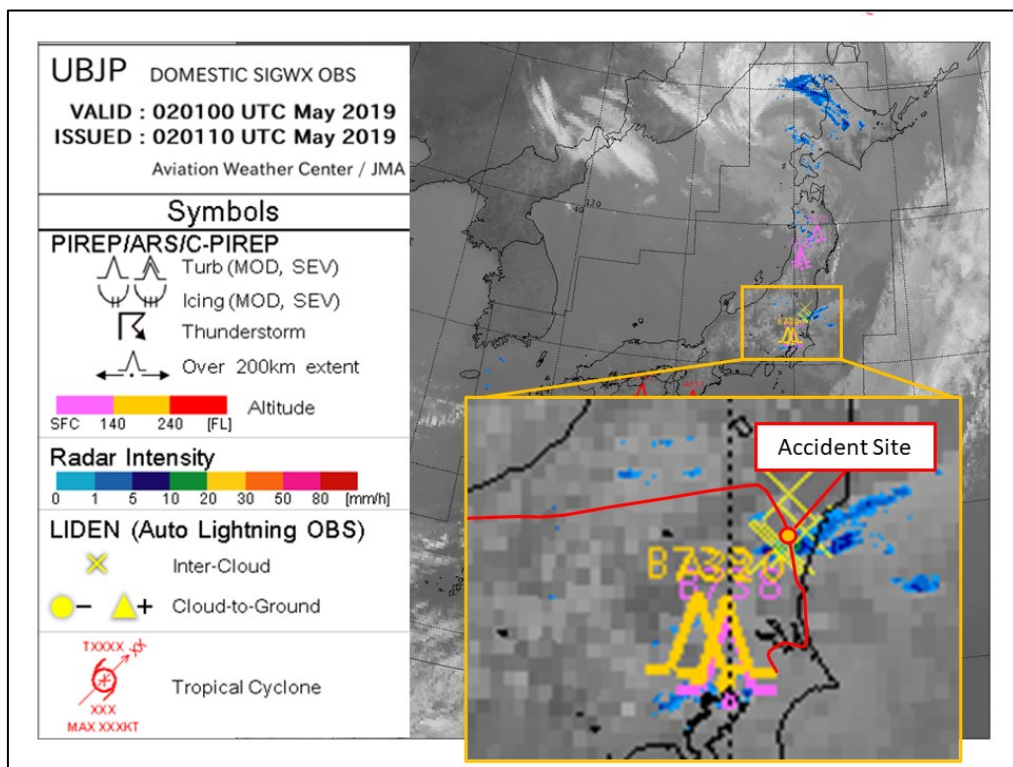
Figure 4: Domestic significant weather observation chart

PIREP (Pilot Report) issued by the Japan Meteorological Agency reported turbulence within an hour before and after the accident over the vicinity of Tokyo International Airport; however, there was no such a report over the vicinity of the accident site. (Figure 4)

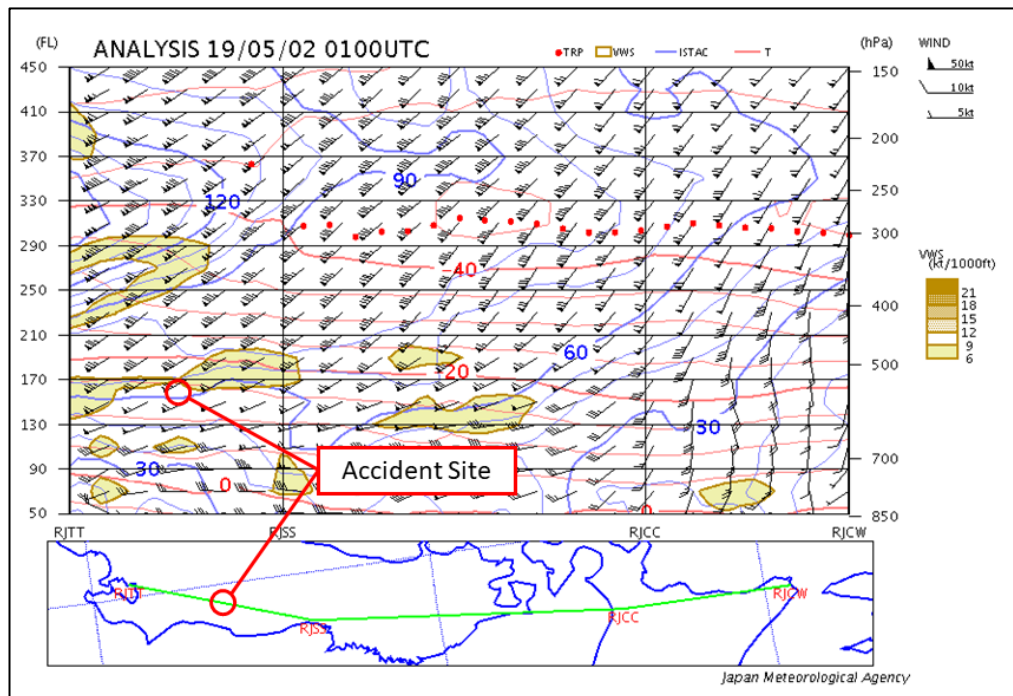
Figure 5: Hourly atmosphere analysis chart (cross section of flight route)

2.6 Meteorological Information	<p>(1) Meteorological Data Confirmed by Flight Crew</p> <p>i) Meteorological data confirmed prior to the flight</p> <p>Flight crew judged that weather conditions were not such that might affect the flight because METAR (Aviation routine weather report) or the significant weather prognostic chart issued by London WAFC*⁴ did not observe or predict severe weather in the flight route of the accident Aircraft although TAF (Aerodrome Forecast) for Narita International Airport they confirmed prior to the departure forecasted a light thunderstorm from 12 o'clock through 15 o'clock after arrive.</p> <p>ii) Turbulence information</p> <p>OCC (Operation Control Center) of the Company always keeps monitoring meteorological data provided by the Korea Meteorological Administration or meteorological forecast providers. Should a severe turbulence that may affect flight be predicted, such information is provided with flight crew by ACARS*⁵. There was no turbulence information that should be reported to the accident Aircraft, and accordingly, no information was provided with the flight crew.</p> <p>Besides, there was no turbulence information provided in flight by ATC.</p> <p>(2) Meteorological Data at the Time of the Occurrence of the Accident</p> <p>i) Domestic significant weather observation chart (Figure 4)</p> <p>According to domestic significant weather routine chart for 10 o'clock issued by the Japan Meteorological Agency at 10:10 on the accident day, on the radar, from 5 mm or more to less than 10 mm precipitation per hour was observed along the flight route of the Aircraft. Besides, lightning was observed in the cloud near the accident site.</p> <p>ii) Hourly atmosphere analysis chart (Figure 5)</p> <p>Hourly atmosphere analysis chart as of 10 o'clock on the accident day indicated Vertical Wind Shears (VWS) of 6 to 9 kt/1,000 ft near the accident site.</p> <p>iii) PIREP</p>
