**AIRCRAFT SERIOUS INCIDENT  
INVESTIGATION REPORT**

## RUNWAY INCURSION

1. THAI AIRASIA X CO., LTD.,  
AIRBUS A330-343X, HS-XTC

2. CHINA AIRLINES  
AIRBUS A330-302, B-18361

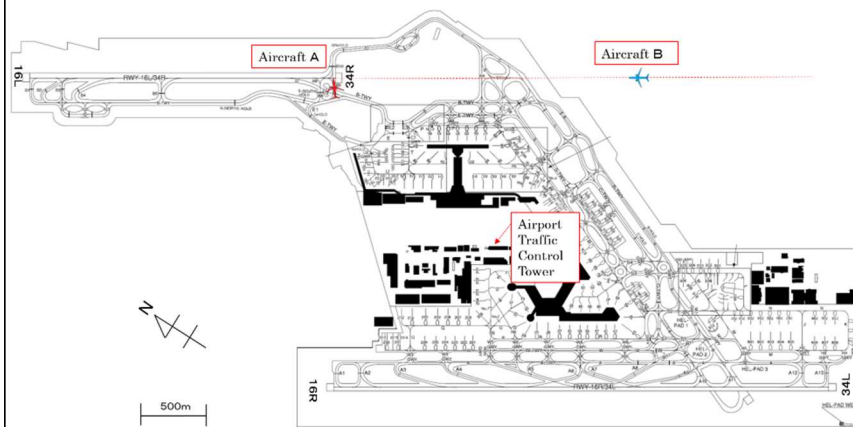
**Figure 1 The Serious Incident Site**

The serious incident occurred at 20:16 (JST: UTC + 9 hours, unless otherwise stated all times are indicated in JST on a 24-hour clock) on February 14, 2017, on the runway 34R of the Airport. On this moment, the Aircraft B which was approaching over the position approximately 2,900 m (approximately 1.57 nm) from the threshold on the final approach course.

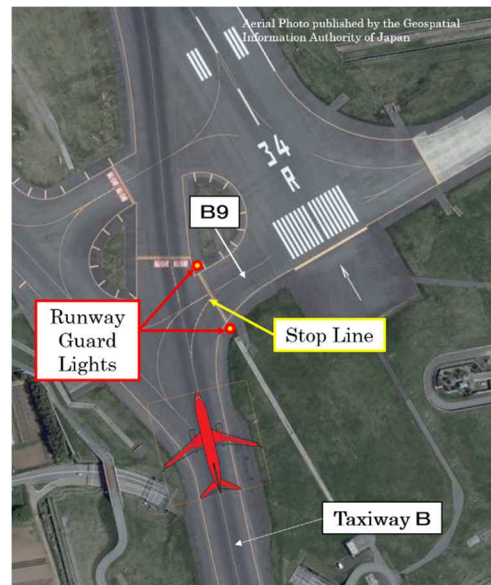
**Figure 2 Image of stopping at B9 stop line**

runway 34R and the runway is narrow. A aircraft with the instruction to hold short of runway 34R, stopped short of B9 on the Taxiway B, because the space in front of the Stop Line of B9 has not enough for the Aircraft to stop with face to the Stop Line right angle. (See Figure 2.)

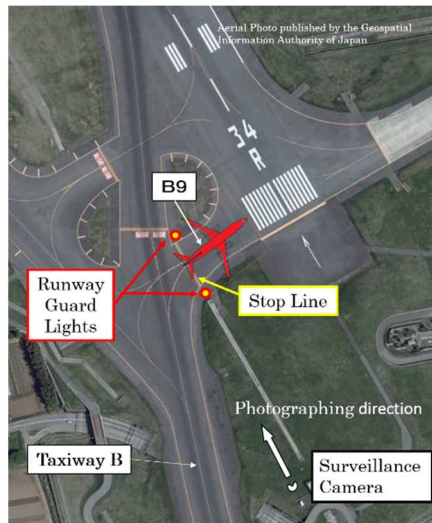
**Figure 3 Estimated Stop Position of the Aircraft A based on FDR and MLAT**

B9 which connects to the runway 34R has the Stop Lines, the Stop Bar Lights and the Runway Guard Lights installed in order to indicate the position to halt before entering the runway. (See Figure 3.) The Stop Bar Lights will turn red light on when the low visibility to indicate the halting position, but when the weather is good, even at night, the light would not be on. The Runway Guard Lights flashes in yellow light to indicate the halting position at night of low visibility. When the serious incident occurred, the Stop Bar Lights were not turned on, but the Runway Guard lights were on.

concerning the halting position where the Aircraft A stopped with the instruction of the Tower is as shown in Figure 3. At the moment, the positional relation between the Aircraft at the time of stop and the Runway Guard Lights, which were recorded by Surveillance Camera, is as shown in Photo 1.

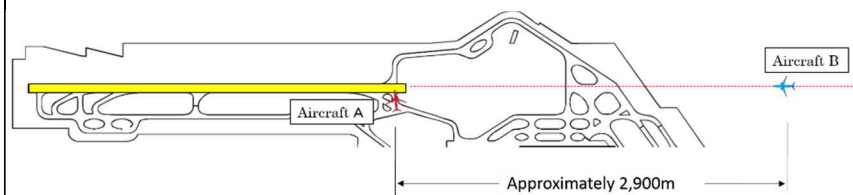
**Figure 4 Display Image on Airport Surface Display system when a warning is activated**

aircraft enters the runway or not based on a position of the aircraft, if other aircraft crosses a stop line, the runway condition becomes yellow on the screen to display warning and calls out attention to controllers.

At the time of the serious incident occurrence, when the system identified that the Aircraft A crossed the Stop Line of B9, because the Aircraft B positioned closer to the threshold than a specified range, the warning was displayed.
