**AIRCRAFT SERIOUS INCIDENT  
INVESTIGATION REPORT**

**The General Incorporated Association  
Tokai/Kansai Student Aviation League  
J A 0 1 K T**

**February 16, 2023**

<b>Company</b>	The General Incorporated Association Tokai/Kansai Student Aviation League
<b>Type, Registration Mark</b>	Scheibe SF25C (Motor Glider, Two-Seater), JA01KT
<b>Incident Class</b>	Dragging during landing of any other part of the landing gears of the Aircraft. Article 166-4, item (iii) of the Ordinance for Enforcement of the Civil Aeronautics Act
<b>Date and Time of the Occurrence</b>	At about 13:05 Japan Standard Time (JST: UTC+9 hours), April 23, 2022
<b>Site of the Serious Incident</b>	Fukui Airport (36°08'42 N, 136°13'25 E)

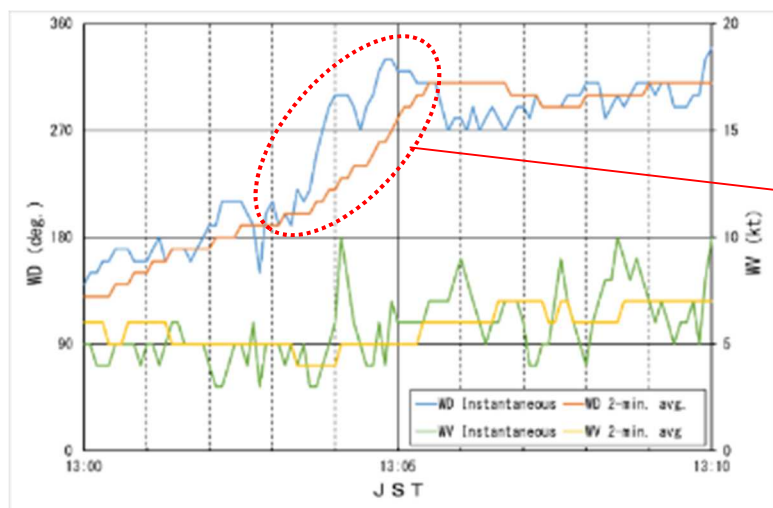
Figure 1: Winds at Fukui Airport

The wind observed by the anemometer located near the apron at the Airport (Figure 1) changed direction from south to northwest from about 13:03 to 13:05 while keeping a wind velocity of about 5 kt.

The wind direction changed over a short time. And the wind direction was not stable as there was a large difference between the instantaneous wind direction and the 2-minute average wind.

The JTSA concludes that as the wind direction at the Airport changed from south to northwest for about two minutes from about 13:03 to the time when this serious incident occurred at about 13:05, it is highly probable that the wind direction changed during the approach of the Aircraft, therefore, the captain performed the flare with a tailwind.

the wind direction changed to northwest, the wind direction reported from Fukui Radio was west, but the variation width was not reported since the wind velocity was less than the reporting criteria. In addition, the reason why there was a difference between the actual wind direction and the wind direction reported from Fukui Radio is most likely because the average values of the wind direction and velocity of the past two minutes would be used to report to the Aircraft, which caused the difference with the instantaneous change in wind direction. (See Figure 1)

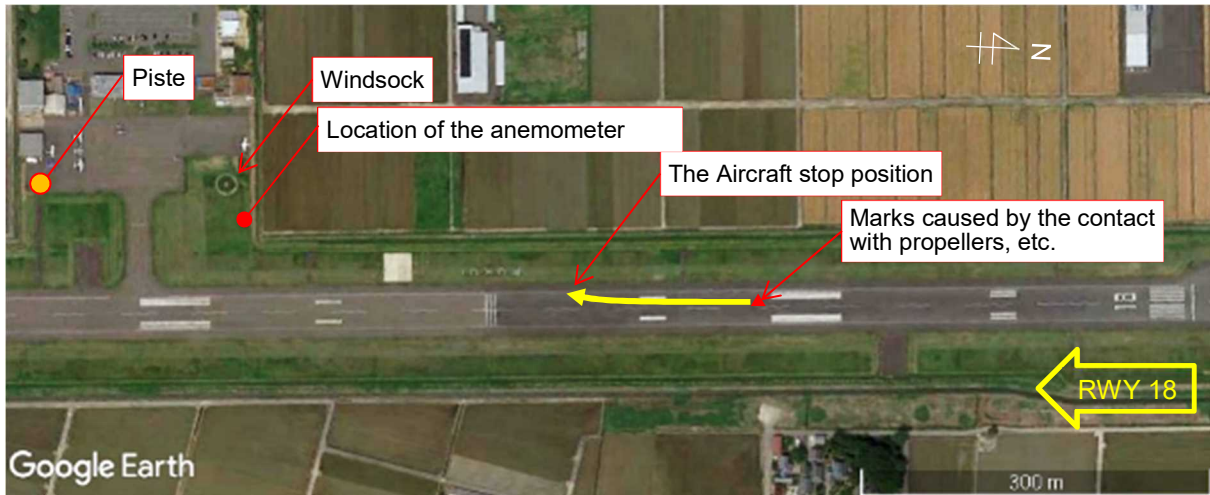
Figure 2: Estimated route on the runway

When the captain commenced the flare while applying the wing-low method\*<sup>1</sup> with the bank to the right slightly at an altitude of about 5 m above ground level, the descent angle of the Aircraft became shallow, which caused the Aircraft to be in the state of floating at a low altitude over the runway, and the Aircraft to sink rapidly at an altitude of about 1 m above ground level, and touched down hard on the runway firstly from the right main wheel at about 13:05. The tip part of the propeller blades and the right main wheel cover contacted with the runway surface at the touchdown, and then the Aircraft bounced and floated, and stopped on the runway after the second touchdown.

It is probable that the landing of the Aircraft was made by flare operations at a high ground speed caused by a tailwind, which resulted in the descent angle being shallower than usual, and the longer flight distance up until the touchdown.

Regarding the fact that the sink of the Aircraft suddenly increased significantly, and the Aircraft touched down hard, it is most likely that the lift decreased, and the descent rate increased because the wind direction and velocity changed, and the tailwind component increased immediately before the touchdown. It is highly probable that as the Aircraft touched down hard, the landing gear strut was greatly bent, and the tip part of propeller blades and the right main wheel cover contacted with the runway surface.

As aircraft with lower landing speed are greatly affected by the wind at the time of landing, it is desirable for pilots to carefully judge whether to make an approach or not by positively inquiring air traffic control facilities about the variation width even when the variation width of the wind direction and velocity are not reported from them.
