**AIRCRAFT SERIOUS INCIDENT  
INVESTIGATION REPORT**

**IBEX AIRLINES CO., LTD.**

**J A 0 6 R J**

## MULTIPLE DEFECTS IMPEDING THE SAFE FLIGHT OF AIRCRAFT, BOMBARDIER CL-600-2C10, JA06RJ IBEX AIRLINES CO., LTD. AT AN ALTITUDE ABOUT 38,500FT ABOUT 33NM NORTH-NORTHWEST OF HIROSHIMA AIRPORT AT 09:29 JST, APRIL 17, 2016

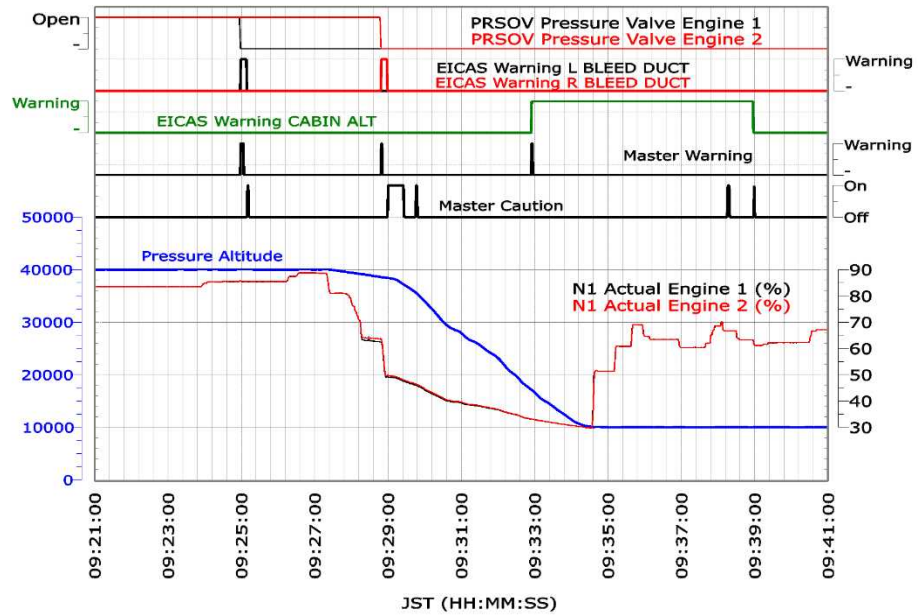
Figure 1 The records of the FDR

On April 17, 2016, a Bombardier CL-600-2C10 registered JA06RJ, operated by IBEX Airlines Co., Ltd., took off from Fukuoka Airport at 07:47 Japan Standard Time (JST, UTC+9hrs, unless otherwise stated all time are indicated in JST based on a 24-hour clock) as scheduled flight 084 of the company and attempted to approach to Komatsu Airport as the destination, however, the PIC decided to return to Fukuoka Airport because of the bad weather at Komatsu. At 09:25 during the flight to Fukuoka Airport at FL400, L BLEED DUCT warning which indicates the left bleed air leak was displayed on the EICAS (Engine Indication and Crew Alerting System) as well as an aural warning was sounded. Because the supply of the left bleed air stopped due to the bleed air leak, the Aircraft commenced the descent following the procedure described in the Aircraft Operation Manual (AOM). At 09:29 right after starting a checklist corresponding to the bleed air leak, R BLEED DUCT warning which indicates the right bleed air leak was displayed on the EICAS as well as the aural warning was sounded, then the supply of the right bleed air also stopped, therefore the supply of both bleed air systems stopped. The Aircraft declared a state of emergency and the flight crew conducted the emergency descent wearing oxygen mask following the emergency descent procedure.

While descending at about FL170, CABIN ALT warning to indicate that the cabin altitude exceeded 10,000ft, was displayed. The PIC did not deploy the oxygen masks for passengers because the climbing rate of the cabin altitude was gradual.

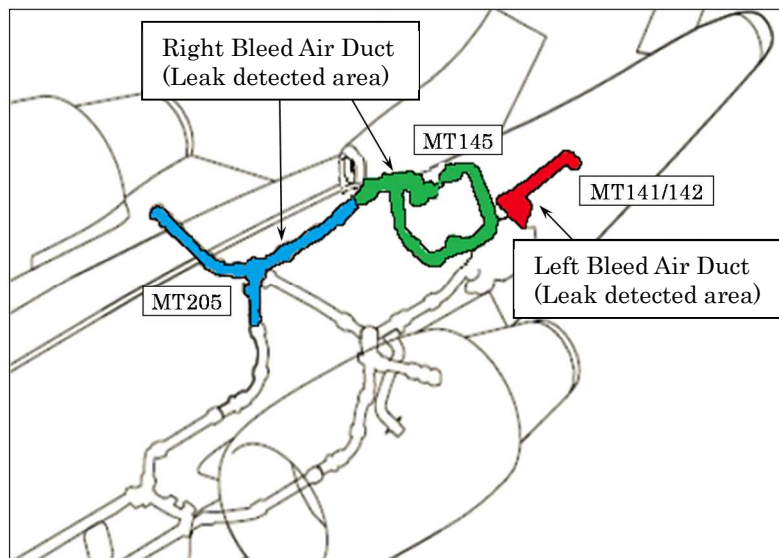
Figure 2 Detected area of bleed air leak

Maintenance Diagnostic Computer (MDC) had respective records that the bleed air leak was detected in the same area by sensing elements of MT141 and MT142 and that the right bleed air leak was detected for each adjacent area by respective sensing elements of MT145 and MT205.

a) At MT141 and MT142 in the left bleed air system, the AILC had detected the bleed air leak.

b) At MT145 and MT205 in the right bleed air system, the AILC had detected the bleed air leak.

Since the area that the AILC detected the bleed air leak from the right system was in the different area on both channels, it is somewhat likely that the AILC had malfunctioned. However, any defect and any abnormality could not be confirmed on the investigations regarding the AILC. Furthermore, since on the investigations of the Aircraft and the sensing elements, any defect, any abnormality and the reproduction of the leak were not confirmed, it was not possible to determine why the AILC detected the bleed air leak.

- i) To confirm the soundness of the bleed air system, it has been checked the clearances among ducts, accessories and sensing elements at the time of heavy maintenance as well as confirming regarding the electrical characteristic of sensing elements every two or three months.
- ii) As a preventive measure of defect occurred in sensing elements, grease-up has been carried out in order to prevent to have water mix in due to lack of grease at the connecting parts of sensing elements.
- iii) AILC software has been upgraded to the latest version.
