**AIRCRAFT SERIOUS INCIDENT
INVESTIGATION REPORT**

**IBEX Airlines Co., Ltd.
J A 0 7 R J**

AIRCRAFT SERIOUS INCIDENT INVESTIGATION REPORT

MULTIPLE MALFUNCTIONS IMPEDING THE SAFE FLIGHT OF AIRCRAFT, BOMBARDIER CL-600-2C10, JA07RJ IBEX AIRLINES CO., LTD. AT AN ALTITUDE OF APPROX. FL 360 OVER ODA CITY, SHIMANE PREFECTURE AT 20:12 JST, APRIL 18, 2022

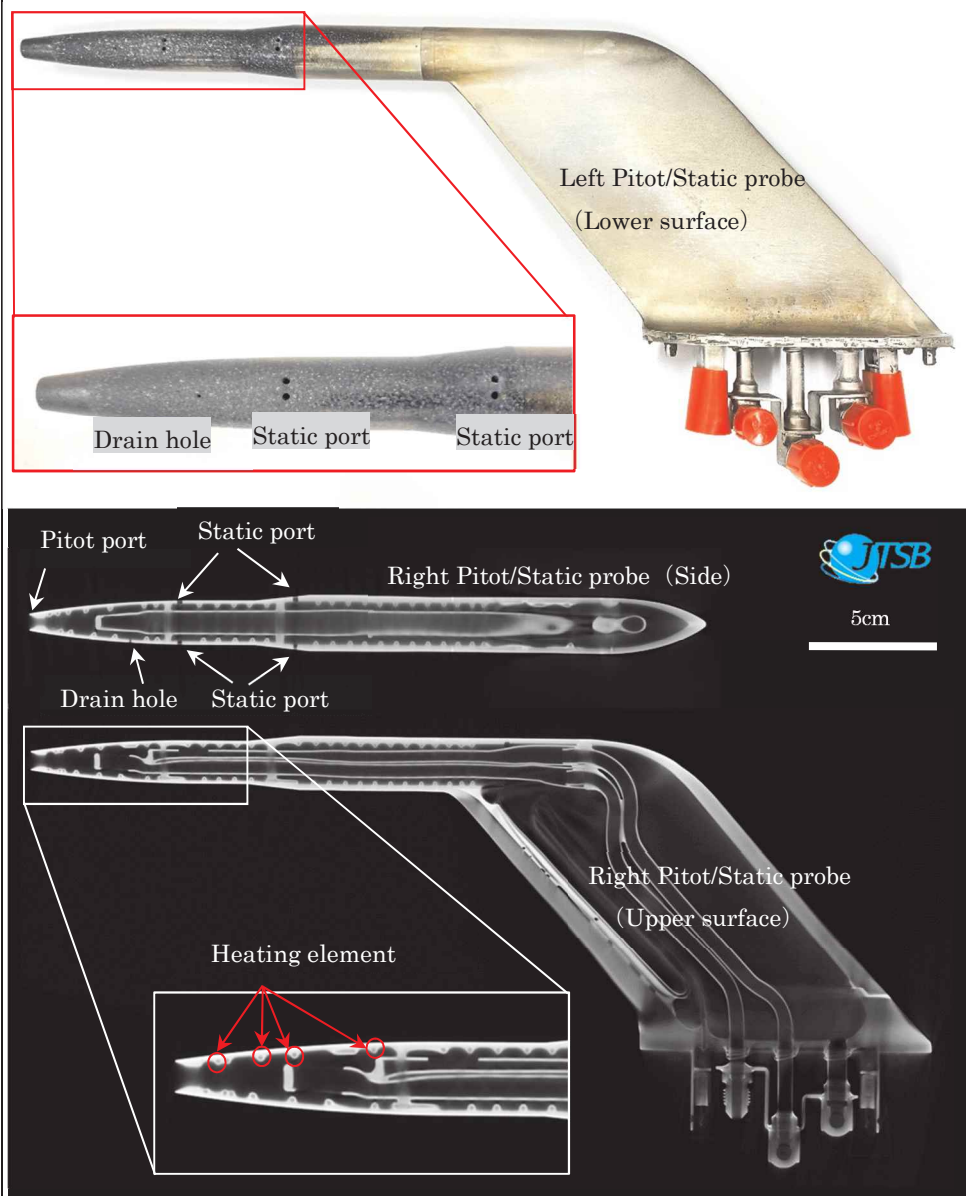
Figure 7: Photo and X-ray CT Scanner Image (the bottom of the Figure) of Pitot Static Probe of the Airplane

provided with a drain hole to drain rainwater outside of the airplane. And the check of the drain hole (Figure 7) conditions found it in good condition.

No deformation of the Pitot/Static probe system tubing and traces of obstructions in the X-ray CT scanner image (the bottom of Figure 7) were confirmed, and there was no abnormality such as a short circuit or disconnection in the conditions of the heater.

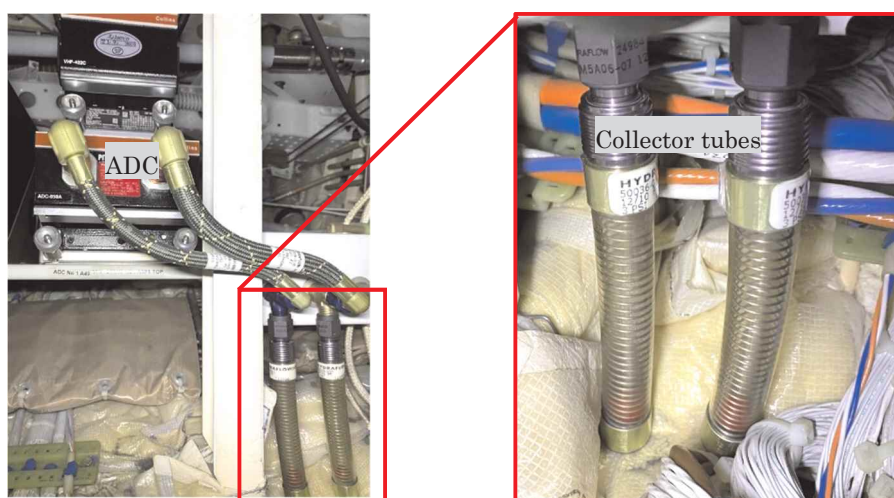
Figure 8: Pitot/Static System Collector Tubes of the Airplane

Rainwater that has not vented through the drain hole of the Pitot/Static probes is collected, by gravity, in the collector tubes. These collector tubes are inspected by mechanics in each flight, and after this serious incident, the collector tubes were inspected, but no rainwater was confirmed (Figure 8).

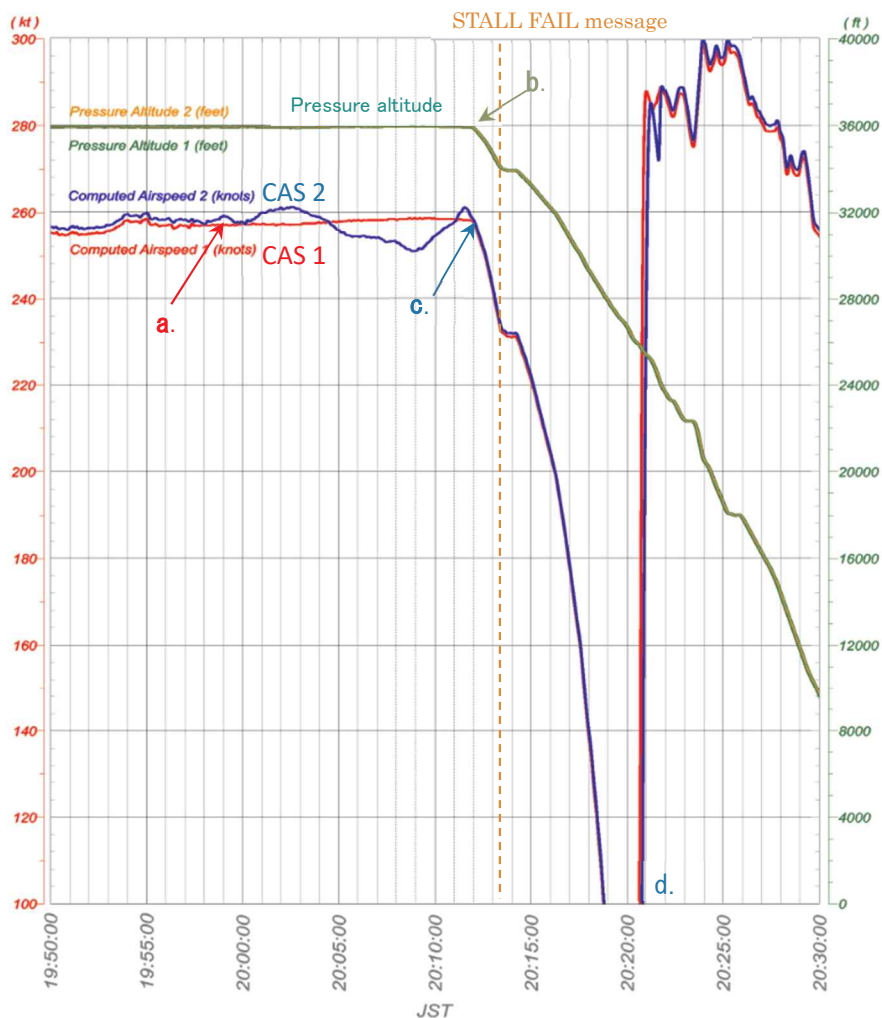
Figure 10: FDR Records before and after the Serious Incident
(Change in CAS and Pressure Altitude)

The IAS of the airplane is recorded as CAS*¹⁰ 1 for the left side of the Pitot/Static system and as CAS 2 for the right side of the Pitot/Static system, respectively. CAS 1 and CAS 2 in normal flying conditions are recorded as close values, respectively, while changing slightly depending on the atmospheric conditions even if flying at a constant speed. According to the FDR records, at 19:58:08, the CAS1 became constant (Figure 10 a.), and the CAS2 continued to change even after that. The JTSC concludes that it is highly probable that this is because the left side of the pitot system, based on which the CAS1 is calculated, became fully blocked. At 20:11:44, the airplane commenced to descent (Figure 10 b.). 20:12:10, the right side of the pitot system became fully blocked (Figure 10 c.), while the pressure of both sides of the pitot system was kept due to the blockage, the static pressure increased as the airplane descended, therefore, the values of the CAS1 and CAS2 highly probably decreased. The airplane continued to descend, and both values of the CAS1 and CAS2 were recovered almost simultaneously at 20:21:41, therefore, at this time, the blocked conditions were highly probable resolved (Figure 10 d.). After the blocked conditions were resolved, the IAS values had most likely indicated normal values until the landing.

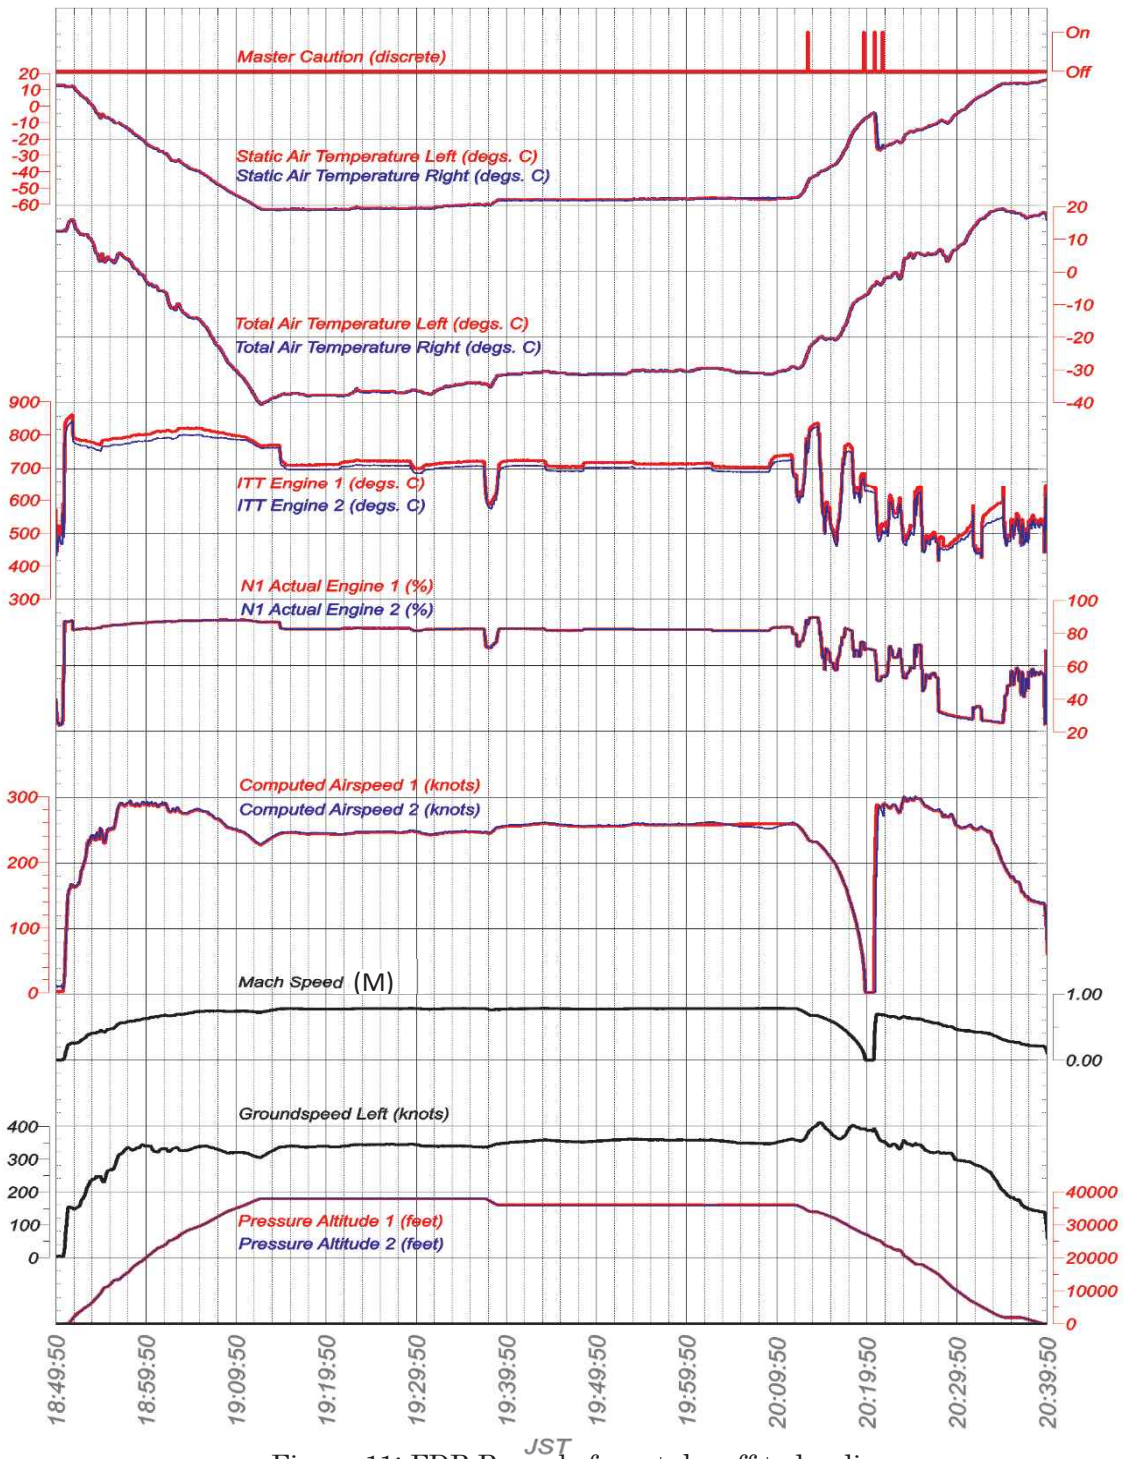
Figure 11: FDR Records from take-off to landing

The JTSB concludes that from the FDR records, the blockage most likely started after the airplane flew at a high altitude with no cloud with a temperature of around -60°C for more than 50 minutes. In the investigation of this serious incident, all the Pitot/Static systems including heaters operated normally, and there were no signs of blockages such as dust, insects, volcanic ash, moisture and others. According to the Designers and Manufacturers of the airplane and the Pitot/Static probes, there are no cases where during flight in high humidity or clouds, icing due to water droplets and others has occurred in the airplane whose Pitot/Static system including heaters

operated normally. From these, it is probable that the airplane flew through the airspace presented ice crystals, therefore the Pitot/Static system became temporarily blocked due to the ice crystals.

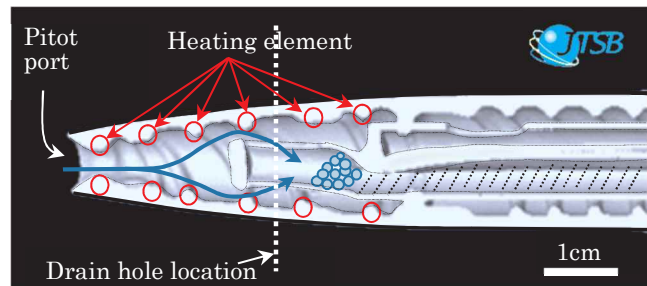
Figure 12: X-ray CT Scanner 3D Cross Section

The JTSCB concludes that the difference in IAS indication probably occurs depending on the blockage sites of pitot system. When the upstream side of the drain hole is blocked, the pitot pressure will vent through the drain hole and will not be kept, resulting in an indication of decreased

IAS immediately after the blockage. On the other hand, when the downstream side of the drain hole is blocked, the pitot pressure will be constant and kept, thus IAS indication will be constant (Figure 12). In this case, the static pressure increases as the airplane descends, thus resulting in an indication of decreased IAS. In addition, as the sites shown in Figure 12 (several circles in light blue that show an image of crystals) indirectly transfer the heat from the heater, its temperature is likely lower than the sites that directly touch with the heater. The rain droplets and others that entered the Pitot/Static probe are instantly evaporated, but it would take more time for icing crystals to be melted and evaporated depending on their temperature, sizes and others. From these, it is possible that at the time of the serious incident, ice crystals accumulated on the downstream side of the drain hole, and the pitot system became blocked.
