**AIRCRAFT SERIOUS INCIDENT
INVESTIGATION REPORT**

**IBEX AIRLINES CO., LTD.
J A 1 1 R J**

ABNORMAL DECOMPRESSION INSIDE AN AIRCRAFT IBEX AIRLINES CO., LTD. BOMBARDIER CL-600-2C10, JA11RJ OVER OHNAN-CHO, OHCHI-GUN, SHIMANE PREFECTURE FL260 AT ABOUT 18:02 JST, OCTOBER 30, 2019

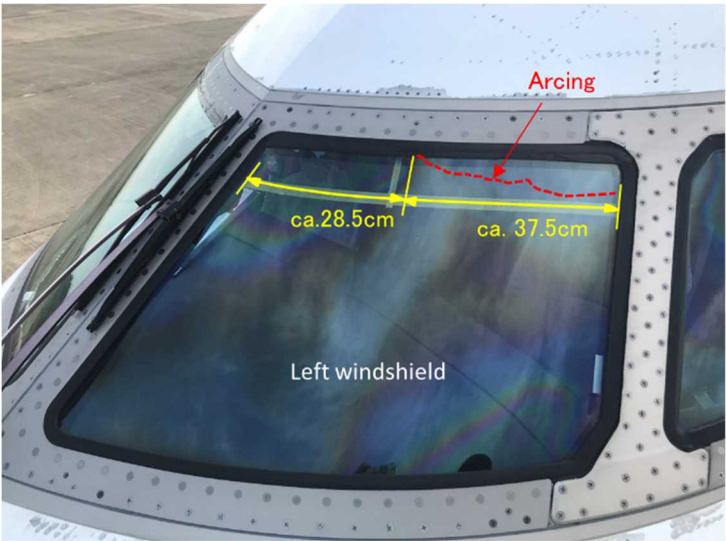
<p>Figure 2: Condition of the left windshield</p>

<p>2.2 Injuries to Persons</p>	<p>None</p>
<p>2.3 Damage to the Aircraft</p>	<p>Arcing on the upper part of the left windshield.</p>

In the upper part of the left windshield, arcing marks were recognized in the heater element layer, but cracks were not recognized in the glass layers.

of the left windshield, were arcing marks, and since cracks were not observed on the windshield. There was no decrease in strength regarding the left windshield. There was evidence of repairing the moisture seal, but it is highly probable that according to the maintenance record of the operator, repair work was carried out in accordance with the AMM. It is probable that the arcing marks were caused by the deterioration of the moisture seal and moisture penetration into inside of the left windshield, resulting in an arcing in the heater element; however, it could not be determined when this moisture penetration occurred.

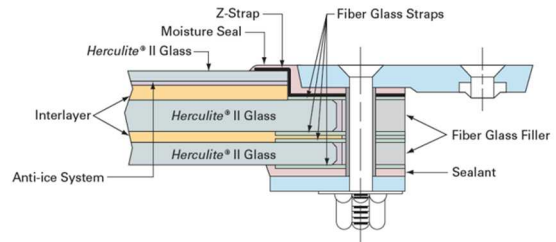
Figure 4: Cutaway view of the Windshield

On the outer upper part of the left windshield, it was confirmed that there was evidence of repairing the moisture seal that prevents moisture from infiltration. As for other three windows, no abnormalities were recognized. Upon confirmation of the maintenance record for the aircraft, it was found that visual inspection was conducted regarding the left windshield at a periodical inspection that was conducted according to the manual established by the Design and Manufacturer of the aircraft. On October 7, 2019, as the operator found degradation (erosion) of the moisture seal of the left windshield during the periodical inspection, they carried out repair work by coating sealant according to the Aircraft's Maintenance Manual (AMM). The left windshield and the left side window of the aircraft were installed at the time of its production, and had no records of replacement.

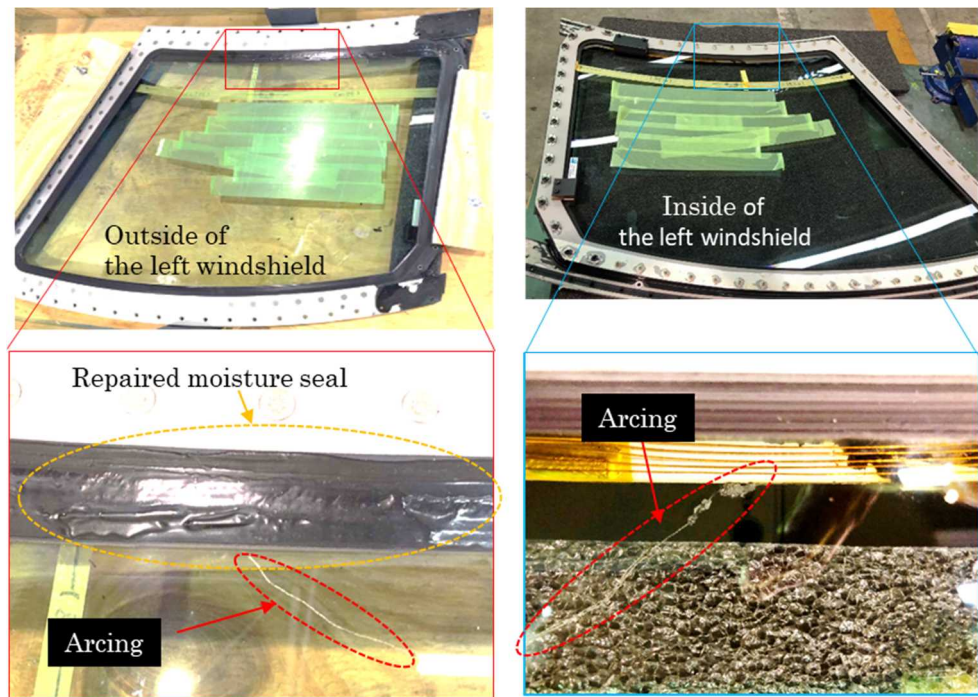
Figure 5: Condition of the Left windshield

As for the left windshield and the left side window removed from the aircraft, the investigation on sensors and heater elements was performed according to the AMM, and it was found that only the resistance of the heater element of the left windshield substantially exceeded the reference value, while all functioned normally for the left side window.

Based on the information obtained through the interview with the PIC, the operator replaced the following parts according to the maintenance actions specified in the AMM established by the Design and Manufacturer of the aircraft.

- i. Left windshield
- ii. Left side window
- iii. Left windshield/heater controller
- iv. Left side window/heater controller
- v. Anti-ice/control panel

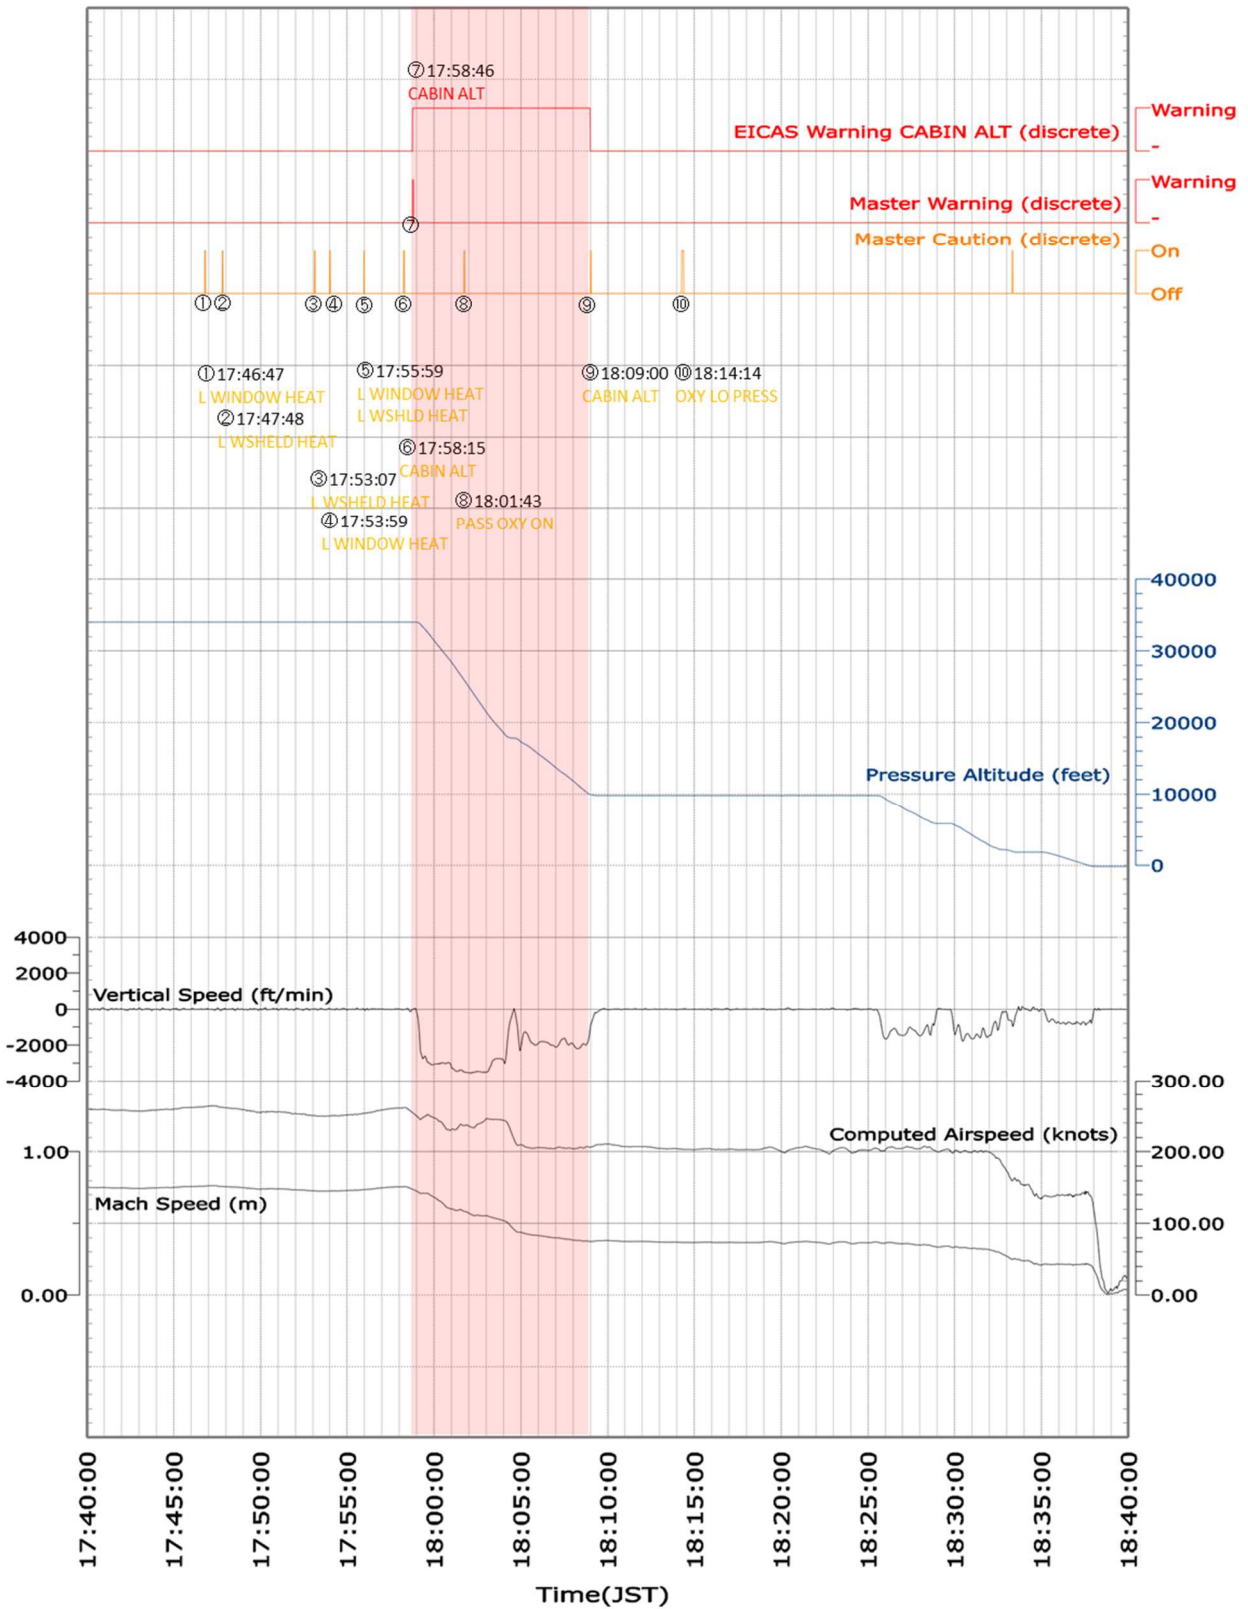
Figure 8: DFDR records and displayed messages (according to the statement of the PIC)

- (5) When flying at FL 340, the PIC commenced the check list, and the aircraft descended at a descent rate of about 3,000 ft/min, however, it is highly probable that it took more than 10 minutes for the aircraft to reach a flight altitude of 10,000 ft. On the other hand, the cabin altitude was approximately 5,700 ft when the PIC commenced the check list. It is highly probable that as the PIC switched to manual mode to set the cabin altitude at the maximum climb rate of $3,000 \pm 500$ ft/min in accordance with the check list, the cabin altitude exceeded 10,000 ft within about two minutes.

- (6) It is highly probable that based on DFDR records, the cabin altitude was exceeding 10,000 ft for 10 minutes 14 seconds between 17:58:46 and 18:09:00 while “CABIN ALT” (Warning) was being displayed.

- (7) It is highly probable that in view of the fact that the oxygen masks in the cabin were automatically deployed and EICAS message “PASS OXY ON” (Caution) was displayed, the cabin altitude had exceeded $14,000 \pm 300$ ft.

The Design and Manufacturer of the aircraft added the procedures to adjust the cabin altitude according to the cruise level, and revised the checklist so as to prevent from occurring an abnormal decompression inside an aircraft.
