AA2023-5

**AIRCRAFT ACCIDENT  
INVESTIGATION REPORT**

**Okayama Air Service Co., Ltd. (OAS)  
J A 1 2 3 R**

<b>Company</b>	Okayama Air Service Co., Ltd. (OAS)
<b>Type, Registration Mark</b>	Cessna 172R, JA123R
<b>Accident Class</b>	Aircraft damage due to bird strike
<b>Date and Time of the Occurrence</b>	At about 17:43 Japan Standard Time (JST: UTC+9 hours), December 10, 2022
<b>Site of the Accident</b>	At an altitude of about 150 ft (45 m) about 0.5 nm (900 m) west of Kohnan Aerodrome, Okayama City, Okayama Prefecture (34°35'N, 133° 55'E)

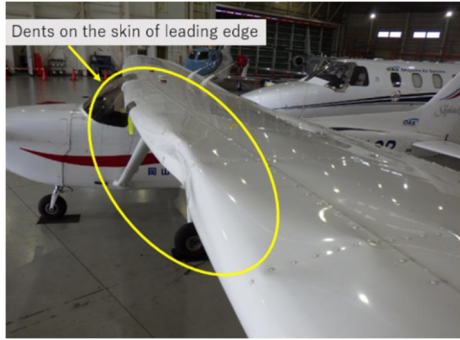
Figure 2: Location of Damage  
(Leading Edge Skin)

Dents and bloodstains were confirmed on the leading edge of the left wing during the aircraft inspection conducted after the Aircraft landing.

- Deformation of the skin of leading edge of the left wing (a dent of about 15 cm long by about 155 cm wide with a depth of 7 cm)

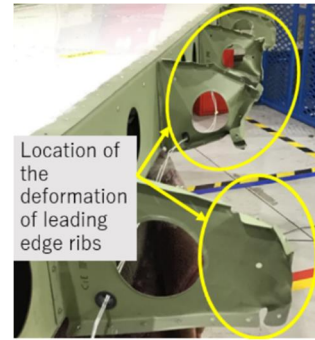
Figure 3: Location of Damage  
(Leading Edge Ribs)

- Deformation of the ribs of leading edge of the left wing (inside the deformed skin)
