**AIRCRAFT ACCIDENT
INVESTIGATION REPORT**

**Nippon Cargo Airlines Co., Ltd.
J A 1 3 K Z**

August 31, 2023

AIRCRAFT DAMAGE DUE TO TAIL STRIKE (LOWER AFT FUSELAGE CONTACT) AT THE TIME OF GO-AROUND NIPPON CARGO AIRLINES CO., LTD. BOEING 747-8F, JA13KZ AT RUNWAY 16R of NARITA INTERNATIONAL AIRPORT AT AROUND 18:51 JST, FEBRUARY 1, 2021

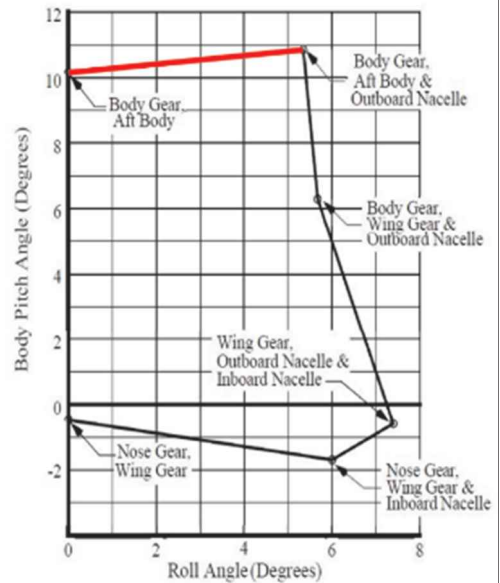
Figure 8: Ground contact angle (During normal landing)

A contact between body gears and tail is possible when exceeding the line segment (Figure 8 Red line) connecting from a roll angle of 0° / a pitch angle of 10.2° to a roll angle of 5.4° / a pitch angle of 10.8°.

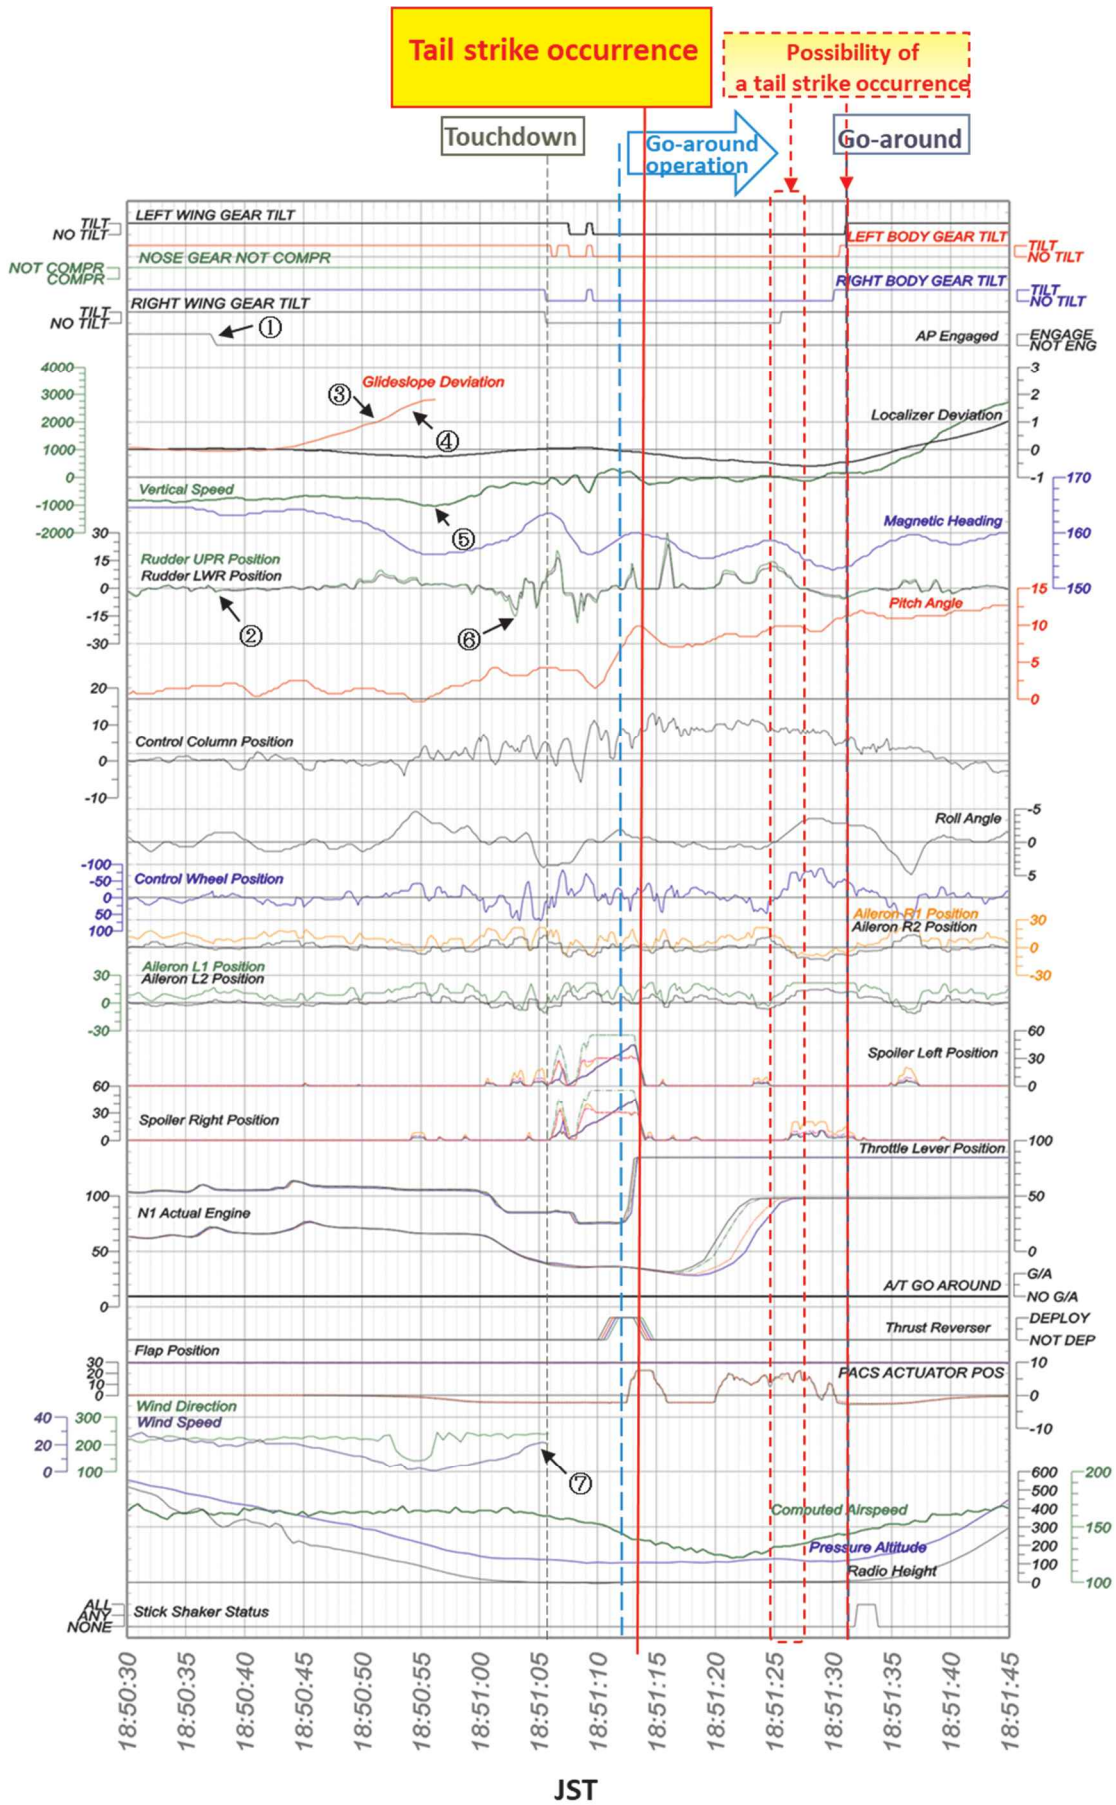
Appended Figure 1: FDR and QAR records (18:50:30 to 18:51:45)

At 18:50:50, when the Aircraft passed 289 ft (154 ft AFE), the deviation from the GS on-glidepath was +1.02 dots (See Appended Figure 1③), and the deviation from the center of the approach course (on-course) of localizer (LOC) was 0.2 dots to the right.

At 18:50:56, the sink rate (V/S) increased and temporally reached 1,024 fpm (See Appended Figure 1⑤).

At 18:51:05, at 132 ft (RA 3 ft, the crosswind from the right recorded on the FDR became at its maximum ($240^\circ / 22$ kt) (See Appended Figure 1⑦). The PIC made the Aircraft roll to the right and applied the right rudder pedal (7.2° right).

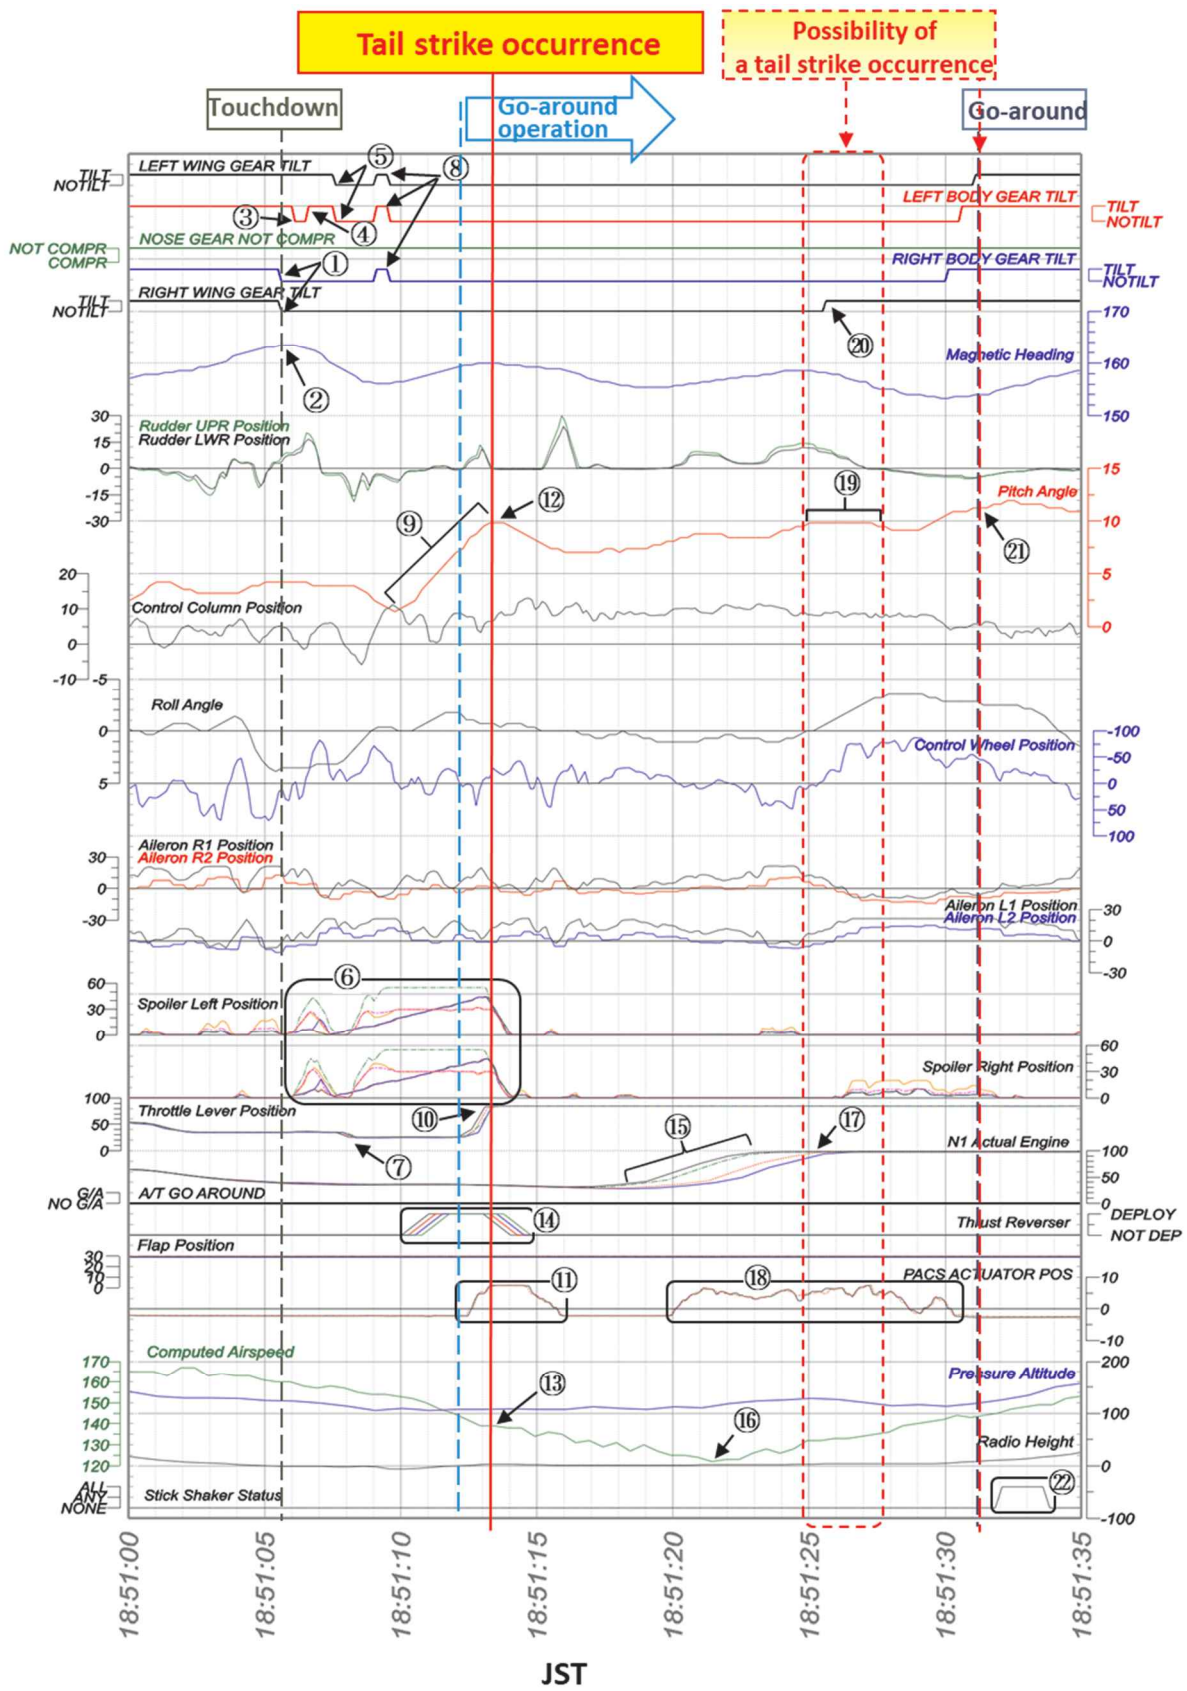
Appended Figure 2: FDR and QAR records (zoom in from 18:51:00 to 18:51:35)

At 18:51:06, with the roll angle at 4.2° right, the left body gear touched down (See Appended Figure 2③), but bounded (see Appended Figure 2④). The Speedbrakes*¹¹ were extended but soon retracted (See Appended Figure 2⑥ for the Speedbrake operating status).

At 18:51:13, the Pitch Augmentation Control System (PACS) (See 2.6 (13)) worked (See Appended Figure 2(11) for PACS operating status), but the pitch angle was 9.8° (See Appended Figure 2(12)). The speed was reduced to 139 KIAS (See Appended Figure 2(13)). The TCs started to move toward the retract position.

At 18:51:25, the N1 of all the engines exceeded 90 % (See Appended Figure 2⑰). PACS worked (See Appended Figure 2⑱ for PACS operating status), but for three seconds after that, the pitch angle became 9.8° (See Appended Figure 2⑲). The speed changed from 132 KIAS to 134 KIAS. The Aircraft made a landing roll without the nose gear touching down. As being concerned about the change in the Aircraft attitude and the runway-remaining-distance even during the landing roll, the PIC was not looking at the Aircraft speed. At 18:51:26, the roll angle was 2.5° left, and the right wing gear became airborne (See Appended Figure 2⑳).

At 18:51:31, the Aircraft executed a go-around. The pitch angle was 10.2° (See Appended Figure 2㉑) and the speed was 143 KIAS, the roll angle was 2.8 to the left. The runway-remaining-distance was 1,619 m.

For two seconds after the go-around, the stall warning system was activated (See Appended Figure 2㉒). The FO called out “PUSH NOSE DOWN”, and urged the PIC to lower the pitch angle.
