AA2015-5

**AIRCRAFT ACCIDENT
INVESTIGATION REPORT**

**J-AIR CO., LTD.
JA 211J**

**CABIN ATTENDANT INJURY
BY THE SHAKING OF THE AIRCRAFT
J-AIR CO., LTD.
EMBRAER ERJ170-100STD, JA211J
AT AN ALTITUDE OF APPROX. 10,600 FT
OVER ISHIOKA CITY, IBARAKI PREFECTURE, JAPAN
AT AROUND 09:45 JST, APRIL 29, 2014**

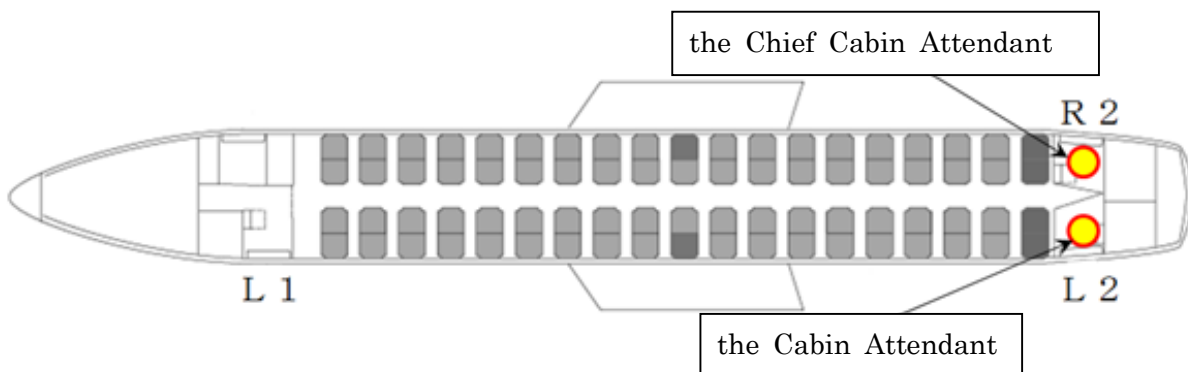
Locations of the Injured when the Accident Occurred.

The Chief Cabin Attendant fell down with her head toward the L2 side on the aft galley floor with the Cabin Attendant (L2), laying on top of each other, and confirmed that the passengers were sitting from there. As the up and down shaking continued for about 10 seconds after falling down, she thought that she might hold down the Cabin Attendant (L2) with her arm.

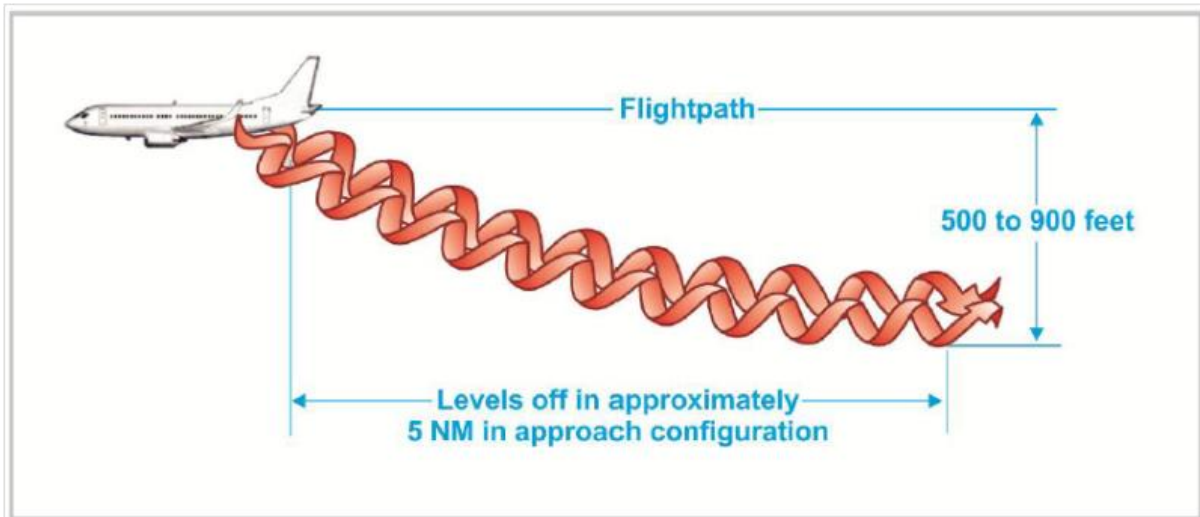
FIGURE 5. DESCENT OF VORTICES FROM LARGE AIRCRAFT

Flight tests have shown that at higher altitude the vortices from large aircraft sink at a rate of several hundred feet per minute (fpm), slowing their descent and diminishing in strength with time and distance behind the wake-generating aircraft (see FIGURE 5. DESCENT OF VORTICES FROM LARGE AIRCRAFT). Atmospheric turbulence hastens decay. Pilots should fly at or above the preceding aircraft's flightpath, altering course as necessary, to avoid the area behind and below the generating aircraft.

The worst case atmospheric conditions are light winds, low atmospheric turbulence, and low stratification (stable atmosphere). In these atmospheric conditions, primarily in en route operations, vortices from Heavy and especially Super aircraft can descend more than 1,000 feet. In rare cases, wake turbulence can rise in an updraft or when it bounces off of a strong inversion layer where the strong inversion layer acts like the ground.

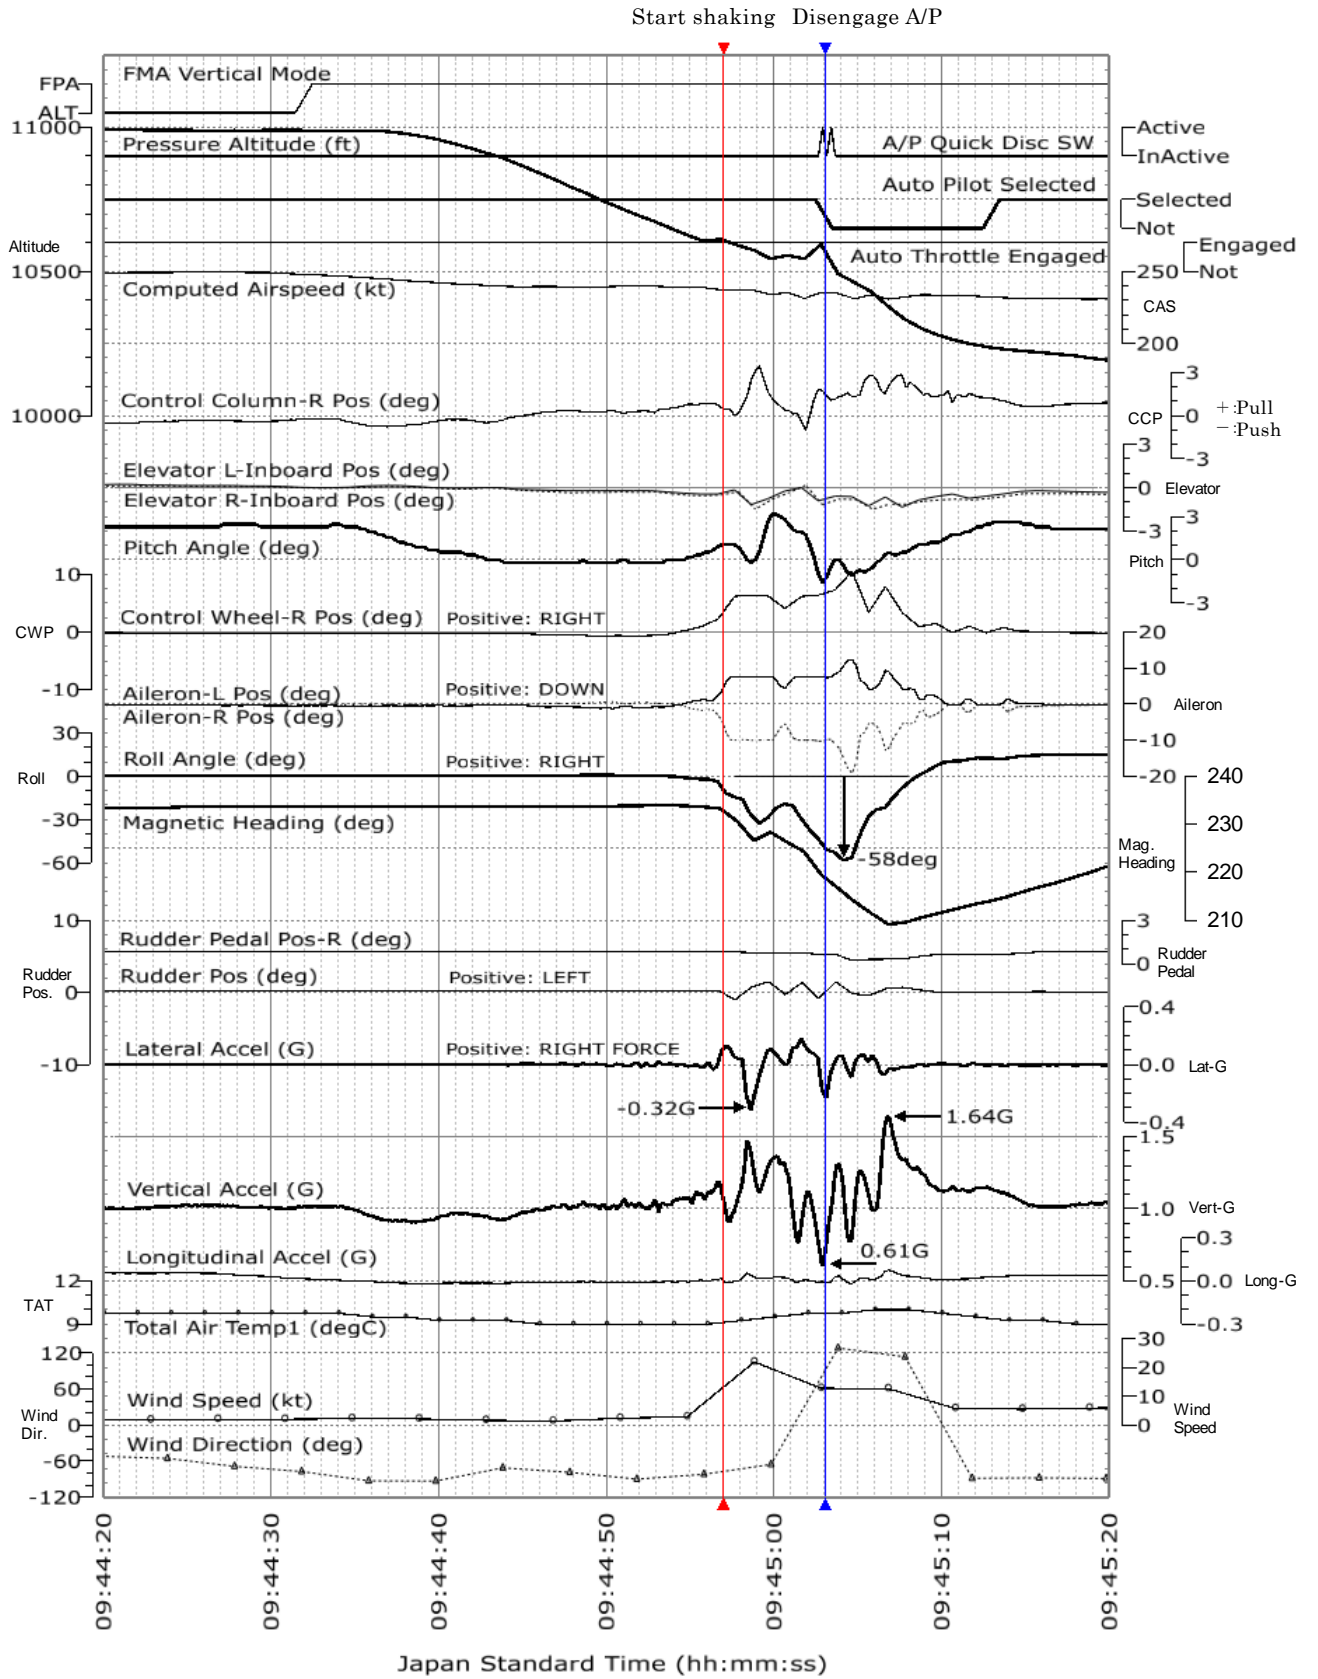
Figure 1: Records of the Flight Recorder

09:44:47 The vertical acceleration of the Aircraft started to fluctuate little by little at an altitude of approximately 10,800 ft.

09:44:57 The Aircraft started to roll and veer to the left, and a large fluctuation of vertical acceleration and lateral acceleration began at an altitude of approximately 10,600 ft. The vertical acceleration fluctuated between 0.61 G and 1.64 G for 10 seconds until 09:45:07.

09:44:59 Lateral acceleration to the left of the Aircraft became approximately 0.32G (the maximum value during this flight).

09:45:04~05 The left bank angle of the Aircraft became approximately 58° (the maximum value during this flight).

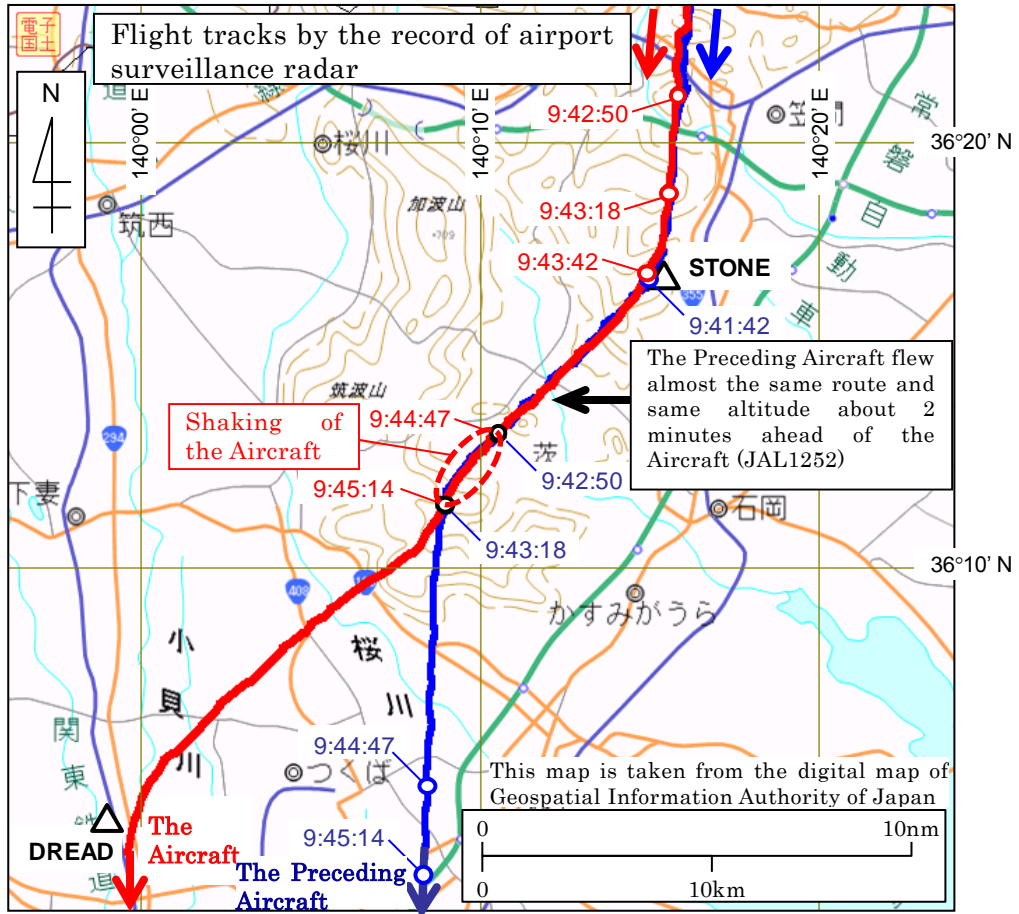
Figure 7: Estimated Flight Route

According to the radar track records of Tokyo radar approach control facility, an Airbus A340-600 (hereinafter referred to as “the Preceding Aircraft”) was flying approximately 10 nm in front of the Aircraft (approximately two minutes ahead) for Tokyo International Airport at the time when this accident occurred. The Preceding Aircraft turned to left heading 190° to the route for the final approach course to runway 22 of Tokyo International Airport, following the radar vector by Tokyo radar approach control facility, at about 12 nm before DREAD on its way from STONE to DREAD. The altitude had been maintained at 11,000 ft since before it passed STONE.

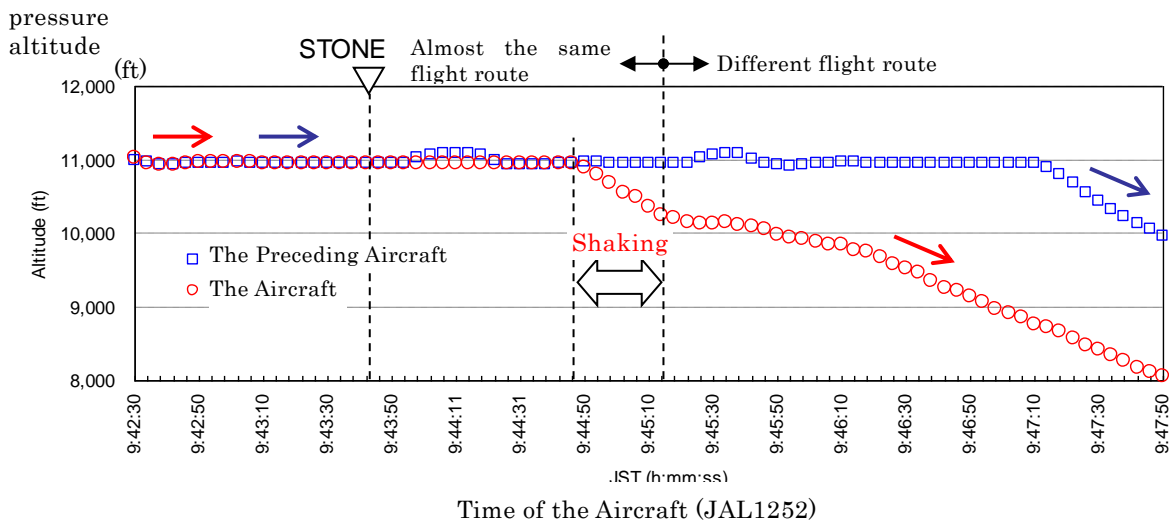
Figure 8: Estimated Flight Altitude

According to the records of the flight recorder and the radar track records of Tokyo radar approach control facility, the vertical acceleration of the Aircraft started to fluctuate little by little at around 09:44:47 when it began to fly approximately 200 ft below the Preceding Aircraft on the same flight route as the Preceding Aircraft, and after the large fluctuation began at around 09:44:57, when it was flying approximately 600 ft below the Preceding Aircraft. After that the fluctuation converged at around 09:45:15 when the Aircraft began to fly on a different route from the Preceding Aircraft due to its left turn.
