AA2022-2

**AIRCRAFT ACCIDENT
INVESTIGATION REPORT**

**KITA-KYUSHU GLIDER CLUB
J A 2 1 8 9**

June 30, 2022

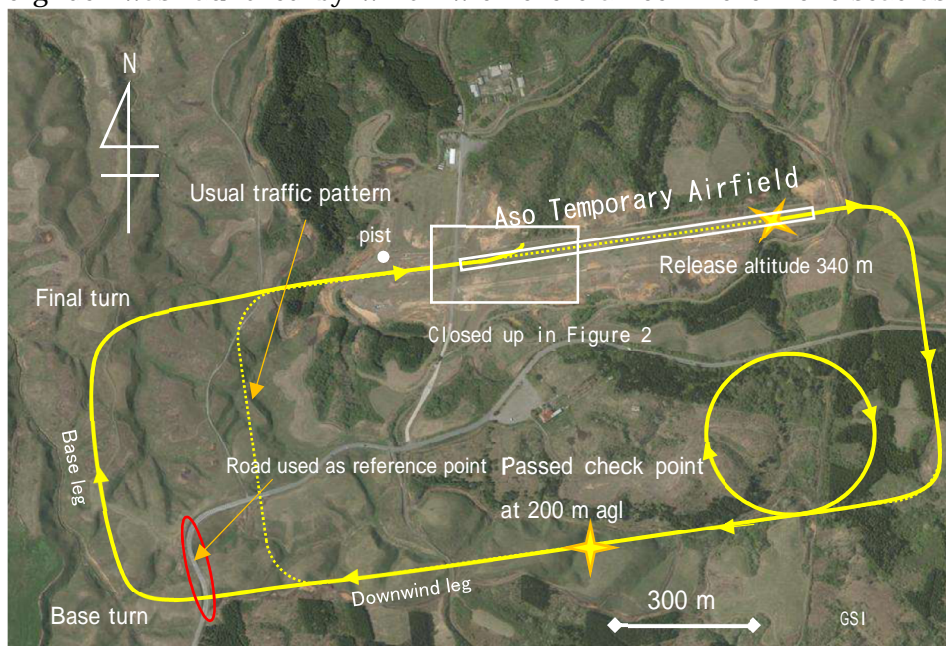
Figure 1 Flight route of accident glider (from statement)

As a result of this decision, distance between the Final turn and touchdown target point became far and the final approach path became too low. As the trainee felt that the final approach path was considerably low, the trainee did not extend the dive brakes which usually opened soon after the Final turn. The flight instructor found the glider was low and transmitted

Glider usually fly by establishing traffic pattern 600m downwind leg width and base leg 600m from the touchdown point. Flight training was conducted likewise at the Aso Temporary Airfield as well by establishing traffic pattern. Normally base turn commenced in reference to the road shown in Figure 1, but at this flight, as the trainee intentionally went beyond the road for he or she was higher altitude at the checkpoint, as a result, approach length which is usually 600m, became 900m, 1.5 times longer.

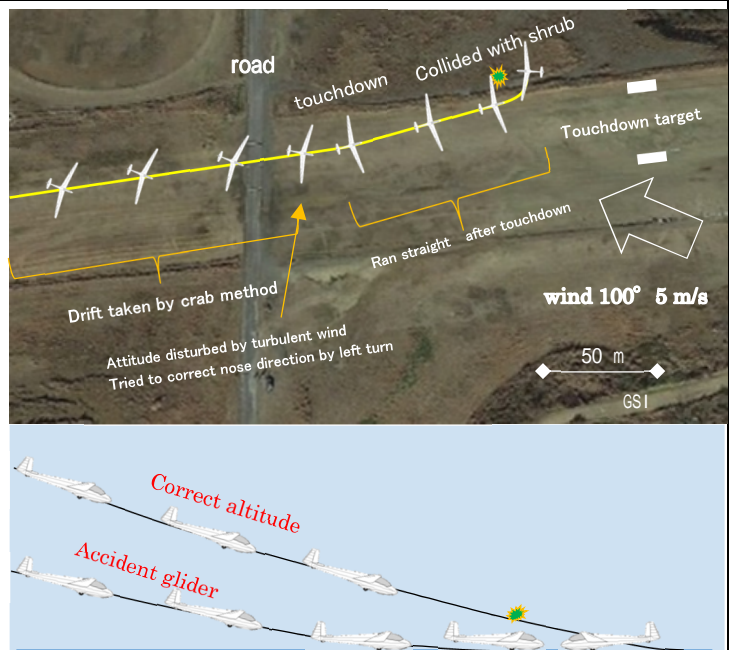
Figure 2 Flight route of accident glider (Closed up)

Confirming the terrain of the southeastern side of the approach path, elevation of the area along the road is high and forming a hill. On the day of the accident, wind was from southeast (100° and 5 m/s), and at the touchdown point, a slightly strong wind coming over from the hill was blowing. According to the flight log of the day of the accident, wind direction and wind velocity were variable between 40° and 100° and 4 m/s and 6 m/s.

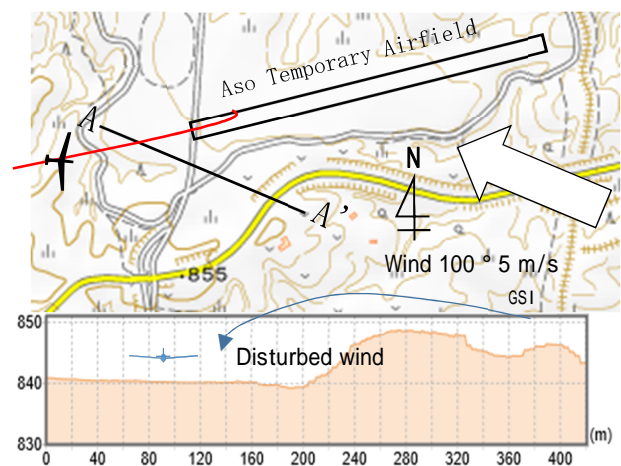
Fig. 3 Terrain and winds in surroundings of airfield (A-A' cross section)

From the flight log, at the time of the accident, wind was 100° and 5 m/s which is crosswind blowing 20° from the right of the runway direction. In addition, it is probable that there were turbulent wind around the touchdown point which was blowing over from the hill on the southeastern side of the final approach.
