**AIRCRAFT ACCIDENT  
INVESTIGATION REPORT**

**J A 2 2 N E**

**Japan Transport Safety Board**

PRIVATELY OWNED  
ROBINSON R22 BETA (ROTORCRAFT), JA22NE  
KAMOTO-MACHI, YAMAGA CITY, KUMAMOTO PREFECTURE, JAPAN  
AROUND 14:01 JST, AUGUST 1, 2010

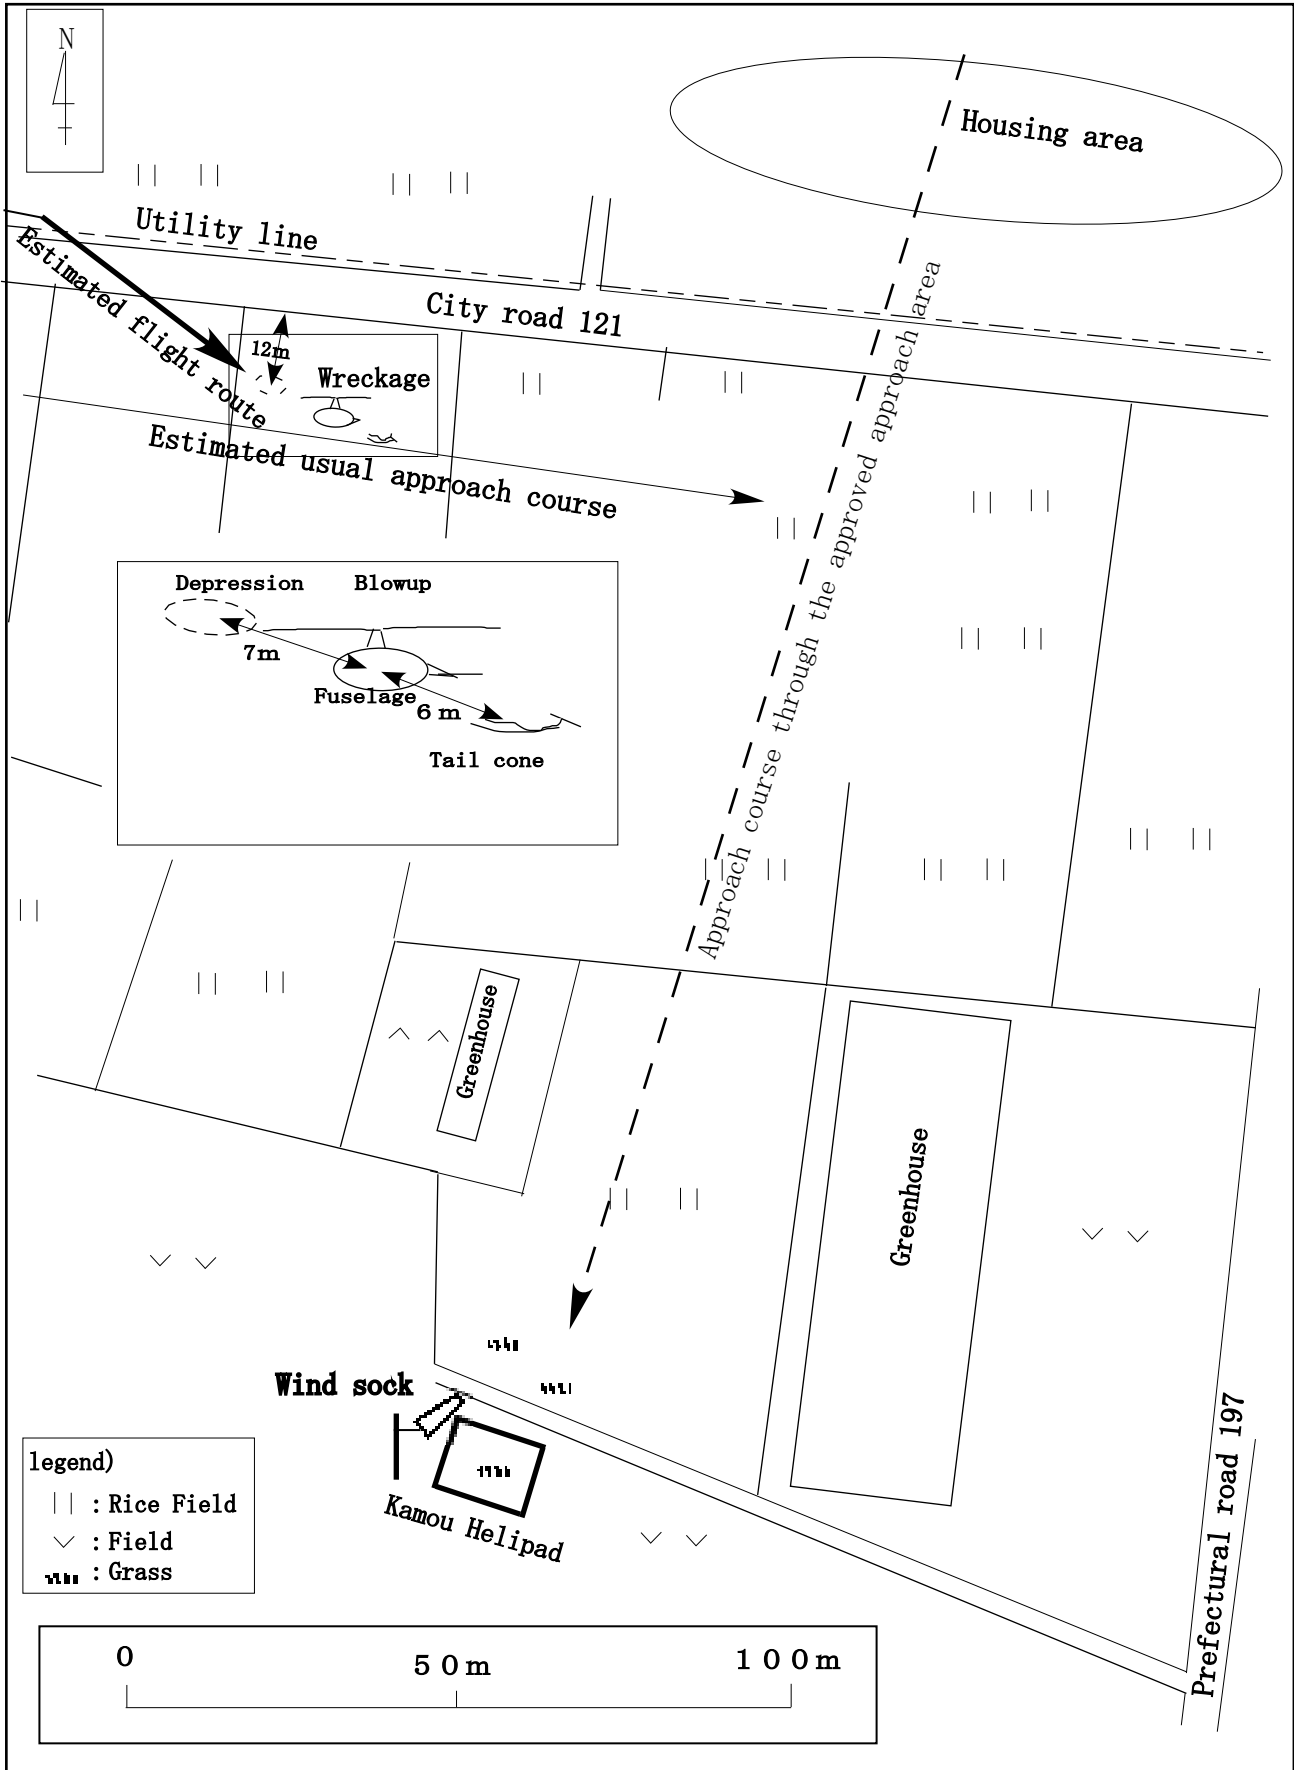
Figure 2 Accident Site Layout

The accident site was in a paddy field about 160 m north of Kamou Helipad. The paddy was muddy due to the irrigation.

The tail cone and the TR, which had been fractured, were found at a place about 6 m from the aircraft on an extended line drawn from the depression, while small pieces of broken components were found around the aircraft. .

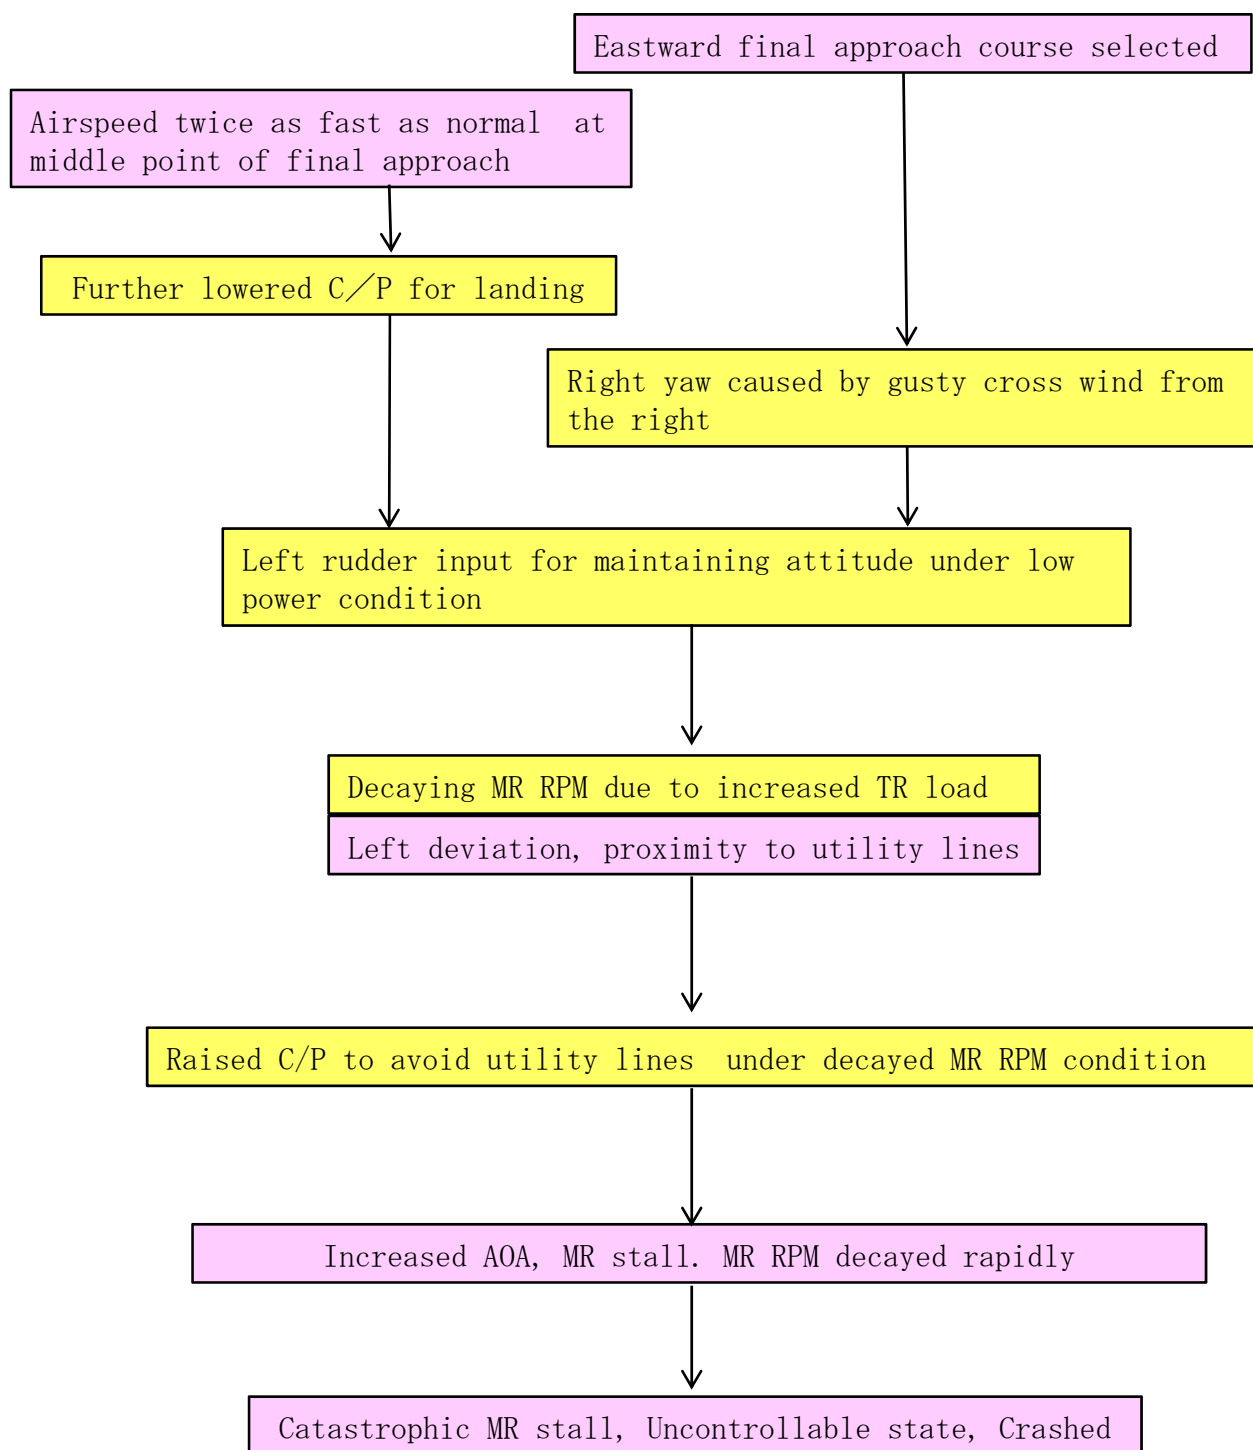
Figure 6 Chain of Events

It is considered highly probable that the Aircraft fell into an uncontrollable condition in its final approach in this accident caused by a catastrophic MR stall with its lift lost almost entirely resulting in the crashed into the ground with a high rate of descent without reducing its fast speed, causing the airframe to be destroyed and the occupants to be killed.

As to the uncontrollable situation caused by the catastrophic stall out of the entire loss of MR lift, it is considered somewhat likely that the PF's pull-up of the C/P in a low MR RPM condition lead to a substantially increased load and the condition where the required power exceeded the available power, followed by the MR's angle-of-attack reaching a stall angle, and rapid decay of the MR RPM.

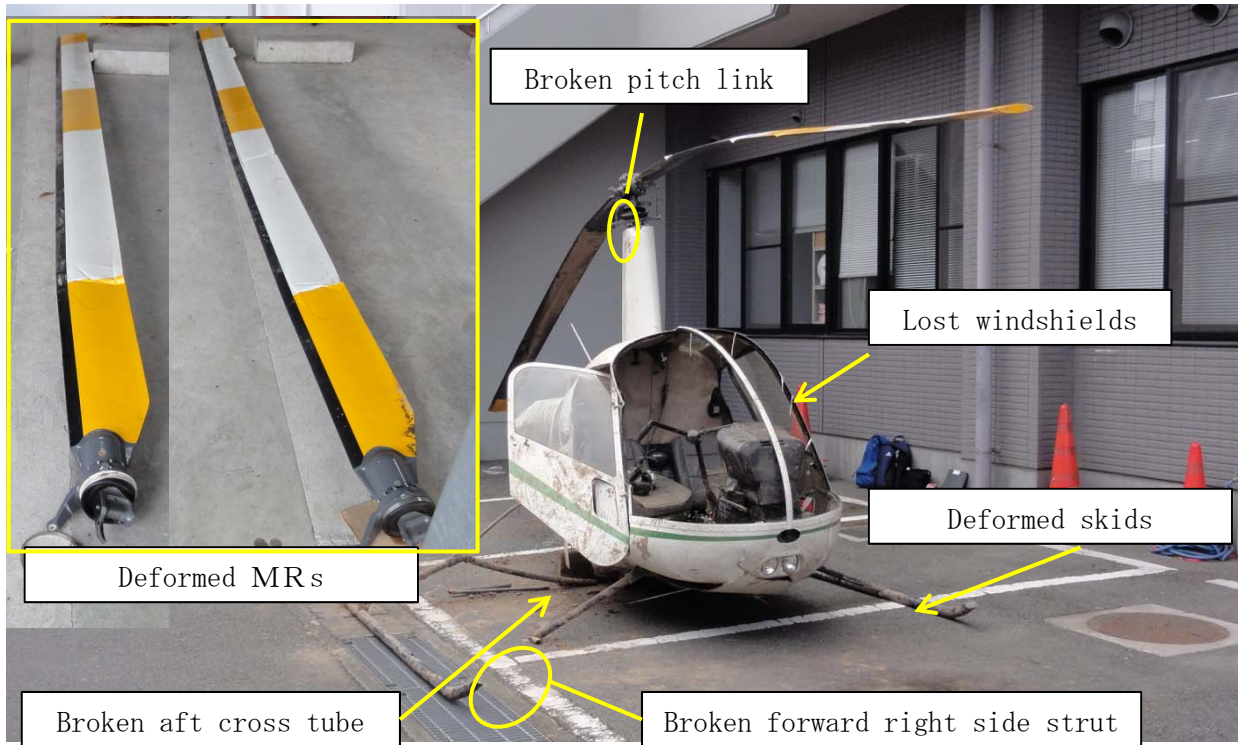
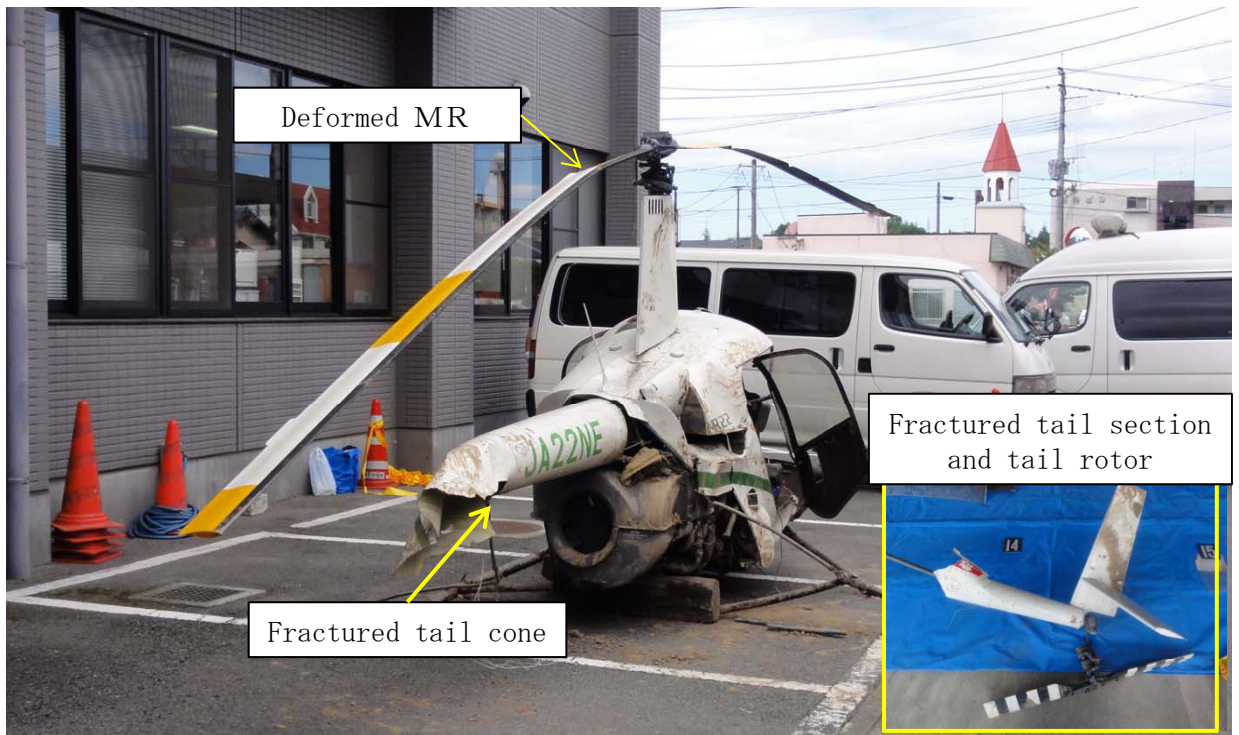
# Photo 2 Accident Aircraft (Overview)

The forward cross tube\*<sup>2</sup> was stuck in the bottom of the fuselage and deformed, while the aft cross tube was found fractured in its middle area. The two skids were widened apart.

The right skid was fractured at the joint with the forward strut and was upright pivoting around the joint with the aft strut.

It is considered highly probable that the stuck forward cross tube into the bottom of the fuselage, the fractured aft cross tube and the widened skids were all caused by a load applied vertically to the airframe at the time of the crash.

It is considered highly probable that the fracture of the skid on the right side in the joint with the forward strut and its pivoting around the aft joint with the strut was caused by a load applied horizontally when the Aircraft struck the ground from its right side with the nose slightly lowered.

It is considered highly probable that the tail cone was bent downward slightly to the right with a vertical load applied to the airframe when the Aircraft hit the ground from its right side with the nose slightly lowered, and it was fractured and detached as if torn off forward with a horizontal load applied and as a result, the tail cone was thrown away forward to a place about 13 m from the depression which is believed to be the first strike point with the ground.
