AA2009-8

**AIRCRAFT ACCIDENT
INVESTIGATION REPORT**

**PRIVATELY OWNED
J A 2 3 8 2**

ASK23B (GLIDER, SINGLE-SEATED)

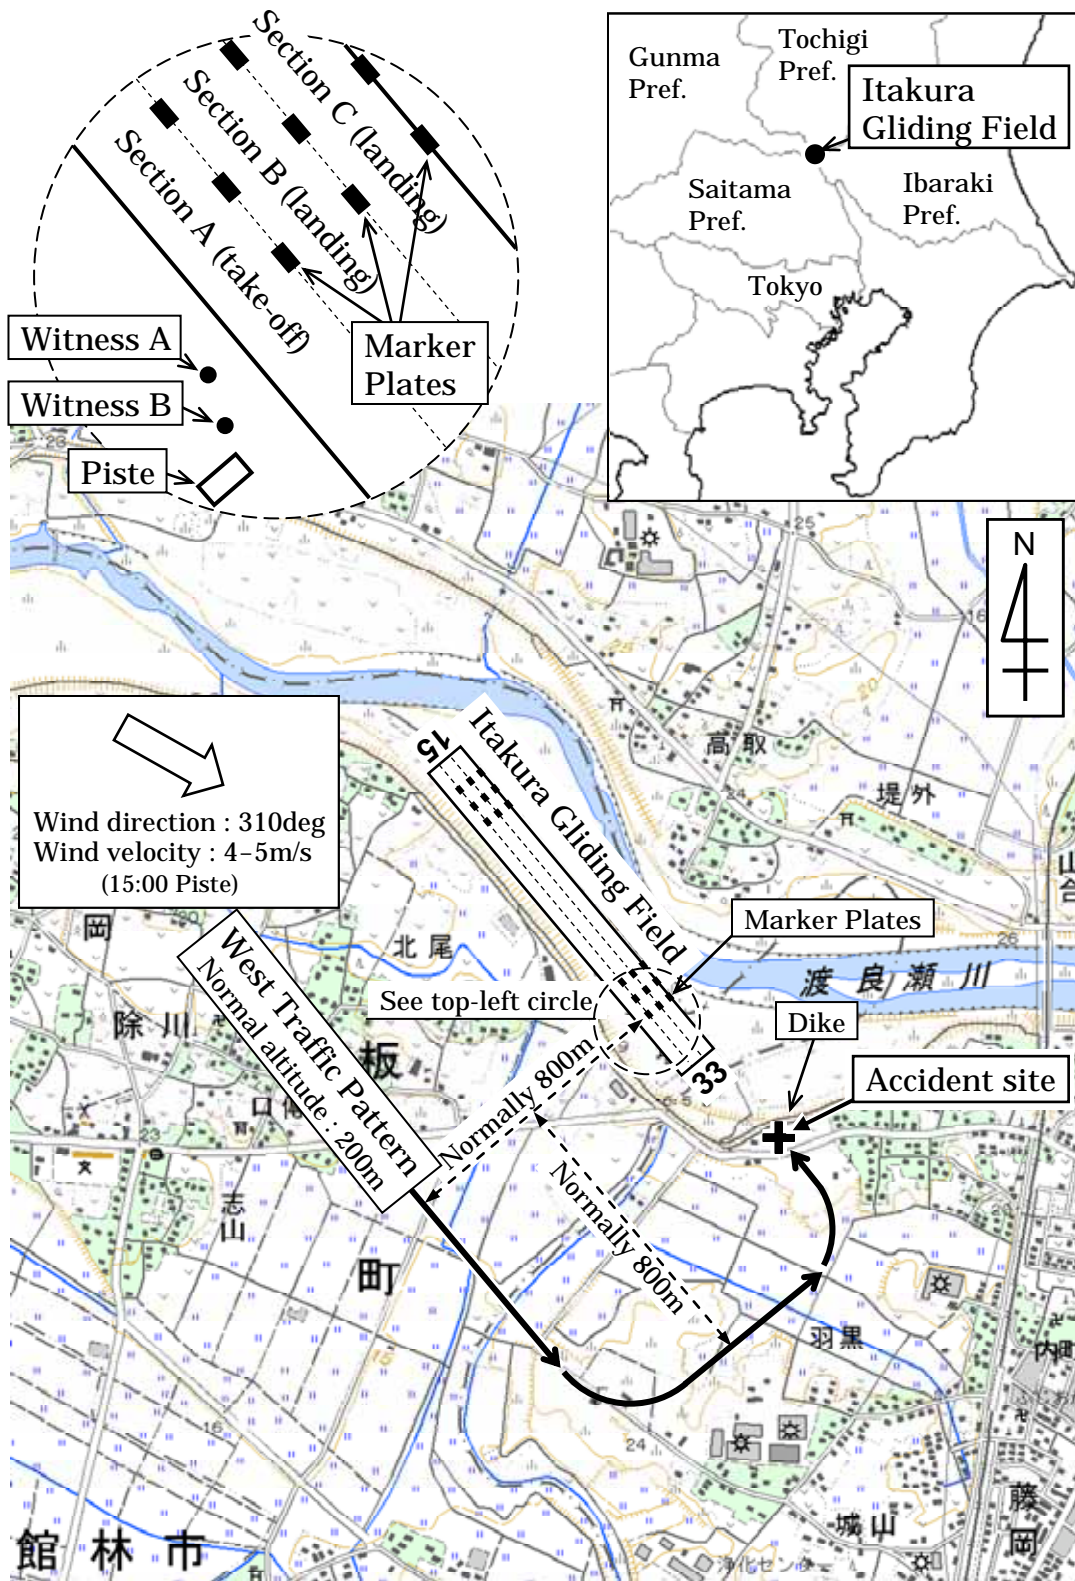
Figure 1 Estimated Flight Route

The accident occurred under the final approach path to runway 33 of the Itakura Gliding Field (Itakura Town, Oura County, Gunma Prefecture), about 460 m SE from the marker plates of the runway (N36°15'40" E139°38' 22") at 15:12.

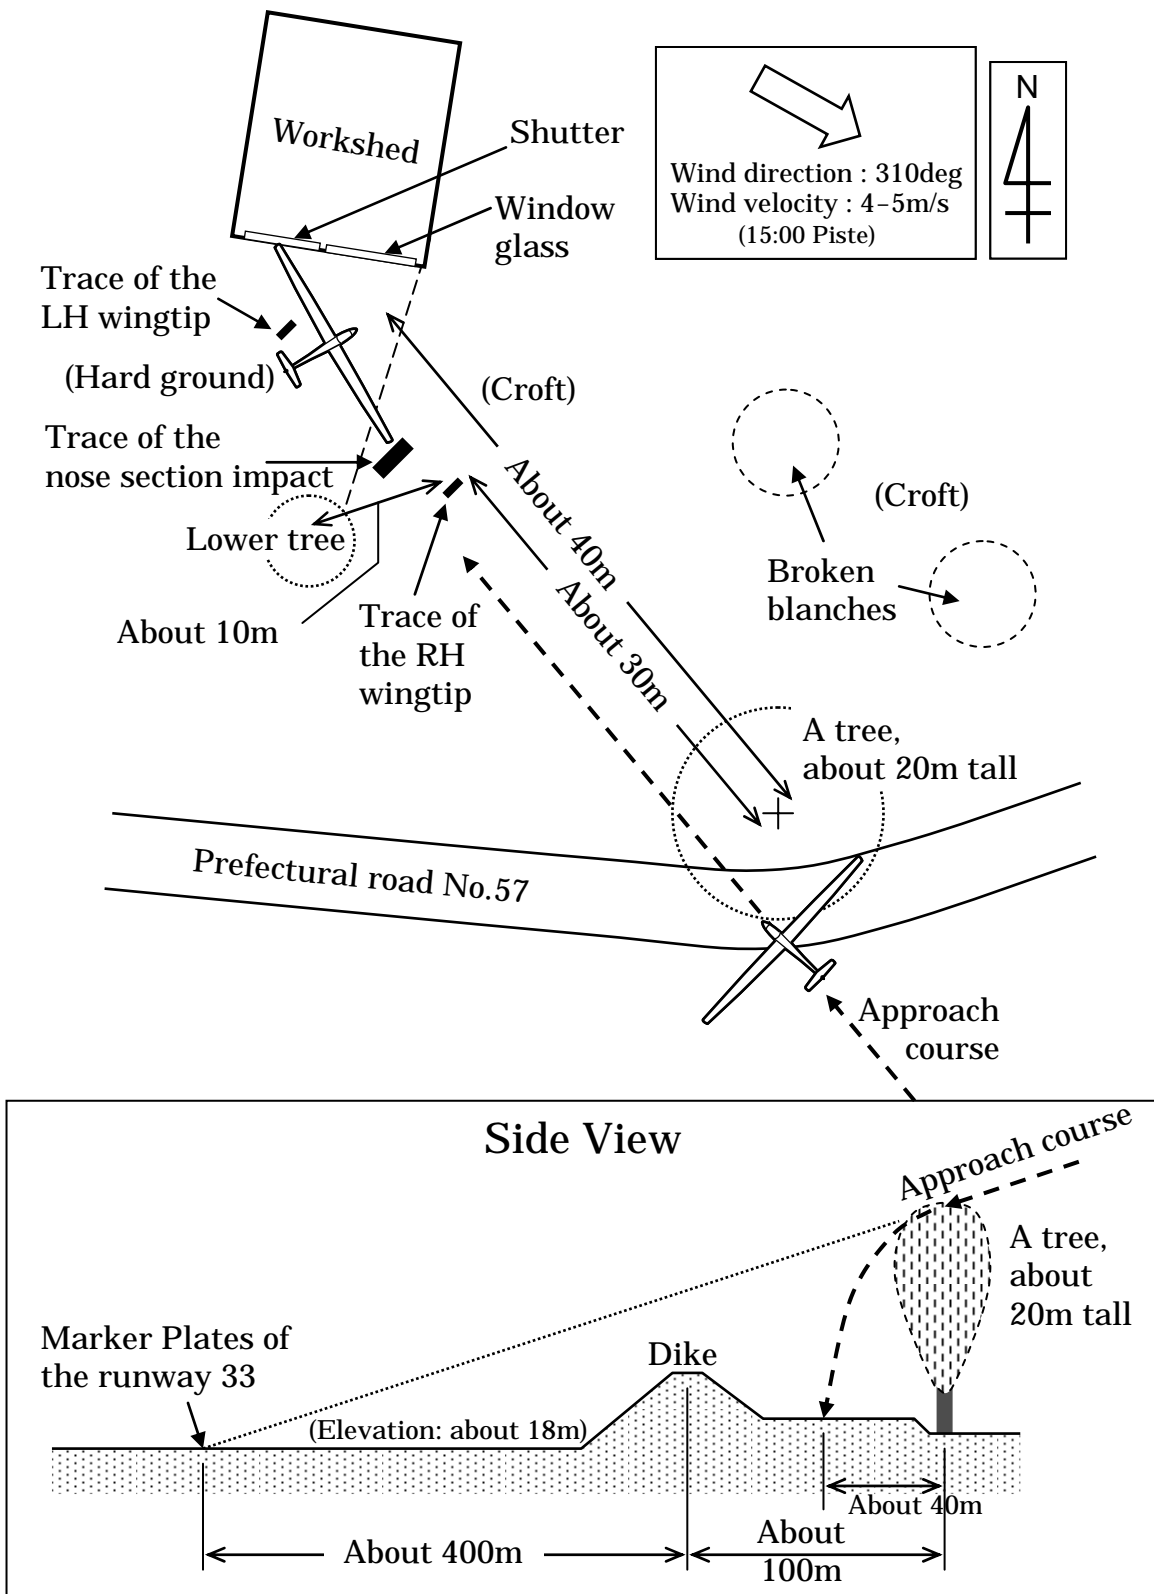
Figure 2 Key Maps of Accident Site

The accident site is under the final approach path to section C of runway 33 of the Gliding Field, and is located at about 460 m SE from the marker plates of runway 33, on the other side of the dike (altitude: about 25 m; the height from the landing area: about 7 m) on the right bank of the Watarase river from the Gliding Field. The Glider was found pointing in the direction of about 060°, about 40 m toward the Gliding Field from a tree that is about 20 m tall and is located about 500 m SE from the marker plates.

The top of the tree snapped off and fell to the ground on the N to NE side of the base of the tree. About 30 m from the tree, in the direction of the Gliding Field, traces of the initial impact of the RH wingtip were left, and about 5 m beyond, traces of the Nose section impact were left. From there to the place where the destroyed main landing gear was found, there were marks showing that the main landing gear had skidded sideways in a straight line.

About 15 m from the traces of the impact point of the RH wingtip, in the direction of the Gliding Field, traces of the impact of the LH wingtip were left. Broken branches of a lower tree were found about 10 m from the impact point of the RH wingtip. The left side of the Rudder surface showed signs that it had made contact with the lower tree.

The LH wingtip hit the shutter of the work shed, which is about 45 m NW of the taller tree.

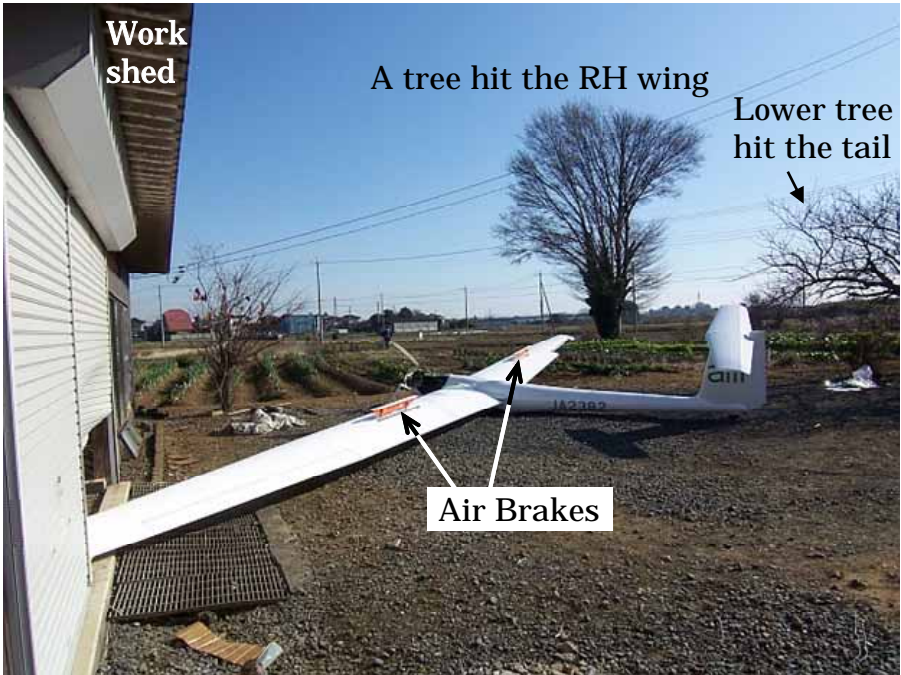
Photo 1 Accident Aircraft and Accident Site

Fuselage: Nose section and main landing gear attachment section were destroyed.

Work shed: Glass windows and shutter were damaged.

The glider was approaching from the other side.

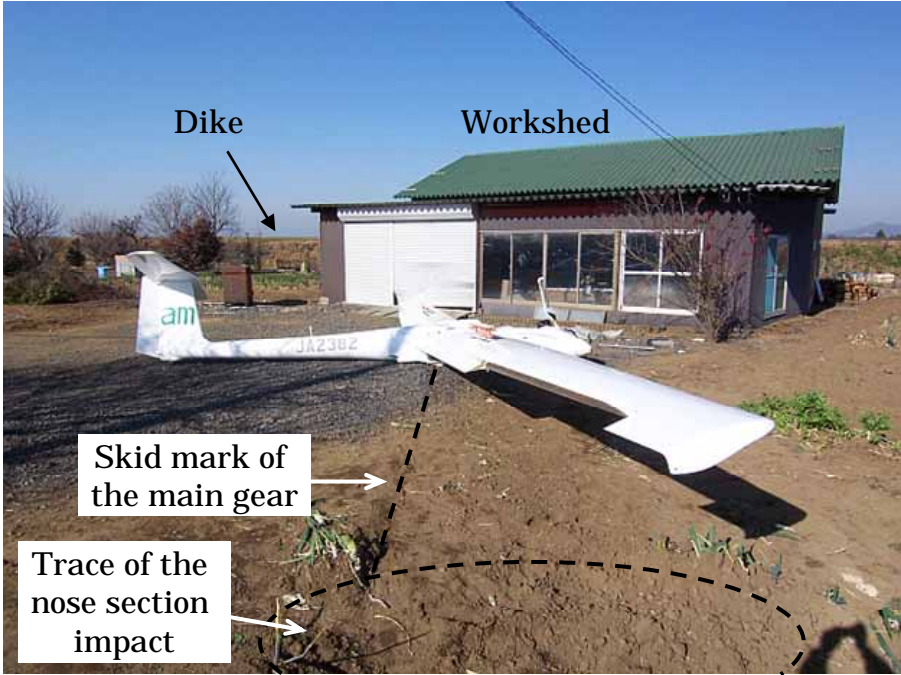
The glider was approaching to the section C over the dike.

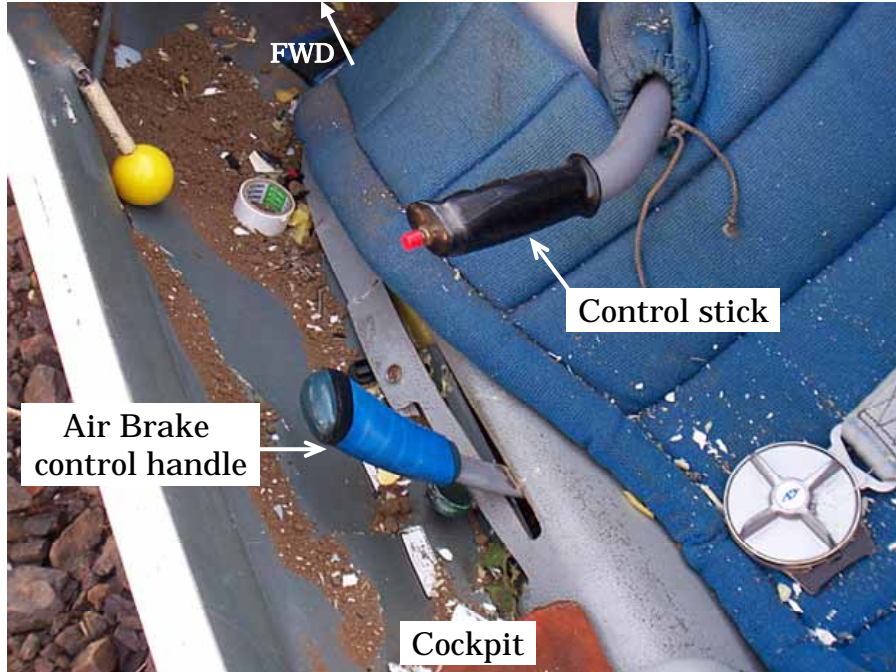
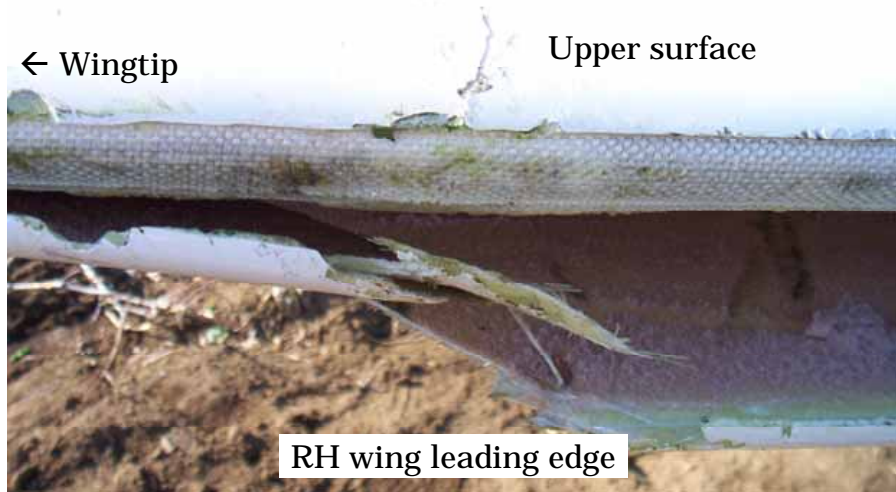
Photo 2 Cockpit and RH Wing

- The connecting section of the LH wing was broken, and the nose section was twisted down to the left.
- The nose section was turned more to the right than the Aircraft's direction (magnetic direction of 60°.)
- The canopy was damaged and fragments were scattered around.

- The wing was detached from the pin at the rear connecting section of the wing
- From about 1 m from the wingtip to about 1.9 m inward, along the wing, the leading edge was split into two main parts: the upper and lower sections. Numerous scratch marks and paint peeling off were found on the upper surface of the wing's forward section.
- A crack was found about 1.2 m inward from the wingtip. Ground soil was stuck to the lower surface the wingtip.
- The Air Brake was fully open, and the actuation rod was bent at a point near the wing connecting section.

- Neither the Aileron nor the elevator responded to control column operation.
- The Rudder did not respond to rudder pedals operation.
- The Air Brake was in the almost-fully-open position and the Air Brake did not respond to handle operation.

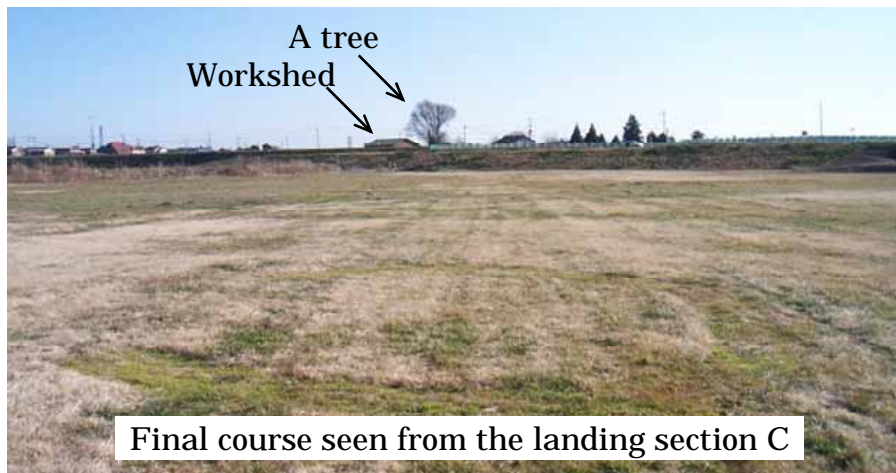
Photo 3 A Tree

As described in 2.8.1, although there was a tree under the final approach path for runway 33, the height of which was lower than the required approach surface of a Temporary Operation Airstrip (600 m landing distance). Therefore, it is certain that the tree had not obstructed the Glider's landing.

The tree that the Glider hit was cut down by the Club after the accident, after the owner's permission was obtained.
