**AIRCRAFT ACCIDENT  
INVESTIGATION REPORT**

**J A 2 4 0 5**

**February 26, 2015**

CRASH INTO THE MOUNTAIN SLOPE  
PRIVATELY OWNED  
HOFFMANN H-36 DIMONA (MOTOR GLIDER, TWO-SEATER),  
JA2405  
NORTHWEST SLOPE OF A MOUNTAIN 1,903M IN ELEVATION,  
LOCATED ABOUT 1.7KM NORTH OF  
MT. KAMUIEKUUCHIKAUSHI,  
NAKASATSUNAI-MURA, KASAI-GUN, HOKKAIDO, JAPAN  
AT AROUND 11:00 JST, MARCH 15, 2013

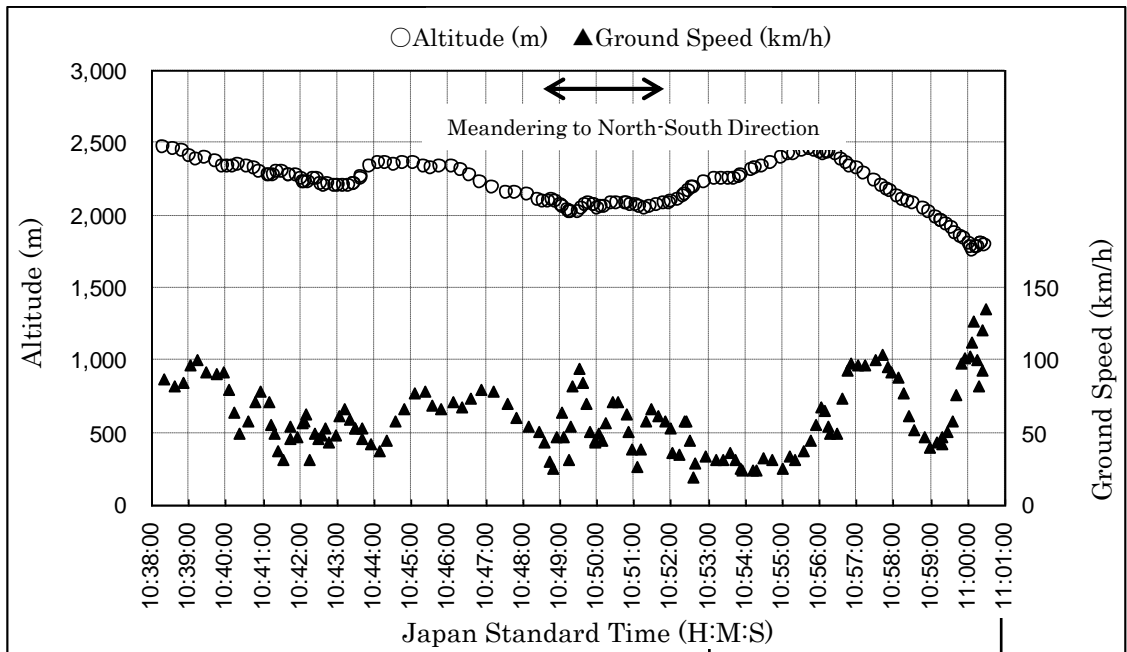
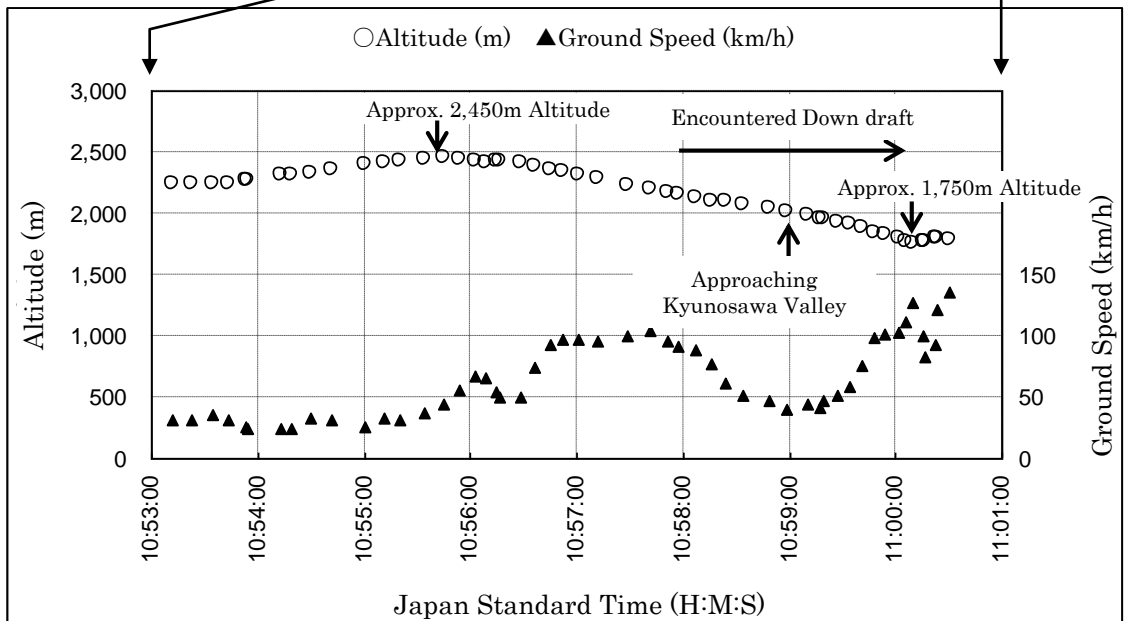
# Figure 3: Flight Altitudes and Ground Speeds

The Aircraft was descending while decreasing its ground speed rapidly.

11:00:10 About 500 m north-northwest of the accident site, the Aircraft began climbing from a GPS altitude of approximately 1,750 m.

As described in 2.6.3, according to the wind profiler observations, during flight at an altitude of approximately 2,500 m, a strong head wind blew from the west at a speed of about 50 kt (about 93 km/h), and the speed of the wind became slower while descending the altitude. It is somewhat likely that judging from the wind condition on that day, the pilot had tried not only to increase its airspeed by descending with the cruise power setting but to reduce the headwind component in order to recover its ground speed decreased during climb.

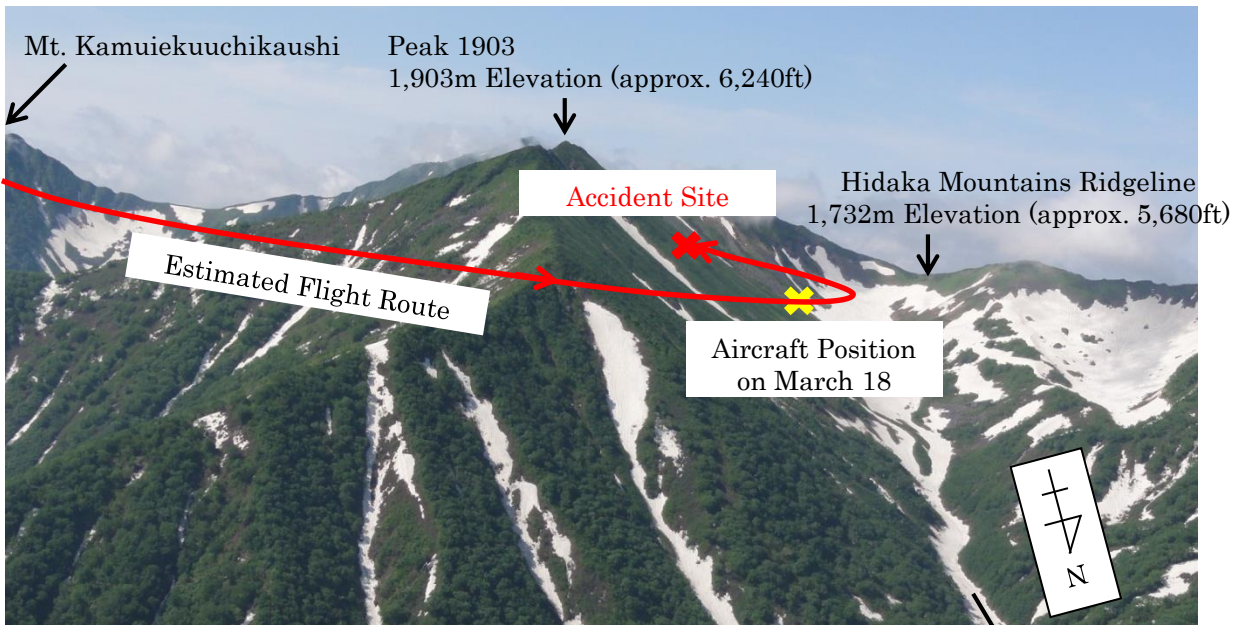
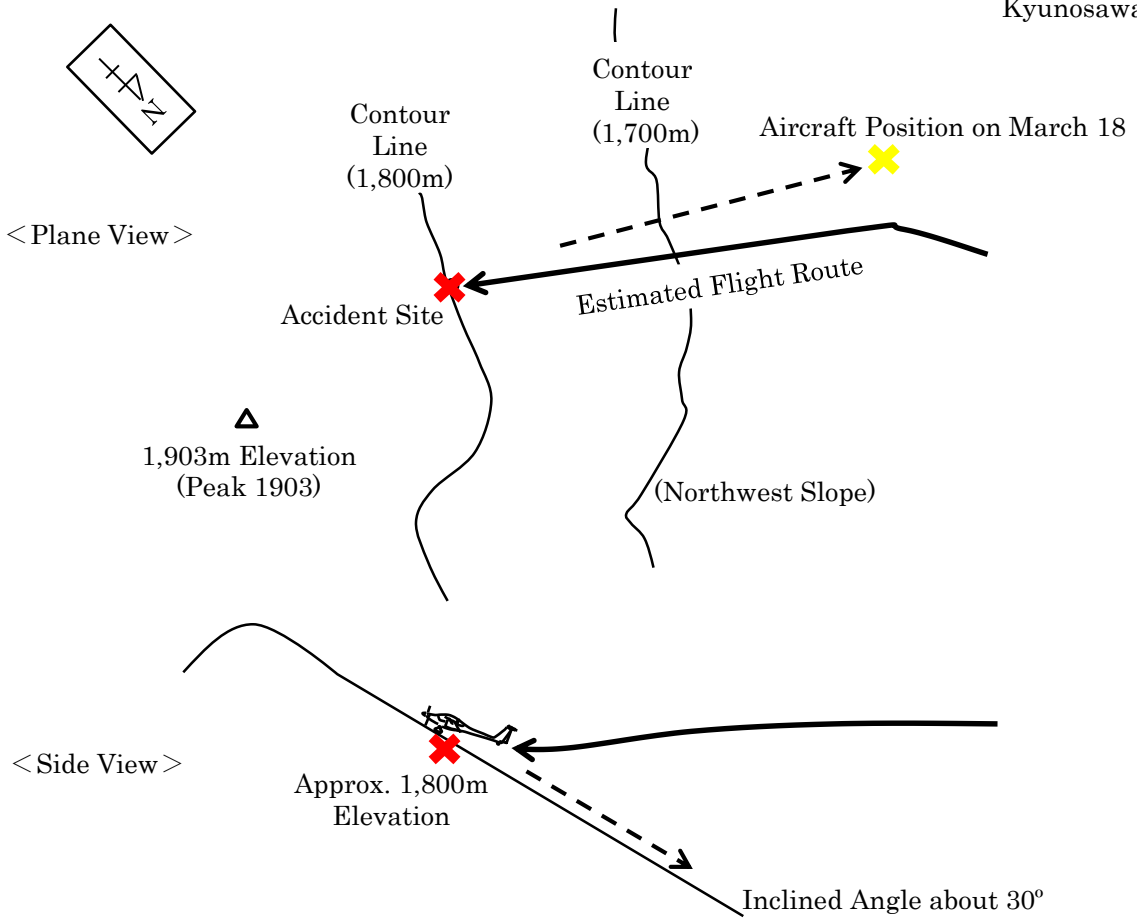
# Figure 4: Accident Site

The accident occurred at approximately 1,800 m in elevation on the northwest slope (with an inclined angle of about 30°) of Peak 1903, which is located about 1.7 km north of Mt. Kamuiekuuchikaushi (elevation 1,979 m: approximately 6,490 ft) in the Hidaka Mountains, Hokkaido. The accident site was located on the east side of the ridgeline of the Hidaka Mountains and was the slope of a mortar-shaped valley northeast part of which was cut open along Kyunosawa.

At the time of the accident, the slope was fully covered with snow. On March 18, three days after the accident, a search and rescue aircraft of the Self-Defense Forces (hereinafter referred to as "Search and Rescue Aircraft") found the Aircraft on the snow surface at approximately 1,600 m in elevation, with the nose in a southeastward direction and the left side of the fuselage on the lower side of the slope.

Aircraft examination was conducted on July 2 for the first time after the snow had melted. The Aircraft had slid about 60 m in elevation below the site that was first identified on March 18. The components of the Aircraft were seen scattered around. In addition, the pitot tube<sup>3</sup> mounted on the top of the vertical stabilizer was found about 70 m in elevation above the site that was first identified on March 18.

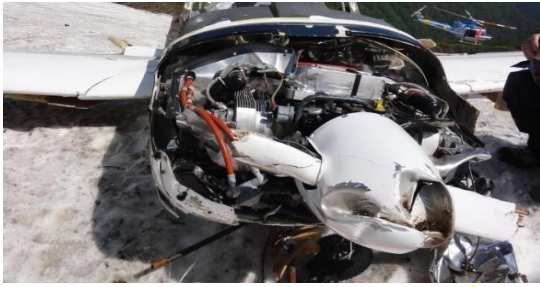
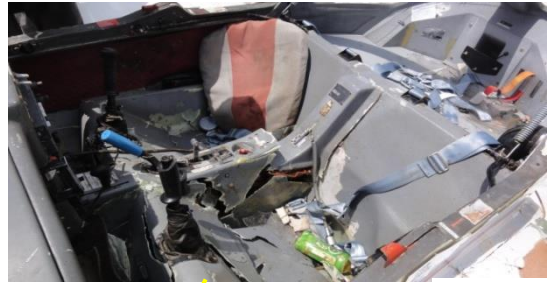
Engine, Propeller and Spinner

The engine support was deformed, and the engine was destroyed particularly on the bottom side. There were no anomalies with the spark plugs and the inside of cylinders.

Both two blades were fractured, with one-fourth of the length remaining on the roots. The spinner was damaged at the tip.

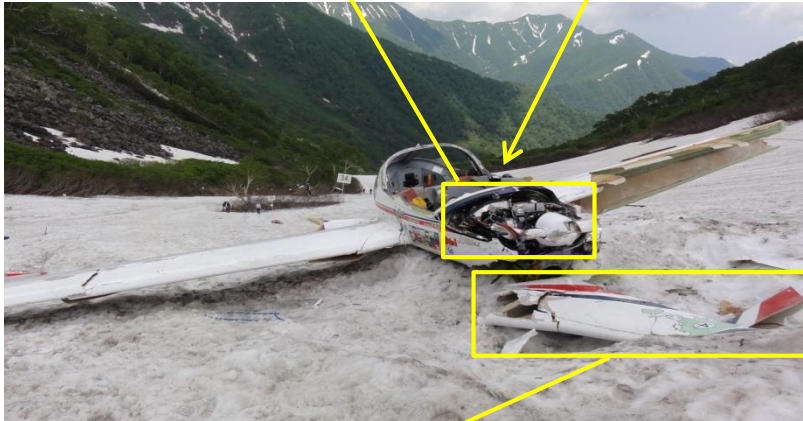
Cockpit

The canopy (windshield) broke apart, and the aft fuselage was fractured. The cockpit was deformed and destroyed on its bottom apparently by the downward force.

As described in 2.8.2, the Aircraft was found in the following condition: the main landing gears detached, the cockpit was deformed and destroyed on the bottom floor apparently by the downward force, and the tips of both wings remained intact. As described in 2.8.3, the bearing indicator pointed at 110°. In addition, as described in 2.9, the pilot and the passenger had their whole body bruised and compressed by strong blunt forces.

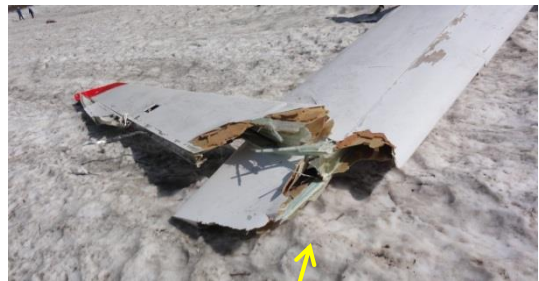
Vertical stabilizer

The vertical and horizontal stabilizers were split off from the fuselage and destroyed.

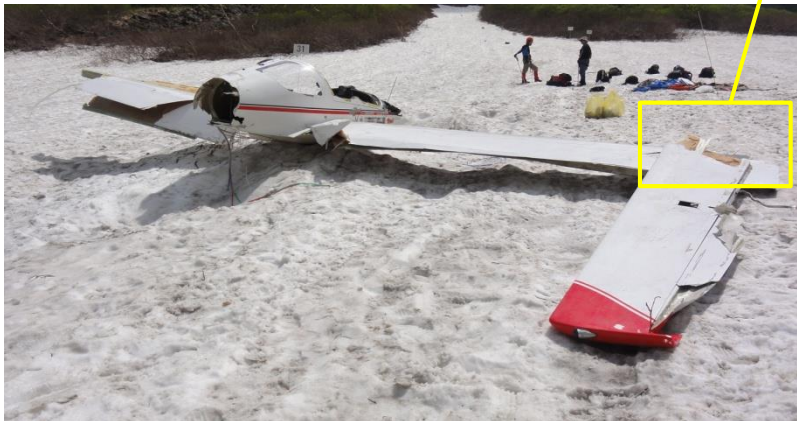
Right main wing

The right main wing was fractured at one-third of the length from the wing tip, which was folded toward the aft fuselage. The left main wing was fractured nearly at the center, but the tips of both wings remained intact.
