AA2023-4

**AIRCRAFT ACCIDENT
INVESTIGATION REPORT**

PASSENGER INJURY BY THE SHAKING OF THE AIRCRAFT STAR FLYER INC.

AIRBUS A320-214, JA24MC
AT FL 280 OVER KURASHIKI CITY,
OKAYAMA PREFECTURE, JAPAN
AT ABOUT 19:48, JANUARY 16, 2022

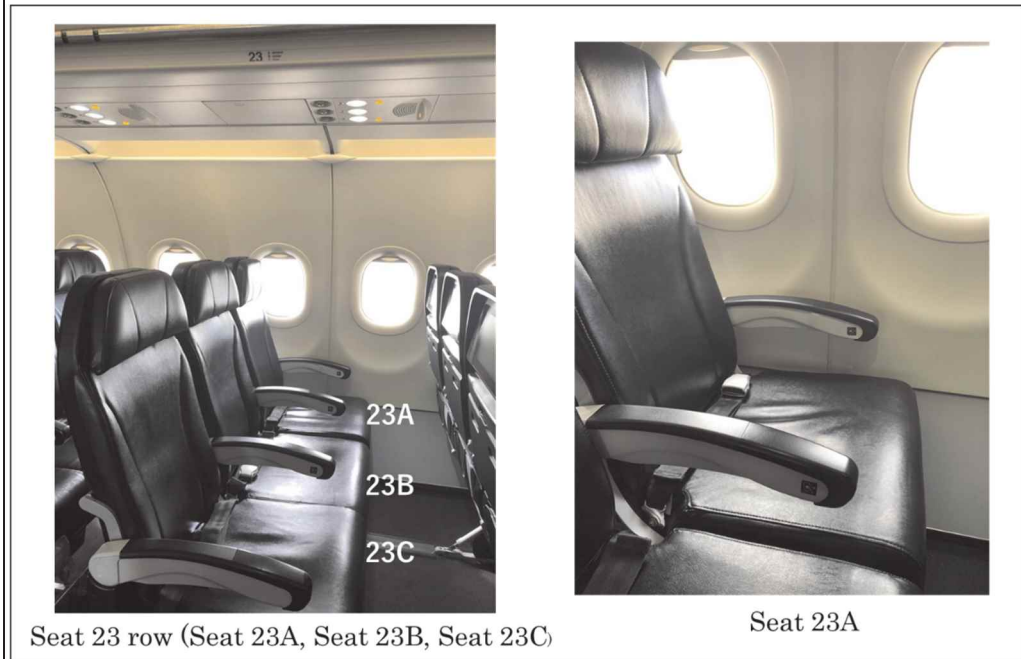
Figure 3: Seat 23A

In Seat 23A, a passenger with a height of 156 cm and a weight of 42 kg was seated. This seat was an all-leather-covered seat with a seat height of 43 cm and armrest height of 63 cm.

The armrests of the seat are 20cm high from the seat surface, which is near the height of the side of a relatively small person.

The JTSB concludes that the passenger remained seated with their seat belt fastened during the flight even after the fasten seat belt sign was turned off, however, in light of the changes in the Aircraft's horizontal acceleration (between 0.22G to the left and 0.15G to the right) and the roll angle (between 7.7° to the left and 3.5° to the right) as well as the situation of the roll rate (4.5°/sec), it is probable that when the Aircraft was shaken, the passenger was shaken from left to right and hit their right side against the armrest on the right side of the seat, resulting in their 9th rib fracture. At what speed did the passenger hit their right side against the armrest on the right side of the seat was unable to be estimated because it was unclear how strongly did the passenger fasten their seat belt.

The JTSA concludes that it is probable that in this accident, when encountering clear air turbulence created due to the jet stream, the Aircraft was shaken to the left, therefore, the passenger hit their right side against the armrest on the right side of the seat, resulting in their serious injury.

In order to prevent horizontal movement of the hips as much as possible, it is important that passengers should always fasten the seat belt at a low waist position with no slack while seated for their own safety.

Based on this case, it is desirable for seat makers to consider the design of seats that accommodate passengers of various body sizes by actively collecting data on similar cases.

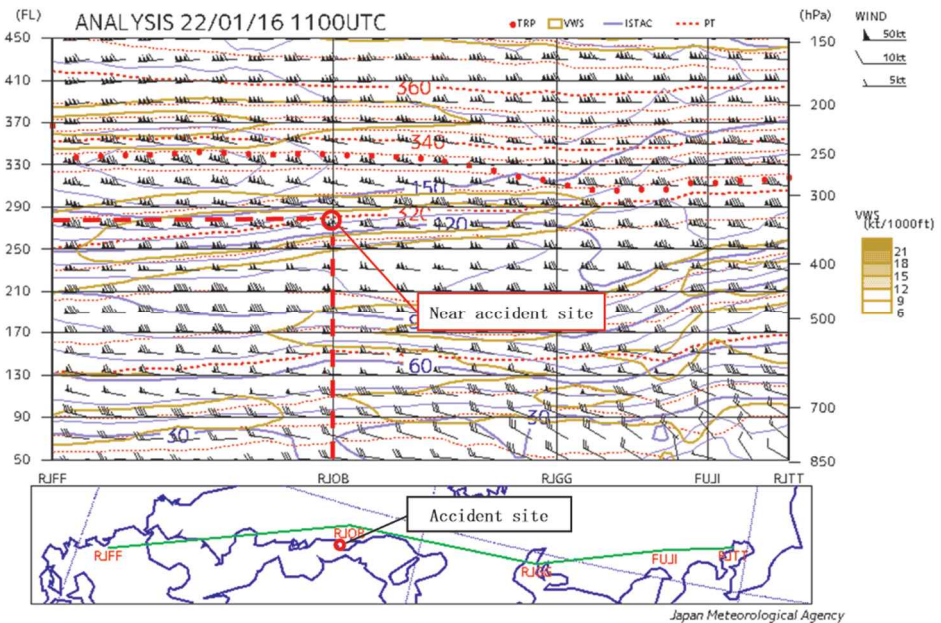
Figure 8: Hourly analysis chart (cross section: Fukuoka – Tokyo)

(Figure 8) for 20:00 on January 16, 2022, issued by the Meteorological Agency, VWS of 9-12 kt/1,000 ft was shown at FL260 to FL290 in the vicinity of the accident airspace.

The JTSB concludes that according to the QAR record (Figure 10), from 19:47:28 to 19:47:54, the vertical acceleration changed from +0.75 G to +1.36 G, and the horizontal acceleration changed between 0.22 G to the left and 0.15 G to the right, and that the Aircraft's turbulence was probably caused by encountering clear air turbulence created due to the jet stream, because the hourly analysis chart showed the area of vertical wind shear, and there were no clouds.

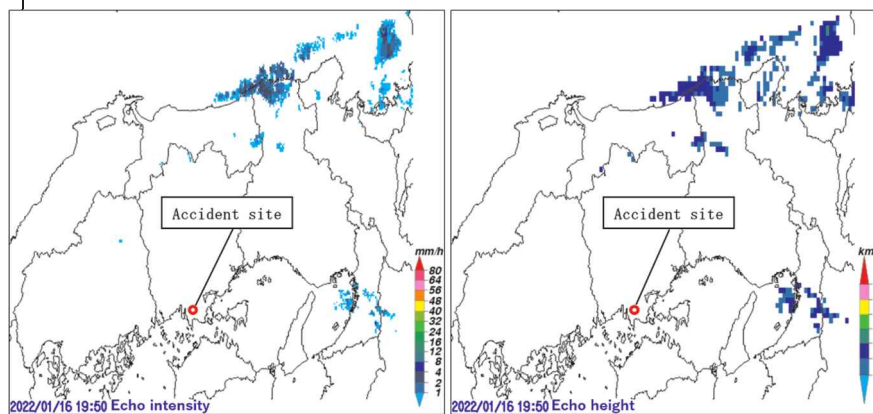
Figure 9: Radar composite chart (Echo strength and top height) at 19:50 on January 16, 2022

According to the radar composite chart (Echo strength and top height)(Figure 9) for 19:50 on January 16, 2022, issued by the Meteorological Agency, no cloud of the echo was observed in the vicinity of the Aircraft's flight route that would cause the aircraft to shake.

The JTSB concludes that any radar echo was not observed in the vicinity of the accident airspace, however, clear air turbulence more likely occurred due to the jet stream.

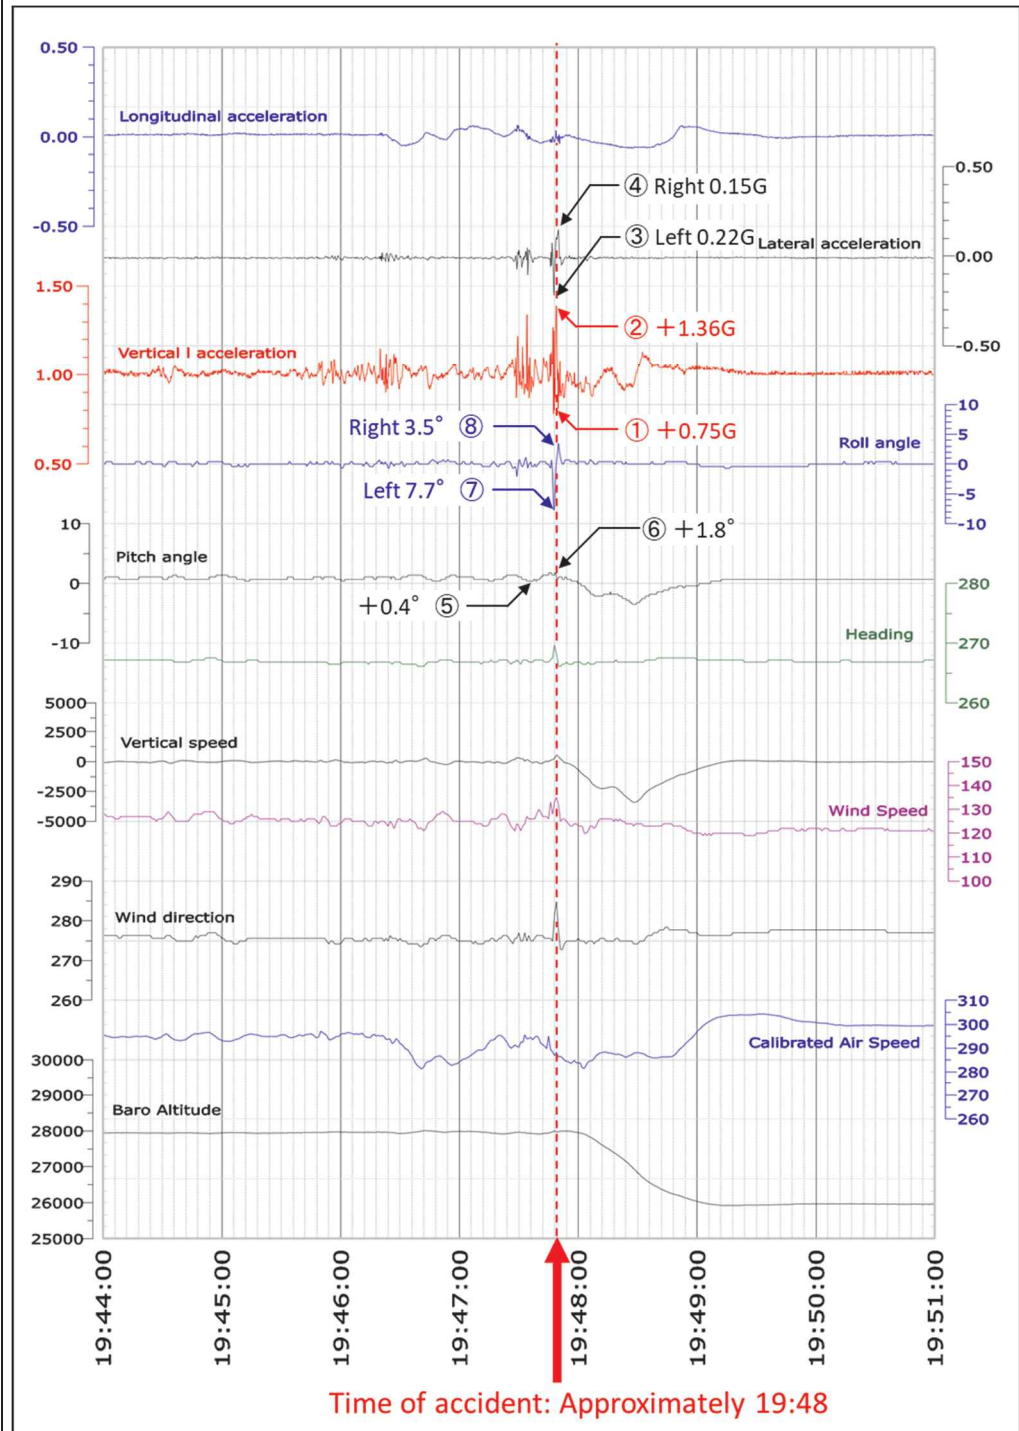
Figure 10: QAR record

According to the QAR record of the Aircraft, the vertical acceleration showed a remarkable change from 19:47:28, and changed from +0.75G (see Figure 10 ①) to 1.36G (see Figure 10 ②) at 19:47:54. The horizontal acceleration at that time changed between 0.22G to the left (see Figure 10 ③) and 0.15G to the right (see Figure 10 ④). The pitch angle changed between +0.4° (see Figure 10 ⑤) and 1.8° (see Figure 10 ⑥). The roll angle changed between 7.7° to the left (see Figure 10 ⑦) and 3.5° to the right (see Figure 10 ⑧). The roll rate at that time was 4.5°/sec.
