**AIRCRAFT ACCIDENT  
INVESTIGATION REPORT**

**J A 2 5 6 9**

**GROB G109B (MOTOR GLIDER: TWO SEATER)**

December 10, 2008

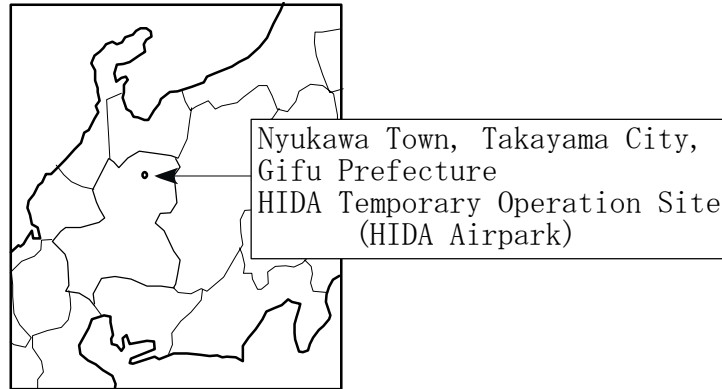
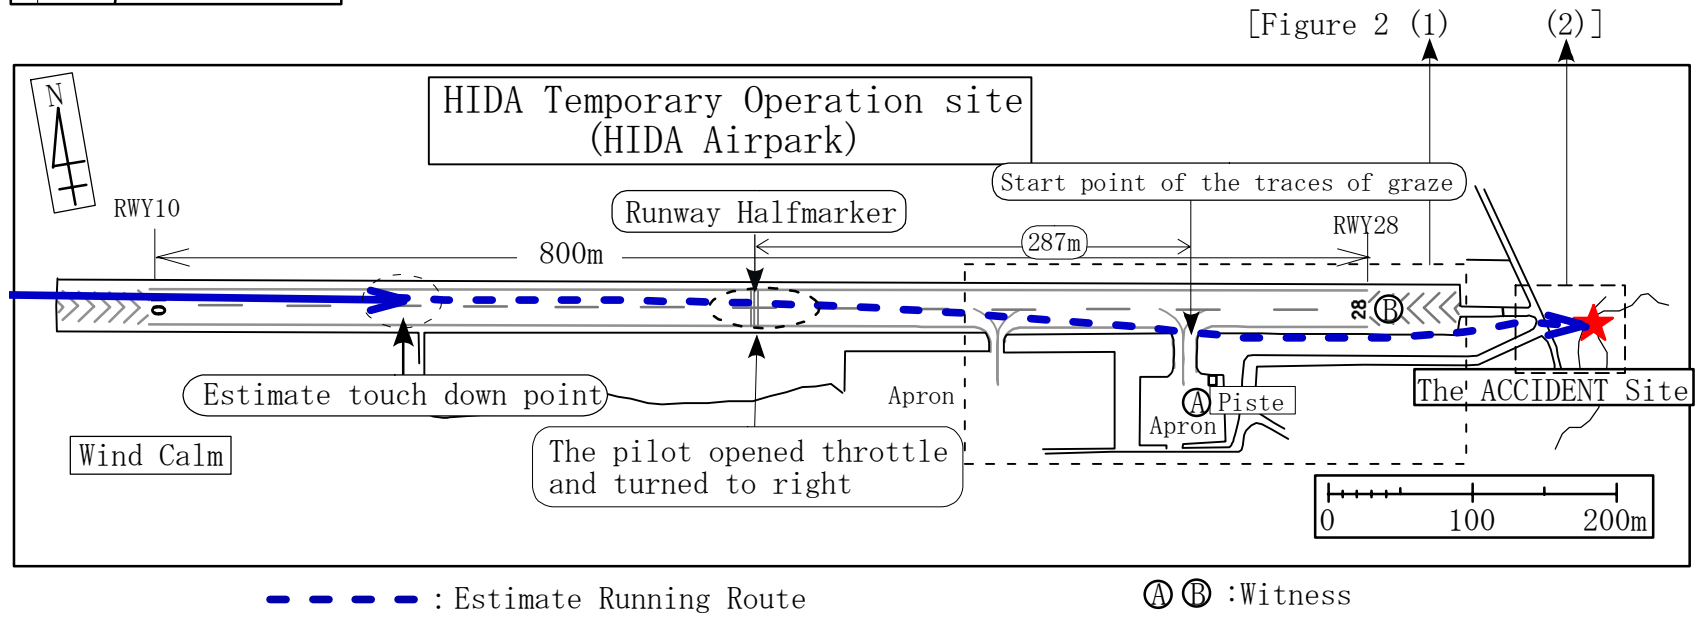
# Figure1 Estimate Flight Route

This accident occurred in mountain forest about five meters lower than the runway surface, approximately 140 meters east of the end of Runway 10 at Hida Site (latitude 36° 10' 44"north, and longitude 137° 19' 09"east, ground elevation at 714 m), at about 14:59. (See Figures 1, 2, and Photos 1 and 2.)

As described in 2.1 (1), it is estimated that the Aircraft entered into a porpoise<sup>5</sup> condition, touched down at high speed and bounded, because the captain didn't flare the Aircraft sufficiently.

(Based on the traces of grazes on the shoulder south of the runway and on the left main wingtip, it is estimated that the Aircraft banked to the right and deviated from the runway, and then banked to the left, causing its left wingtip to touch the runway shoulder.)

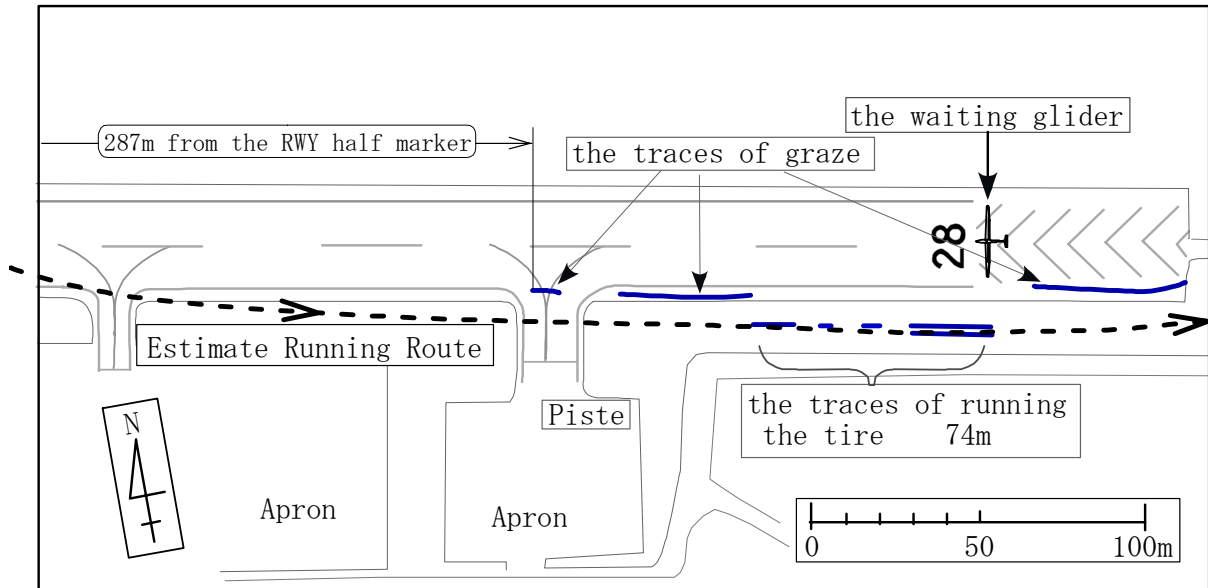
(1) The traces on the shoulder of the RWY south side and grass area

On the shoulder south of the runway, 287 meters east of the runway halfway marker, there was a fine linear trace of a graze. Then there was a tire trace on the grass area just next to the place where the trace of a graze ended, and the tire trace disappeared for a while and then two tire traces appeared. There were no traces of grazes on the shoulder between these two points. After that fine linear traces of a graze appeared again on the shoulder of the overrun, 15 meters east of the location where the traces of the tires ended, and continued until the east end of the overrun. The traces of the tires were light, not ones made under heavy weight.

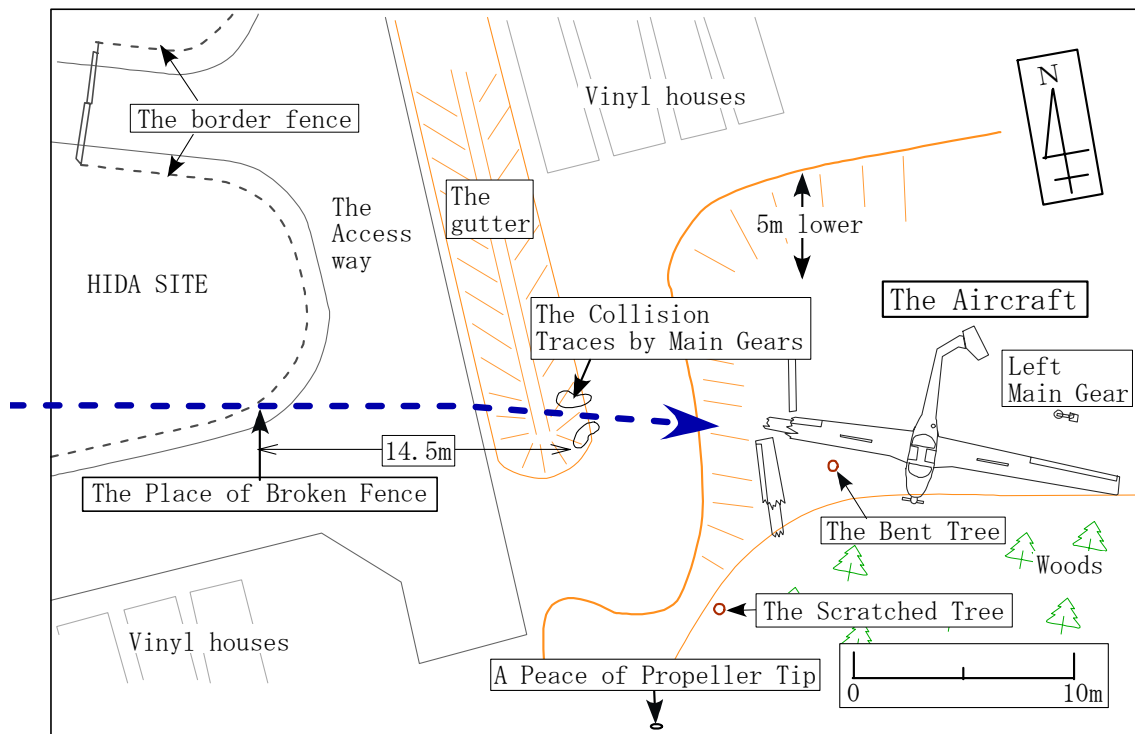
(2) The Accident Site

The border fence east of the site was damaged at one place, and two collision traces were found on the slope of a gutter, which was 14.5m east from the fence in the heading direction. The interval between the collision traces roughly corresponded to the width of the two main wheels of the Aircraft. A piece of the tip of the propeller blade was found 15 meters on the right (south) of the collision trace.

The Aircraft stopped at 30 meters east of the border fence of Hida Site, in woods downward of the levee, where the ground level is 5m lower than the runway surface.

The Aircraft stopped with its heading at 180 degrees, the tail section was bent, and the left main wheel was separated and had fallen to the left of the airframe. Also, a tree in front of the right main wing was bent, and another tree which was diagonally in front of the damaged right main wing, had scratches.

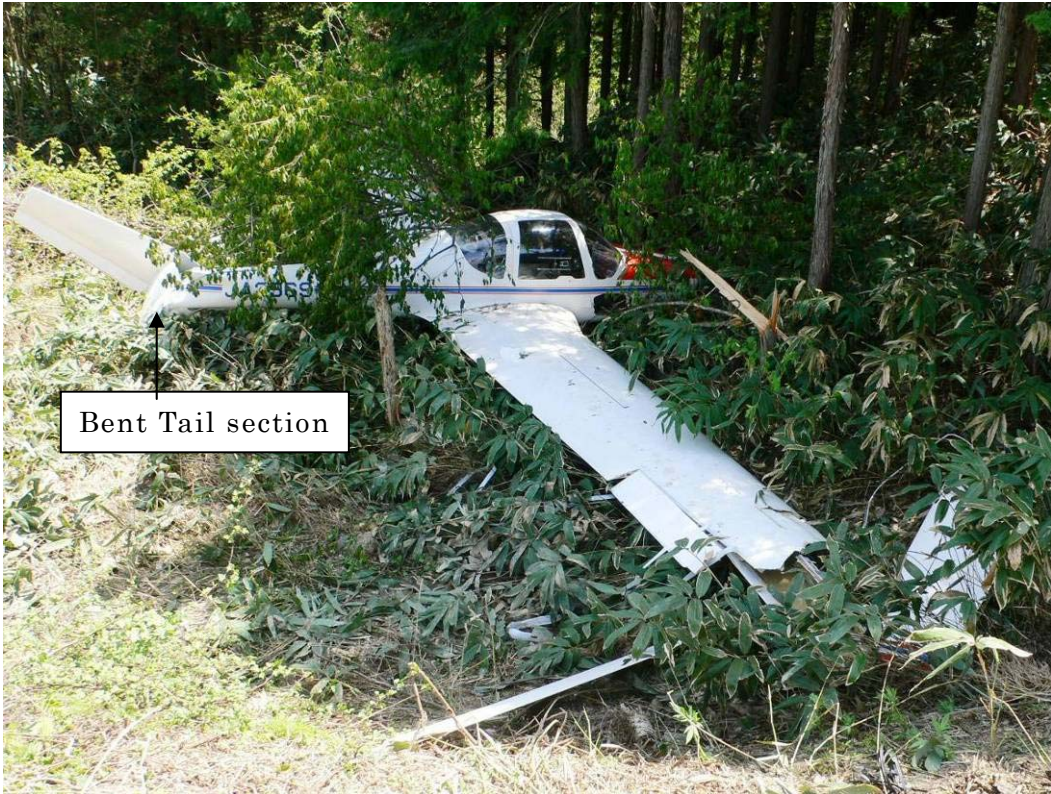
Photo 1 Accident Aircraft

The Aircraft was completely destroyed.

- (3) Cockpit front wind shield: Damaged
- (4) Propeller blades: Both were torn off at half length.
- (5) Gear: Left main gear: Broken and torn off  
Right main gear: Damaged (cut into the airframe)  
Neither had flat tires.
- (6) Engine: Not damaged

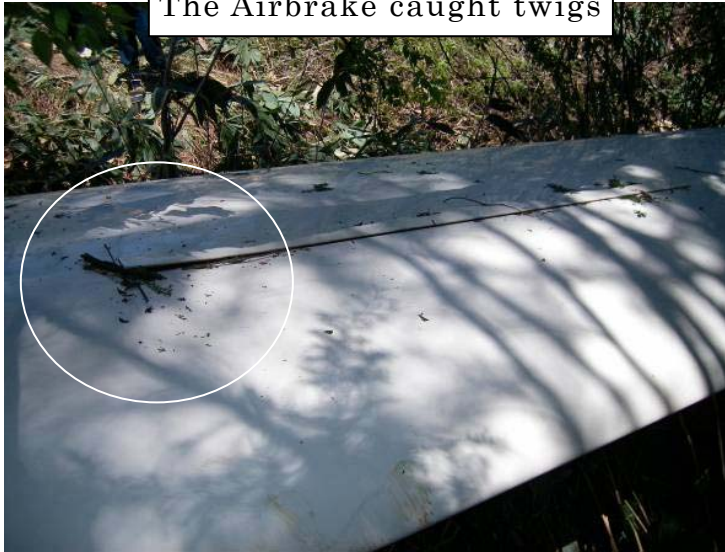
### Photo 3 Airbrake

Twigs had caught between the air brake and the wing upper surface of the left main wing.

(Based on the air brake was not locked, and twigs were caught between the air brake and the surface on the wing, it is estimated that the Aircraft plunged into the woods with its air brake in the open position.)

The Airbrake caught twigs

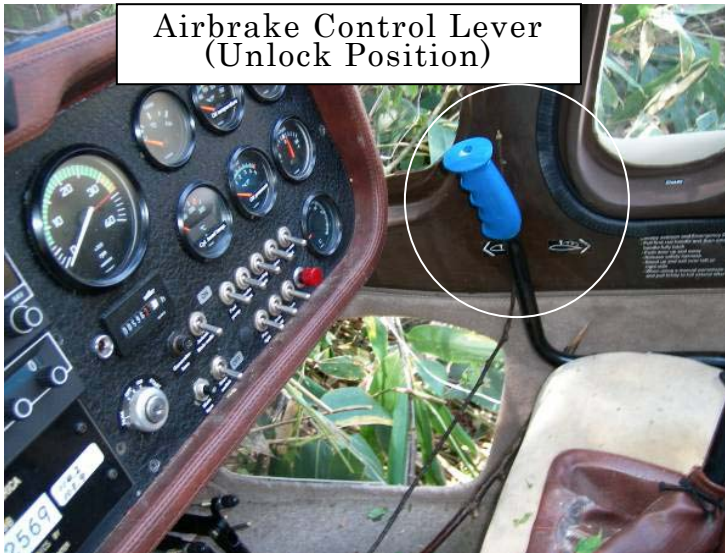
Airbrake Control Lever (Unlock Position)

Just after the accident, the airbrake control lever of the Aircraft was in the unlocked position, pulled approximately 3 to 5 cm in the opening direction. It is the condition in which the air brake rose up slightly (opened) on the wing surface.

During investigation, the twigs were removed to enable operation of the air brake, and it was found that the control lever and the air brake could be operated normally; they could be locked normally, too.
