**AIRCRAFT ACCIDENT  
INVESTIGATION REPORT**

**PRIVATELY OWNED  
J A 2 5 C H**

CONTACT WITH TOWLINE AND GLIDER  
PRIVATELY OWNED SCHEIBE SF25C FALKE  
(MOTOR GLIDER, TWO-SEATER), JA25CH  
KINUGAWA GLIDING FIELD,  
UTSUNOMIYA CITY, TOCHIGI PREFECTURE, JAPAN  
AROUND 13:03 JST, JUNE 14, 2014

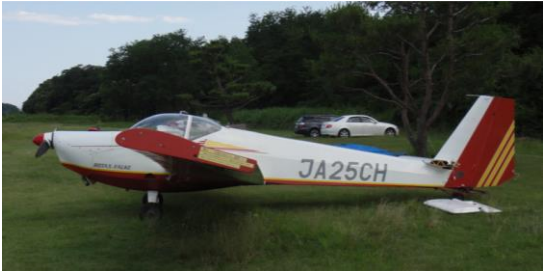
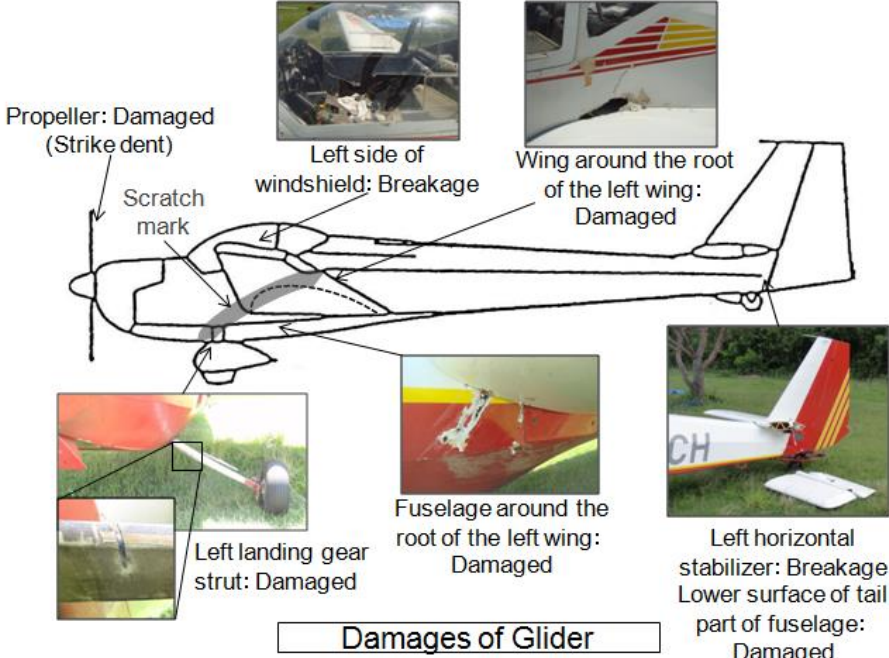
<p style="text-align: center;"><b>Damages of Glider</b></p>

2.2 Injuries to Persons	None
2.3 Damage	<p>Extent of damage of Glider A: Substantially damaged</p> <ul style="list-style-type: none"> <li>• Propeller: Damaged</li> <li>• Left side of windshield: Breakage</li> <li>• Left landing gear strut: Damaged</li> <li>• Wing and fuselage around the root of the left wing: Damaged</li> <li>• Left horizontal stabilizer: Breakage</li> <li>• Lower surface of tail part of fuselage: Damaged</li> </ul>

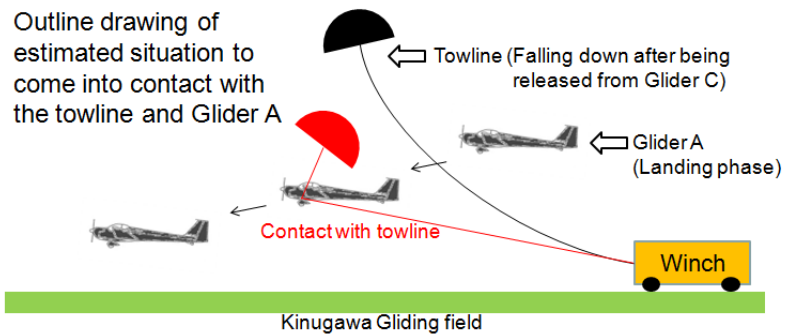
3.1 Involvement of Weather	No
3.2 Involvement of Pilot	Yes
3.3 Involvement of Glider	No
3.4 Analysis of Findings	<p>(1) Situation to come into contact with the towline and Glider A</p> <p>As described in 2.1, it is highly probable that the spot where the towline and Glider A come into contact was on the Gliding Field, at around 100 m inside from the threshold of runway 34 and an altitude of about 10 m. It is probable that the parachute and wire of the winch side were torn off at the connecting part after the left wing of Glider A came into contact with the wire of the winch side of towline, and the left horizontal stabilizer of Glider A came into contact with the parachute and was broken.</p>
