**AIRCRAFT ACCIDENT
INVESTIGATION REPORT**

ALL NIPPON HELICOPTER CO. LTD

J A 3 1 N H

ALL NIPPON HELICOPTER CO., LTD.
EUROCOPTER EC135T2 (ROTORCRAFT), JA31NH
ON THE MARSH LOCATED ABOUT 800m SOUTHWEST OF
SHIZUOKA HELIPORT
AT SHIZUOKA CITY, SHIZUOKA PREFECTURE, JAPAN
AT ABOUT 10:53 JST, DECEMBER 9, 2007

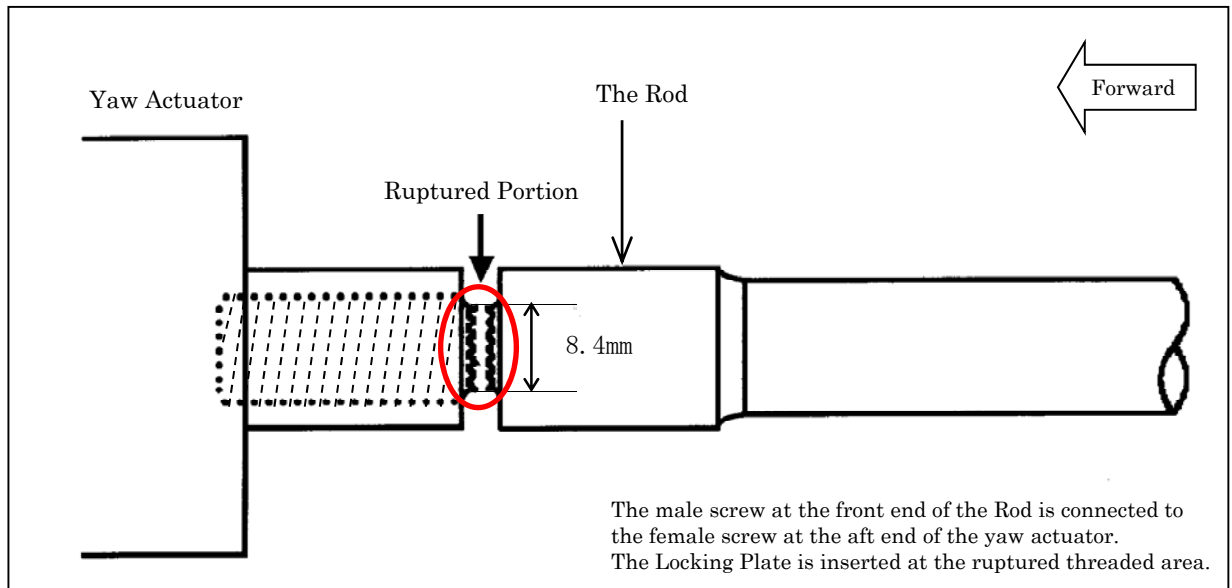
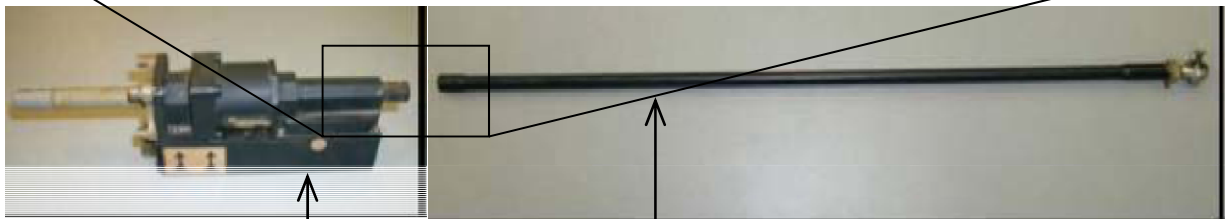
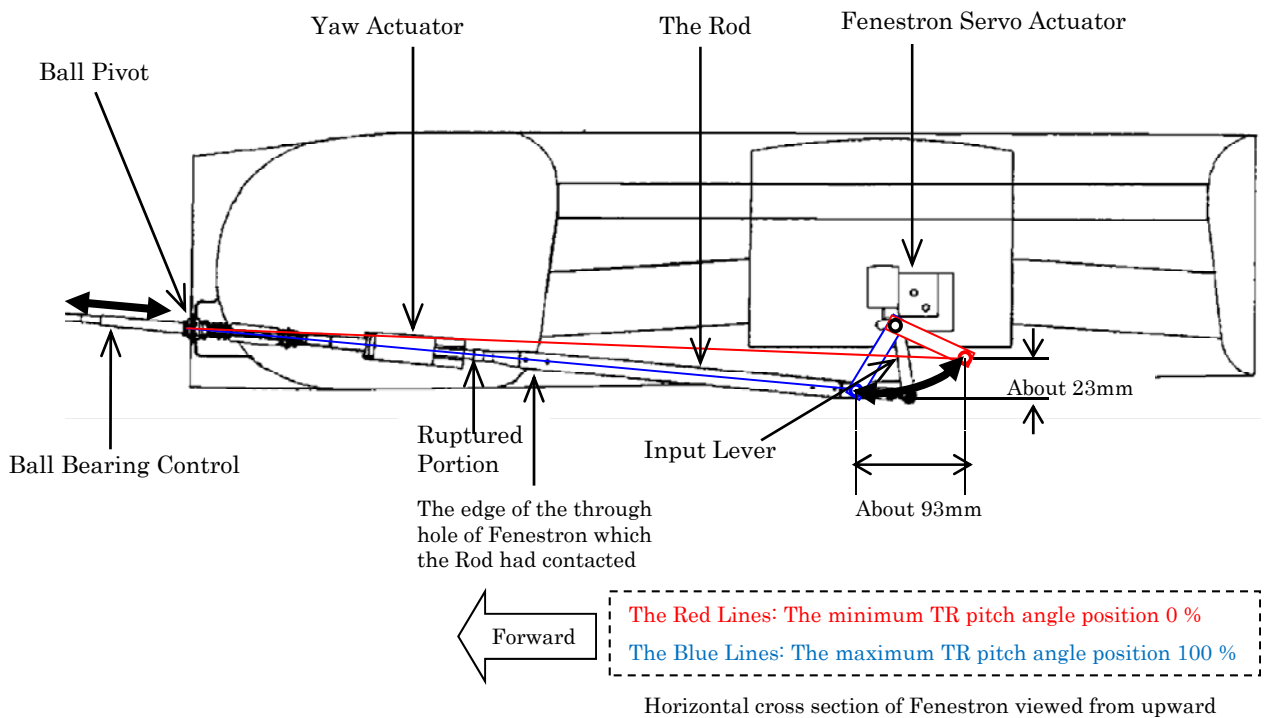
Figure 4 Ruptured Portion and Movable Range of the Rod

The Rod had ruptured in the threaded area, while the locking plate could not be found.

In the lower aft part of the section where the Rod had ruptured, a metal underneath had been exposed with a black paint stripped in a rectangular area about 3 mm lengthwise and breadthwise, and the straight striated scratch mark about 3 mm wide and about 39 mm long were found further backward from there. The black paint for the Rod was found at the edge of the through hole of Fenestron which the Rod had contacted. When the Rod's position was adjusted in the longitudinal direction so that the section of the Rod where its metal underneath had been exposed matches the place where the stripped paint was found, the input lever of the Fenestron servo actuator came to a position with the minimum TR pitch angle.

The movable range of the tip end of the input lever of the Fenestron servo actuator was about 93 mm in the longitudinal direction on the whole stroke from the minimum pitch angle position to the maximum pitch angle position. When the minimum pitch angle position is assumed to be 0 % and the maximum pitch angle position 100 %, the most aft of the straight striated scratch mark found on the Rod was located at a place about 42 % longitudinal direction on the Rod from the minimum pitch angle position.

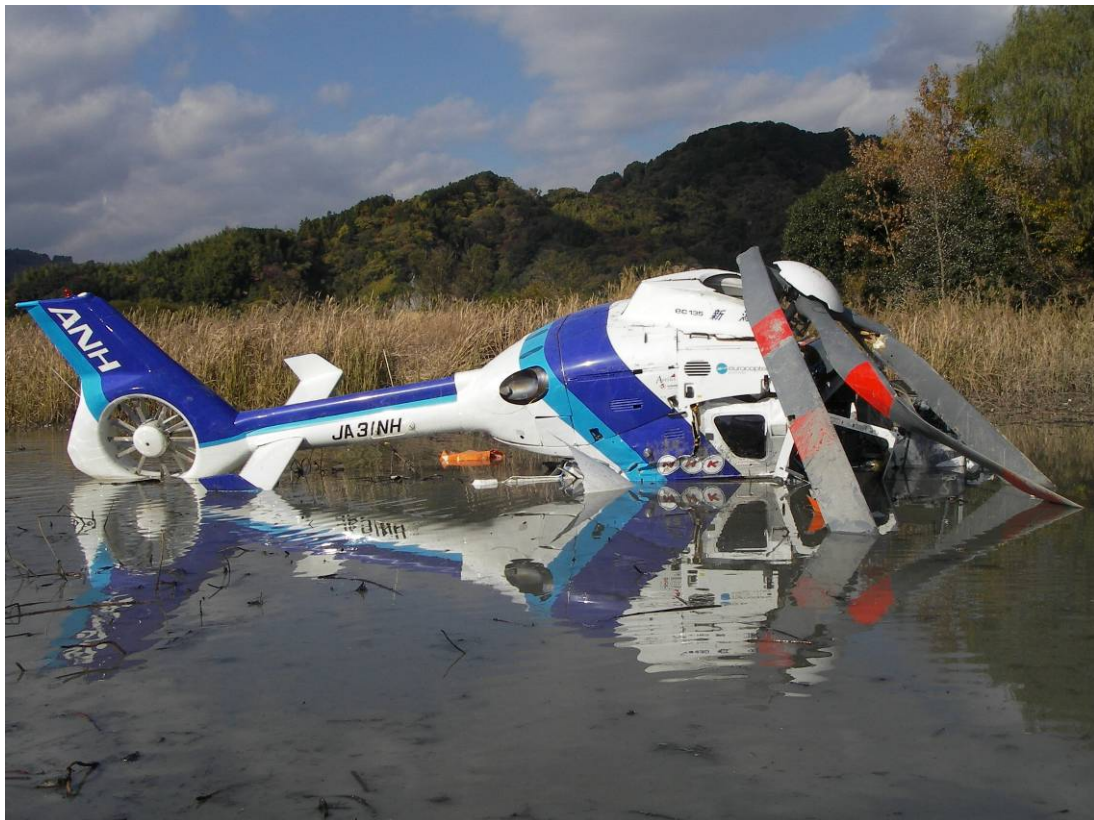
Photo 1 Accident Aircraft

Regarding the fuselage, components forming the enclosure of the cabin, such as the ceiling, the windshield, doors, window and door frames, had completely fallen apart. The transmission deck was found banking about 30 degrees forward along with the main gear box. The floor structure was found separated into two parts forward and backward at a section near the aft end of the pilot's seat, while the skin of both sides of the fuselage had developed wrinkles vertically and in some parts, cracks.

The tail boom had been bent from the section where it is connected to the fuselage. The tail boom as a whole was found deflected about 30 degrees to the left. The lower part of Fenestron was damaged with cracks and holes found. But there was no other major damage in this area. Damage to the backward areas from the tail boom was less serious than that to the fuselage.

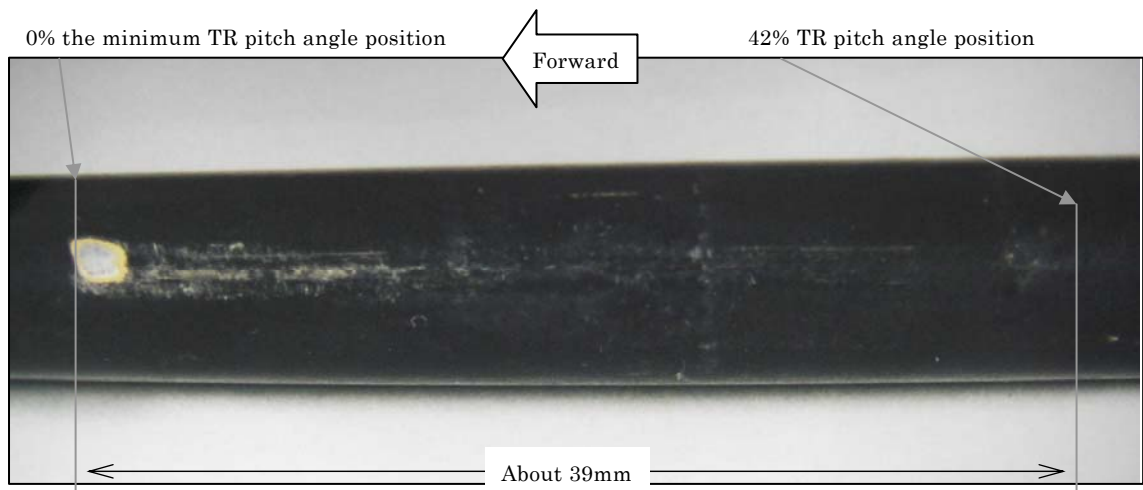
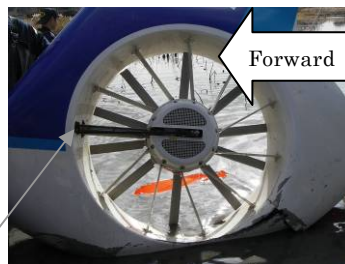
Photo 2 Marks Left on the Rod

The edge of the through hole of Fenestron which the Rod had contacted

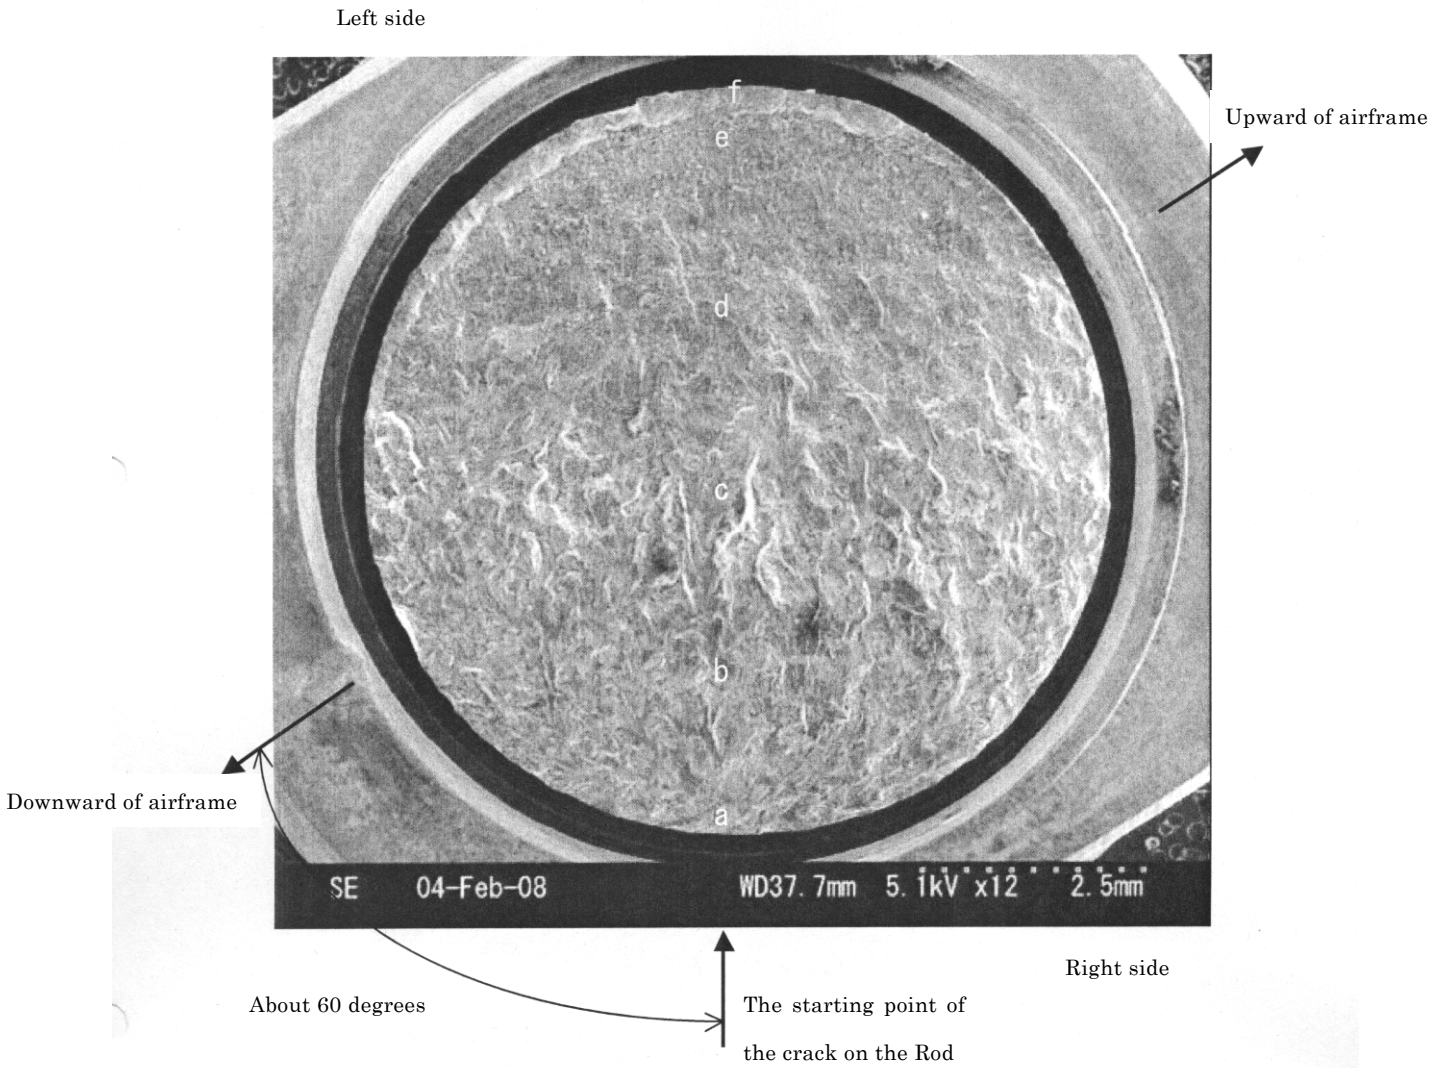
Photo 3 Fractured Surface in the Front Side of the Rod

- ② The ruptured portion of the Rod, when seen from outside, had been ruptured in the threaded area almost vertically against the direction of the axis of the Rod. The diameter of the ruptured portion is 8.9 mm. This is identical to information from the Manufacturer and it means that plastic deformation had little occurred in the ruptured portion.

- ③ A low magnification electron microscope observation of the fractured surface in the front side of the Rod showed radial markings as a sign of fatigue failure which was centered on the surface about 60 degrees inclined to the right from the lower part of the Rod. The starting point of the crack on the Rod is recognized to be traceable to this surface. The condition of the fracture surface from the starting point of the crack to about 5 mm ahead was rough, while the condition was relatively flat in the area further ahead where a deep crack was seen.

- ④ According to a high magnification electron microscope observation of the fracture surface in the front side of the Rod, the area from the starting point of the crack to about 5 mm ahead had generally shown a structure-dependent condition which can be seen in the initial stage of fatigue failure in areas where the crack grows at a relatively slow speed. Striation^{*2} was observed in some parts in this area. Striation was seen mainly in an area about 5 mm to about 8.6 mm, and in part of this area, dimple^{*3} was also seen. A small area from about 8.6 mm to 8.9 mm is a place where shear lip^{*4} occurs in the final stage of failure. Mainly dimple was observed in this area. As described above, signs of fatigue failure were seen in most parts of the fracture surface.

- ⑥ As for the cause for the rupture of the Rod, in view of the repetitive load frequency and the crack growth direction, it is considered probable that the Rod had developed fatigue failure following repetitive bending loads due to vibrations with vertical and horizontal factors mixed.

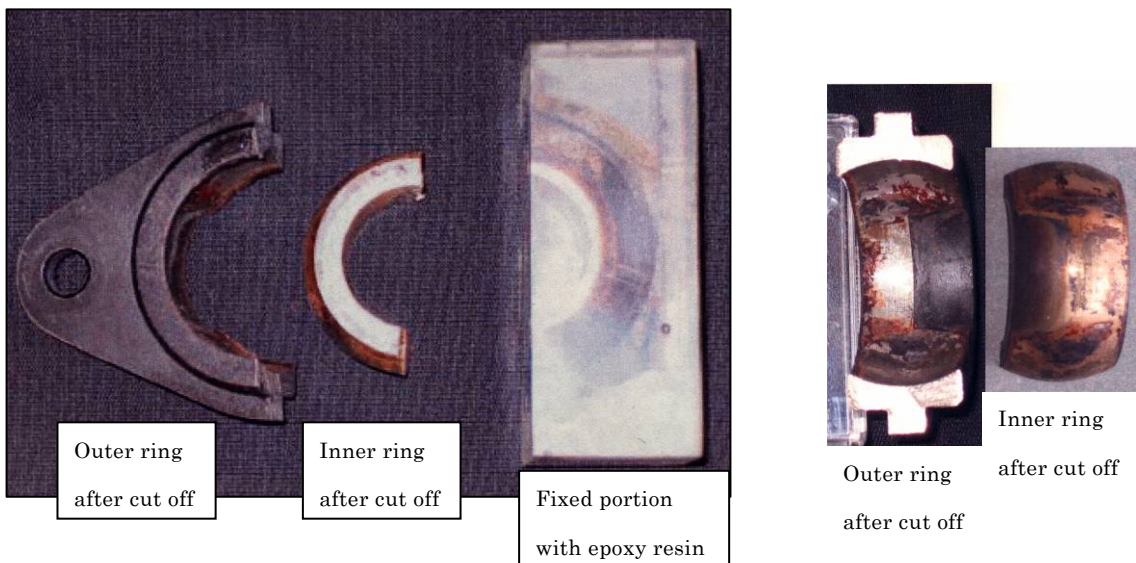
Photo 4 Ball Pivot after Cut Off

- ② In the outward appearance, corrosion was observed in the contact surface of the inner and outer rings. But there was no particular sign of corrosion on the outer circumferences of the rings.

- ③ A microscopic observation of the section of the contact surface of the rings fixed with epoxy resin showed no sign of corrosion with the inner ring as a copper-based alloy. Signs of corrosion were observed only with the outer ring as an iron-based alloy.

- ④ It is considered highly probable that the corrosion seen in the contact surface of the outer ring had been caused by galvanic corrosion or crevice corrosion.

- ⑤ Judging from the factors described above, it is considered highly probable that the stiffening of the ball pivot had occurred because red rust created with the corrosion of the contact surface of the outer ring caused volume expansion in the space between the two rings and this restricted the movement of the two rings.

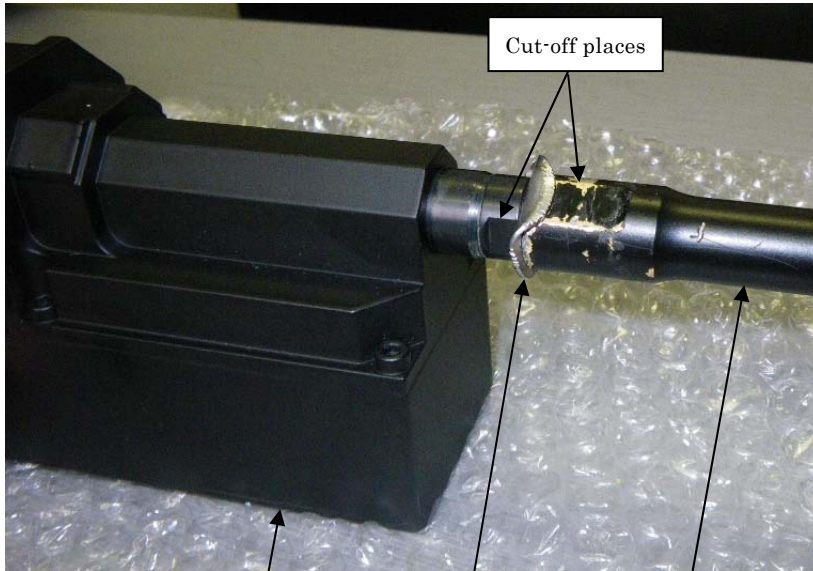
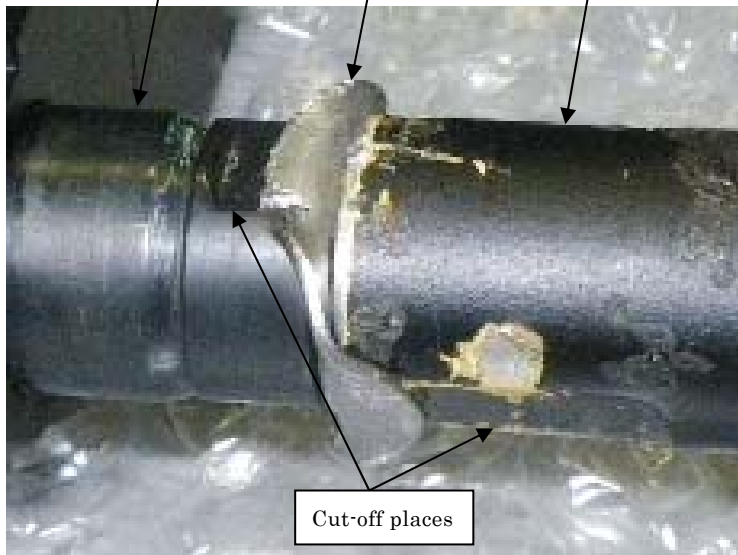
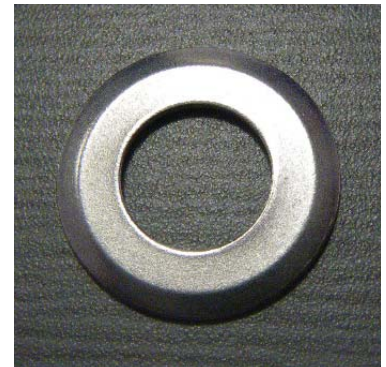
Photo 5 Locking Plate

The bending of the Locking Plate to the Yaw Actuator side had been accomplished at a cut-off place of Yaw Actuator which is opposite side of that of seeing on this Photo.
