**AIRCRAFT ACCIDENT  
INVESTIGATION REPORT**

**J A 3 2 C T**

**Japan Transport Safety Board**

**PRIVATELY OWNED  
ROBINSON R44 II (ROTORCRAFT), JA32CT  
AT ABOUT 15 KILOMETERS SOUTHEAST OF TAJIMA AIRPORT,  
JAPAN  
AT ABOUT 09:30 JST, JULY 20, 2009**

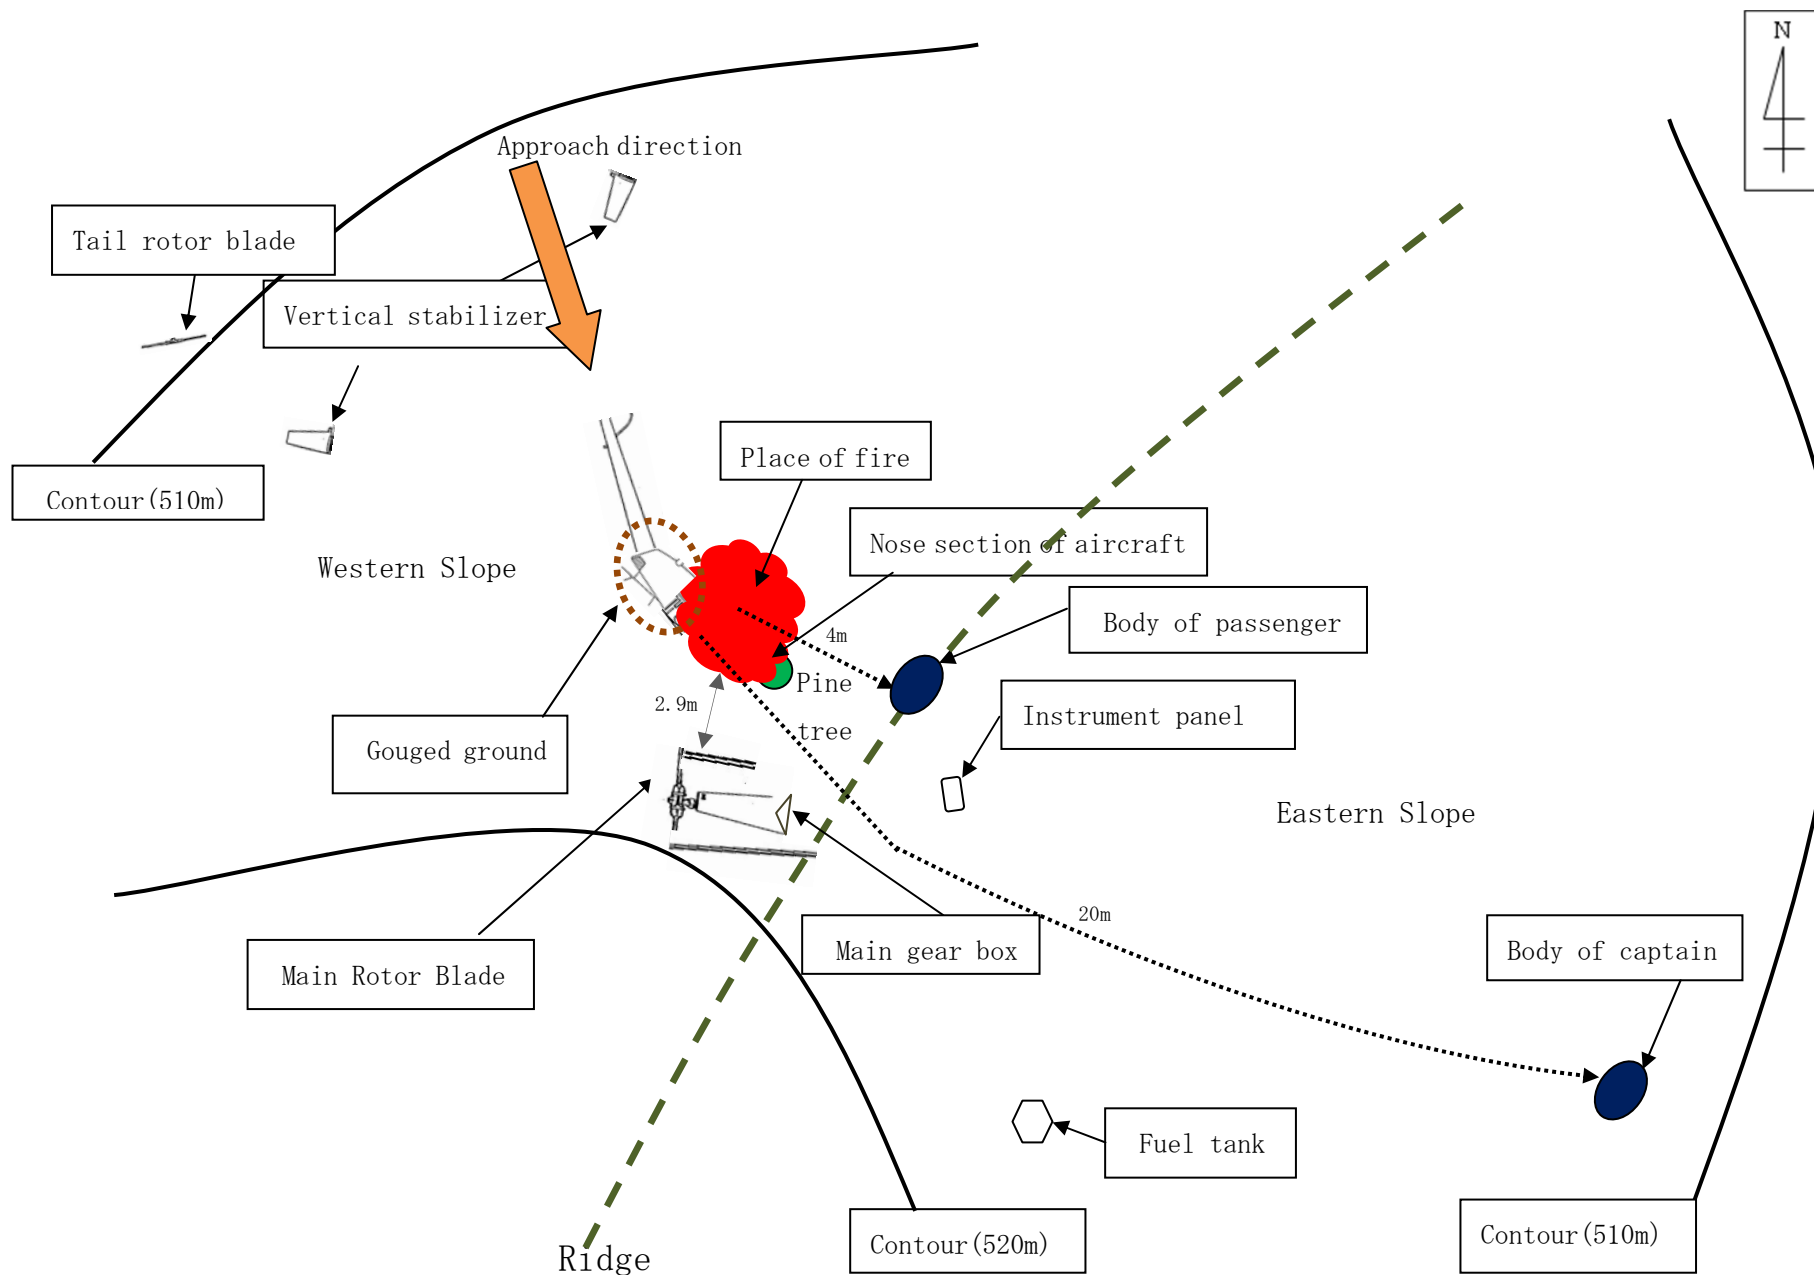
Figure 2 Accident Site Layout

The Aircraft crashed into a slope beneath the peak of the ridge with its nose lying in the direction of south-southeast. The main rotor blades and the wreckage were found widely scattered around the ridge and on eastern and western slopes. The fuselage of the Aircraft was lying in the direction of southeast with its right side down on the ground. The front part of the Aircraft was destroyed that its original shape could not be observed. When the Aircraft crashed into the ground, it is believed that the nose broke down and flew ahead toward a pine tree, and the tree was found burned from the bottom of its trunk.

The body of the passenger was found at a place about 4 meters ahead left of the fuselage, while the body of the captain was found on the eastern slope of the ridge about 16 meters ahead right of the place where the passenger's body was found. Their seat belts were found to have been torn apart in the joints with which they were fixed to the Aircraft.

The shell plating of the tail cone barely remained connected to the fuselage, but the shaft of the inside was found broken. The tail rotor and the stabilizer were removed and scattered around. The main gearbox was detached from the fuselage and found at a place about 4 meters ahead of the fuselage with the mast lying in the direction of the west. The crash created a dent 2.7 meters in length, 1.8 meters in width and 0.5 meter in depth on the ground.

The nose section of the Aircraft and some trees in the surrounding areas were burned. Branches and leaves of trees were found to have turned red-brown in a broad area ahead of the fuselage. On the western slope, to which the Aircraft approached, about 20 trees with a diameter of 4 to 23 centimeters were found chopped at the top. A line linking the place of the chopped trees and the place where the blades hit the ground had an angle of about 25 degrees downward from the level surface.

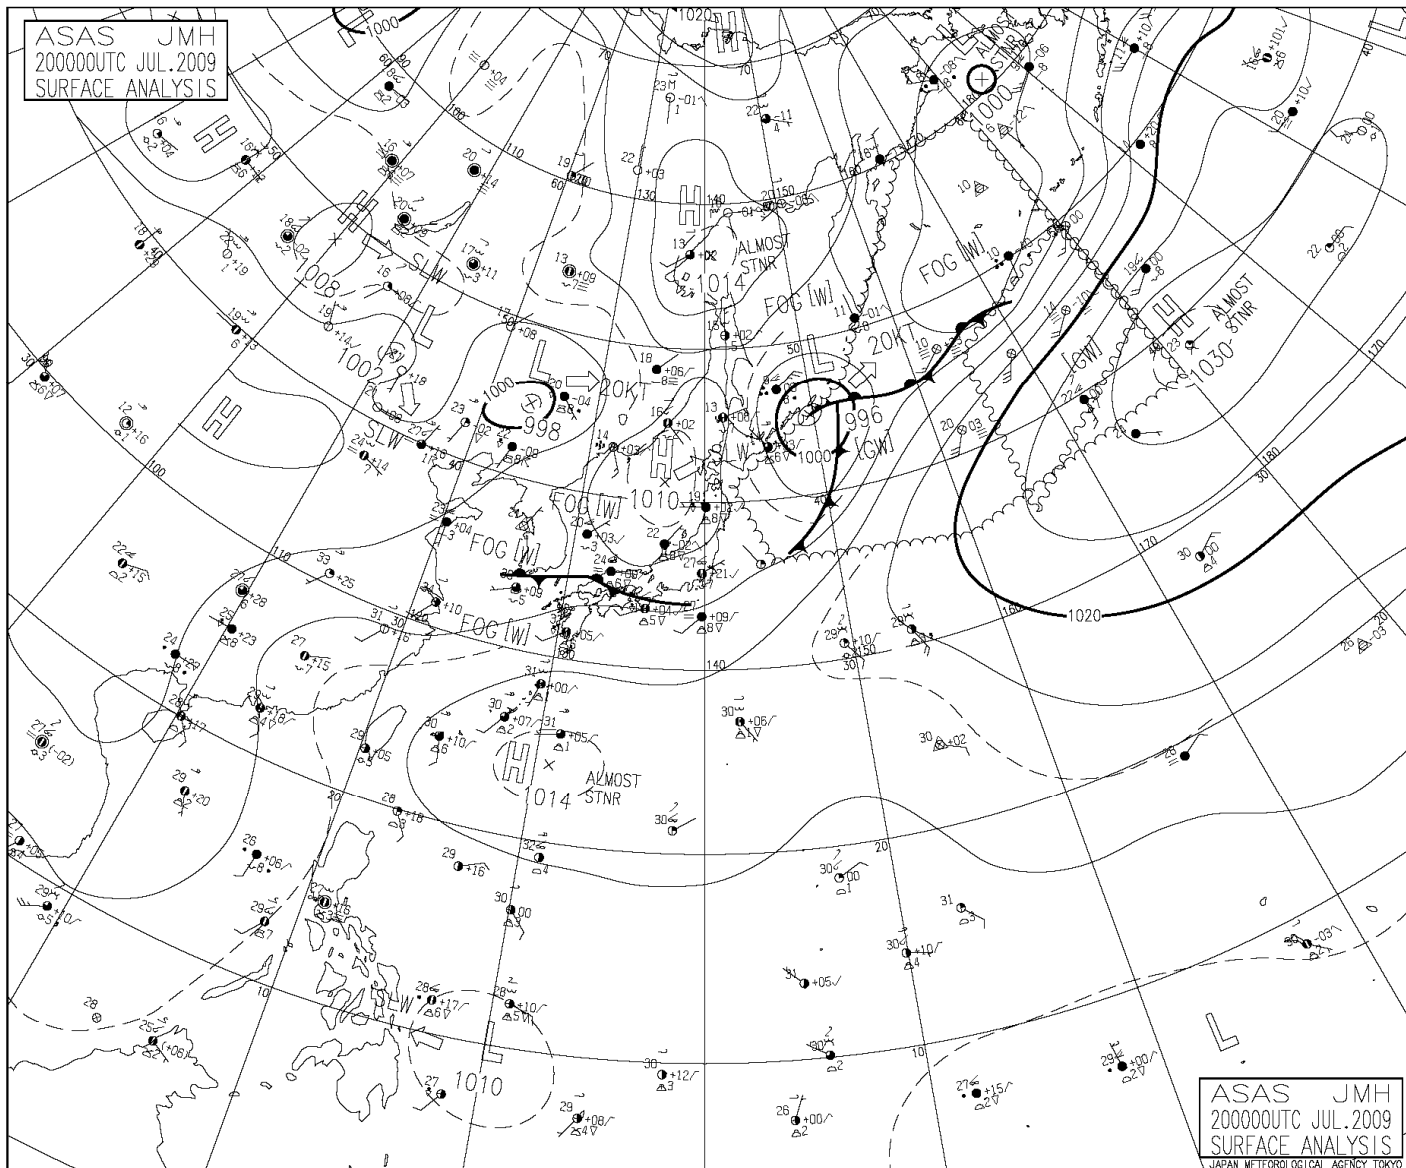
Figure 3 The Asia-Pacific Surface Analysis Chart (0900JST 20 July)

Asia-Pacific Surface Analysis Chart as of 09:00 on July 20 indicated the “Baiu” rain front extending from the Yellow Sea to western Japan, which was seen almost stationary. The 850 hPa and 700 hPa weather charts showed the whole of western Japan was covered by a humid air area. As the tip of the area extended to the Kinki region, the weather condition was highly likely to create clouds. A cloud imagery by a geostationary meteorological satellite indicated the whole of western Japan was enveloped by many layers of clouds over a wide area.

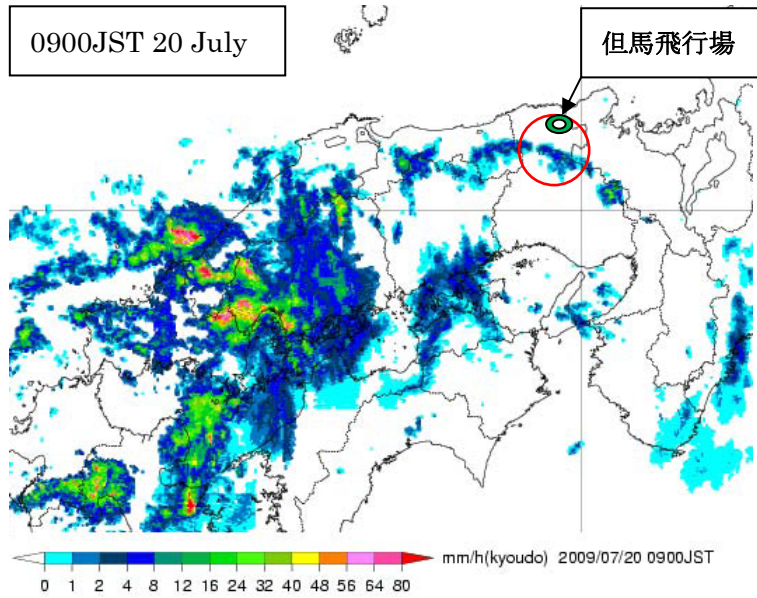
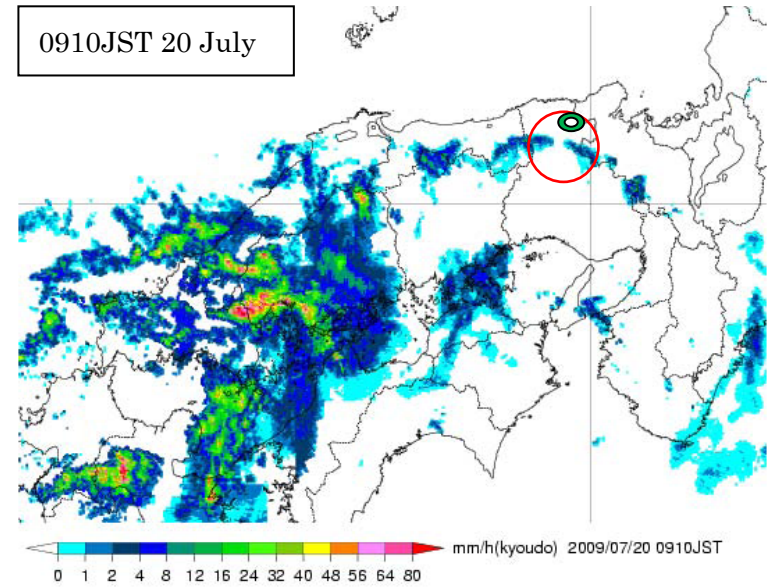
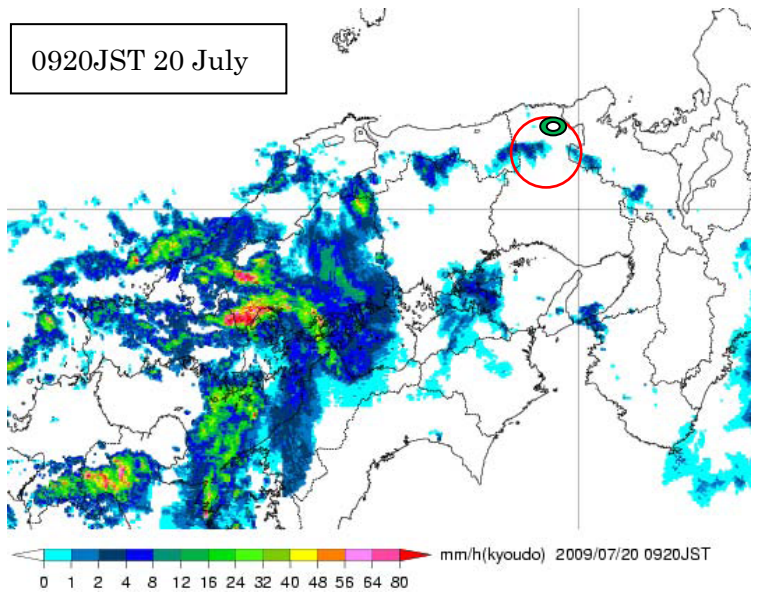
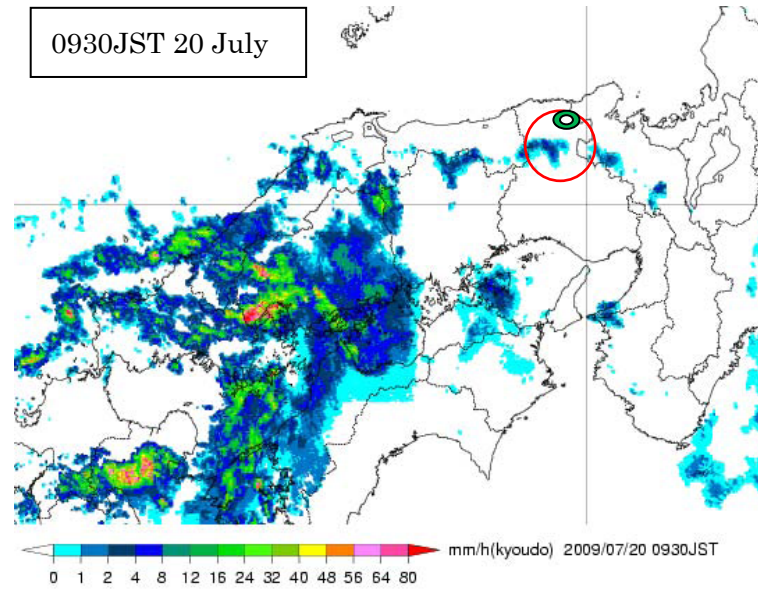
Figure 4 The Radar Echo Charts

Radar observation data and echo intensity (hereinafter referred to as “the Radar Echo Chart”) for the day of the accident indicates a strong echo area believed to have been caused by cumulonimbus existed mainly over Yamaguchi Prefecture. But the echo intensity was relatively weak at less than 6 millimeters an hour in the Sea of Japan coast areas from Tottori to Hyogo prefectures. According to the radar echo chart around the time between the beginning of communications between the Aircraft and Osaka FSC and the occurrence of the accident, at 09:00, a long echo area with a relatively weak reading of 0 to 4 millimeters an hour was lying from the east to west 15 kilometers south of the Tajima Airport and moving slowly to the east. At about 09:20, the time when the captain started communications with the Flight Service, the echo area observed exactly to the south of the Tajima Airport had temporarily disappeared and became so weak that it could not be shown up on the radar screen. At about 09:30, the time when the Aircraft is believed to have crashed into the mountain, an echo area was moving from the west to the south side of the Tajima Airport or to the southeast side of the Tajima Airport, which is in the direction of the accident site. The cloud top height of the echo was at about 6 to 8 kilometers.

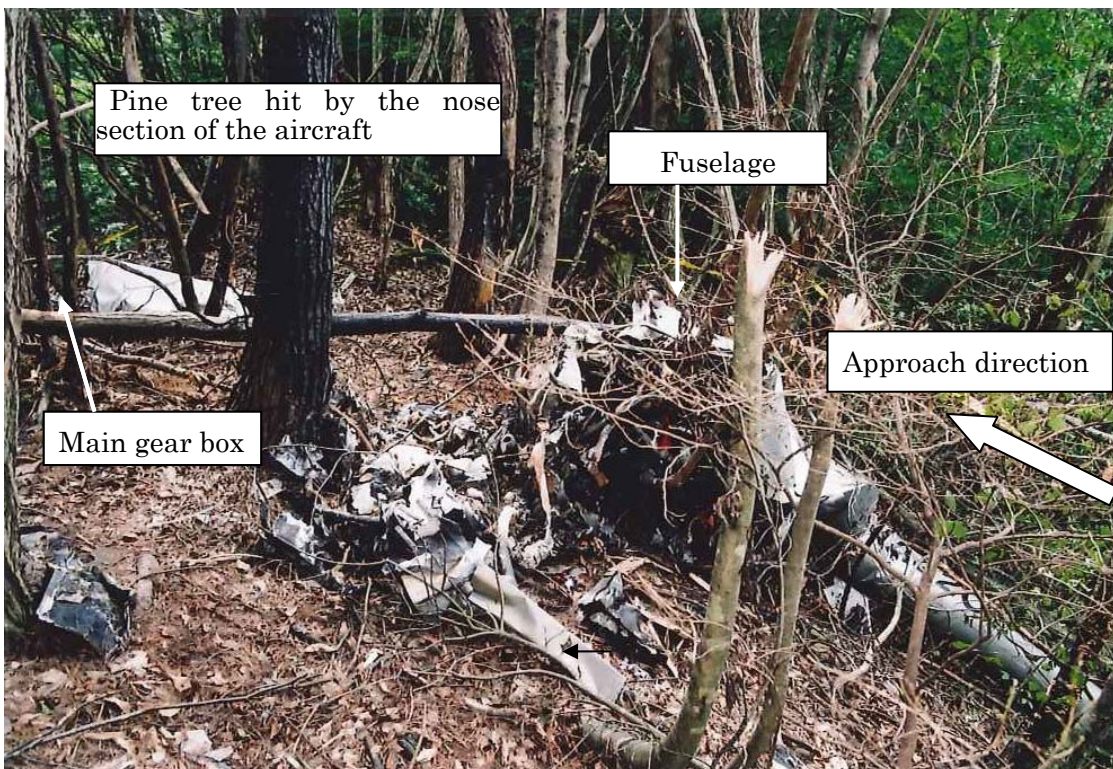
Photo 2 Wreckage of Accident Aircraft

The whole sections were extensively damaged with the original shape unseen. The nose section was burned out by a fire and a part of it was burned down.

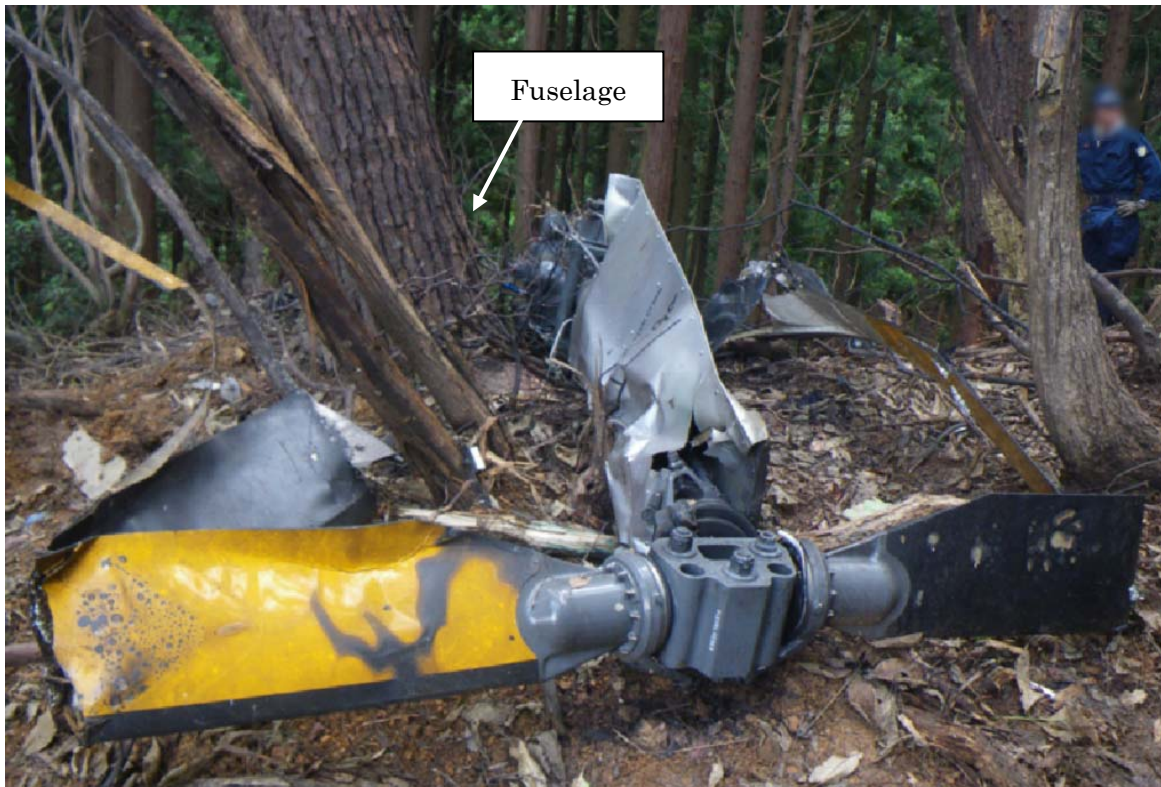
Photo 4 Main Rotor Blades

The red blade was found bent at a distance of 180 centimeters from the joint.

The black blade was found bent at distances of 65 and 235 centimeters from the joint.

Both blades were found partially broken and torn apart in the honeycomb structure section.

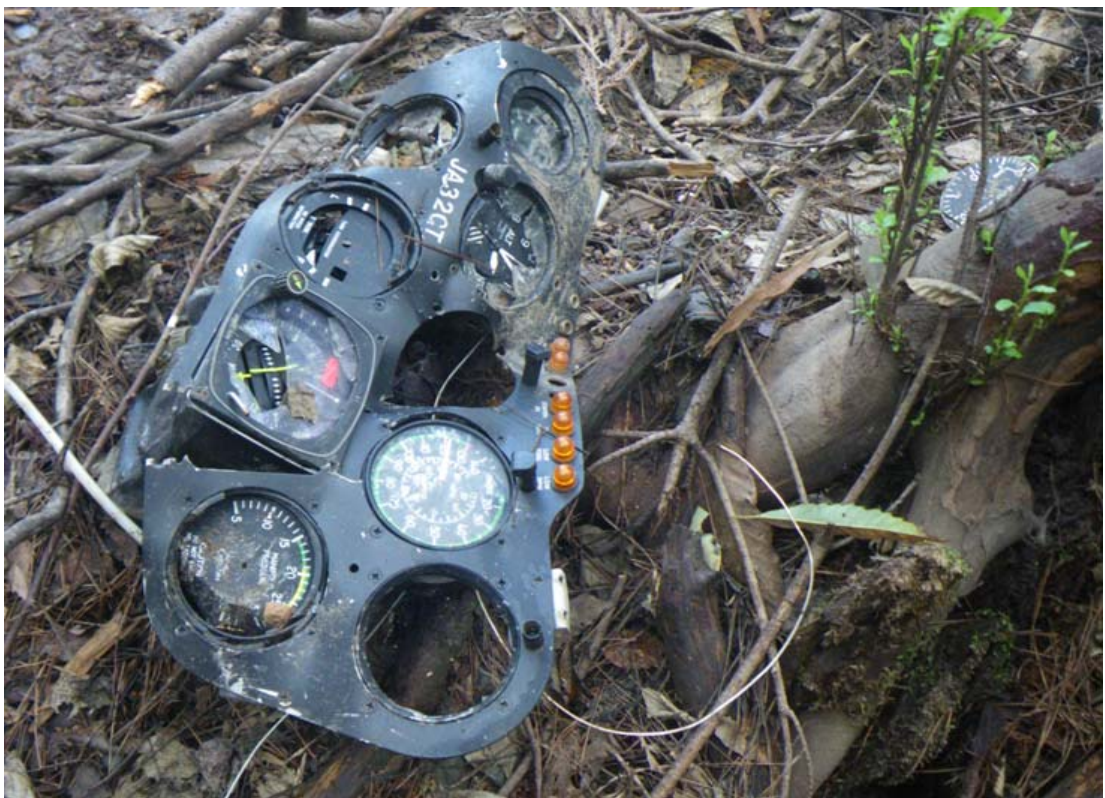
Photo 6 Instrument Panel

A teardown inspection and function checks of instruments revealed many places of damage, but these were all parts damaged due to the impact at the time of the accident. There were no problems and defects regarding components which may be linked to the cause of the accident. The outline of the results of the inspection is as follows:

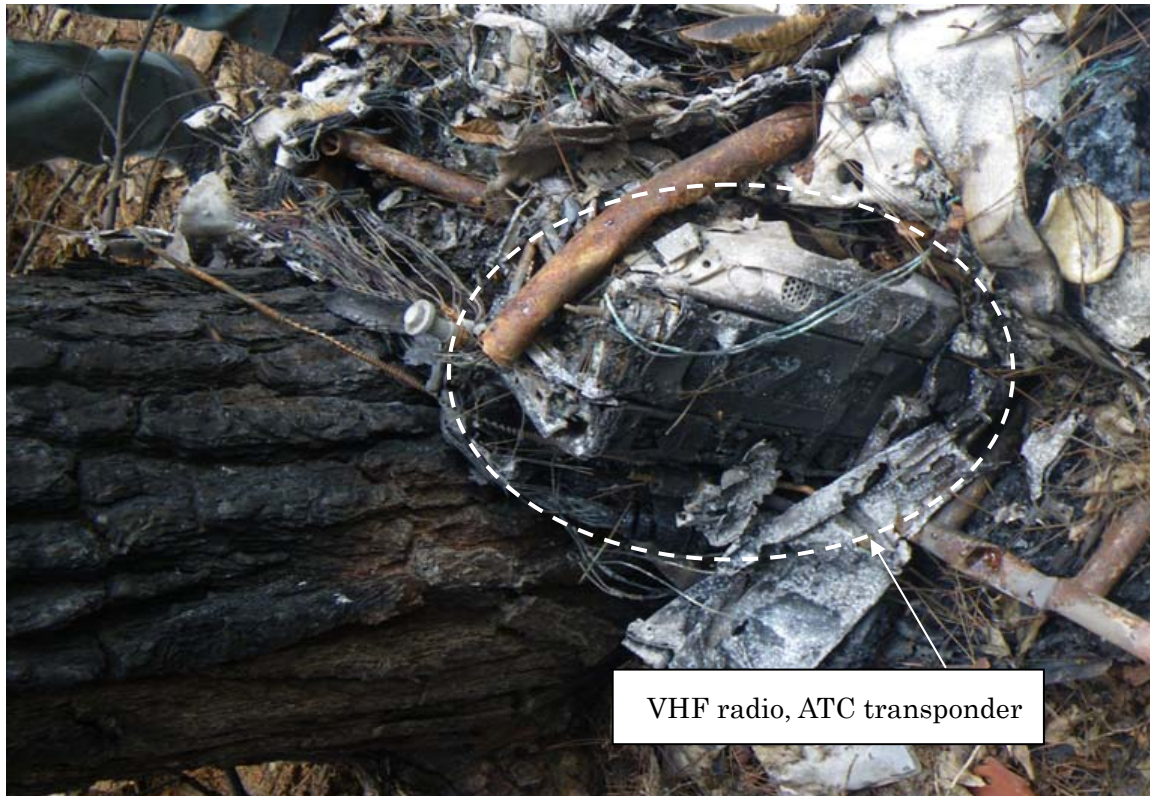
Photo 7 Radio Instruments

(1) VHF transmitter/receiver	Burned out
(2) VOR receiver	Burned out
(3) ILS receiver	Burned out
(4) ATC transponder	Burned out
(5) ELT	Burned out
(6) GPS receiver (GNS430)	Burned out

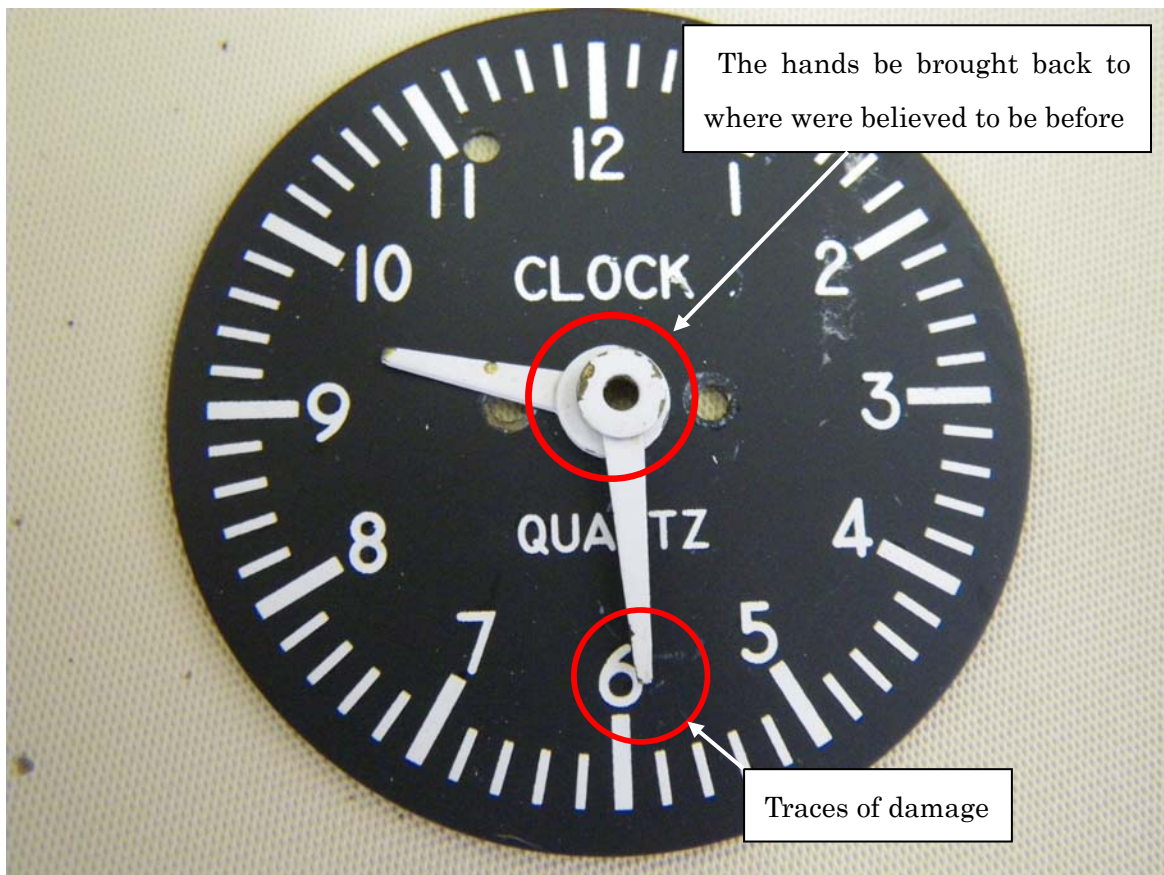
Photo 8 Clock and Hands

The hands were found displaced inside. When stains and scratches left on the dial were matched to traces of damage and scratches on the hands so that the hands may be brought back to where they were believed to be before, the time proved to be around 09:30.

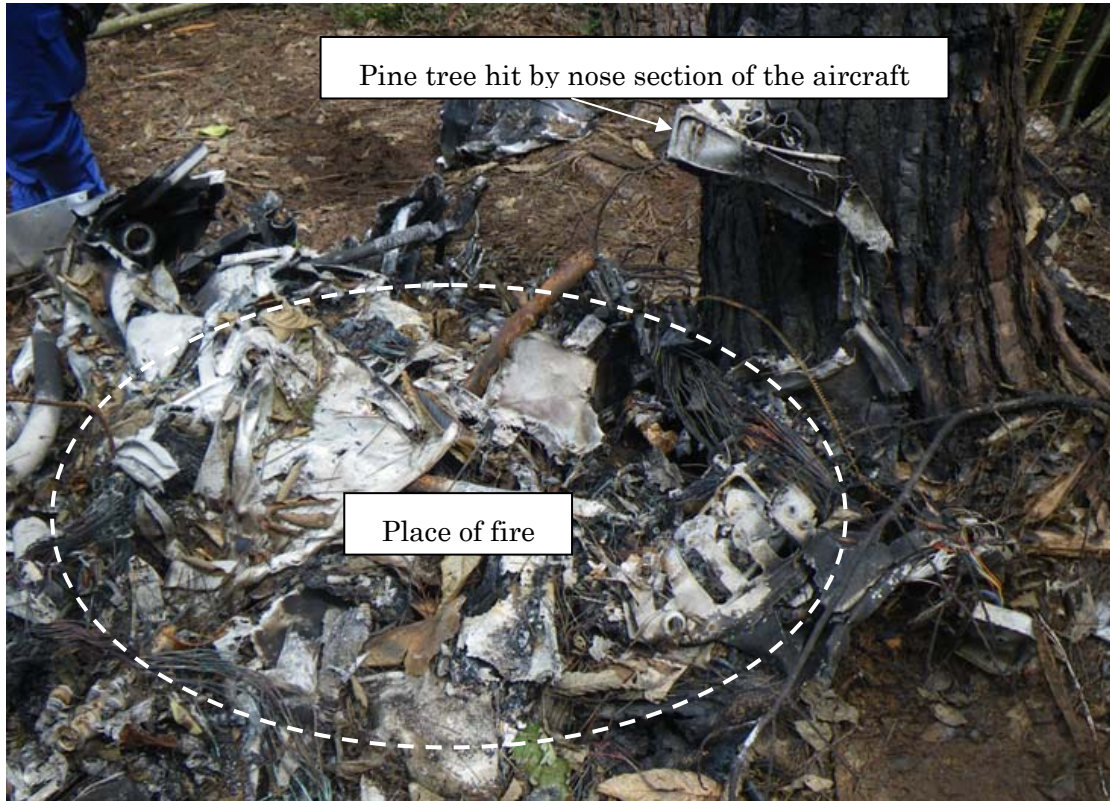
Photo 9 Pine Trees Hit by the Accident Aircraft

Judging from the condition of the chopped top parts of trees at the accident site, it is considered highly probable that the Aircraft came from the direction of north-northwest and crashed into a slope with a height of about 1,700 feet, with no time to avoid a collision with the ground. The chopped parts of trees cut down by the Aircraft had an angle of about 25 degrees downward.

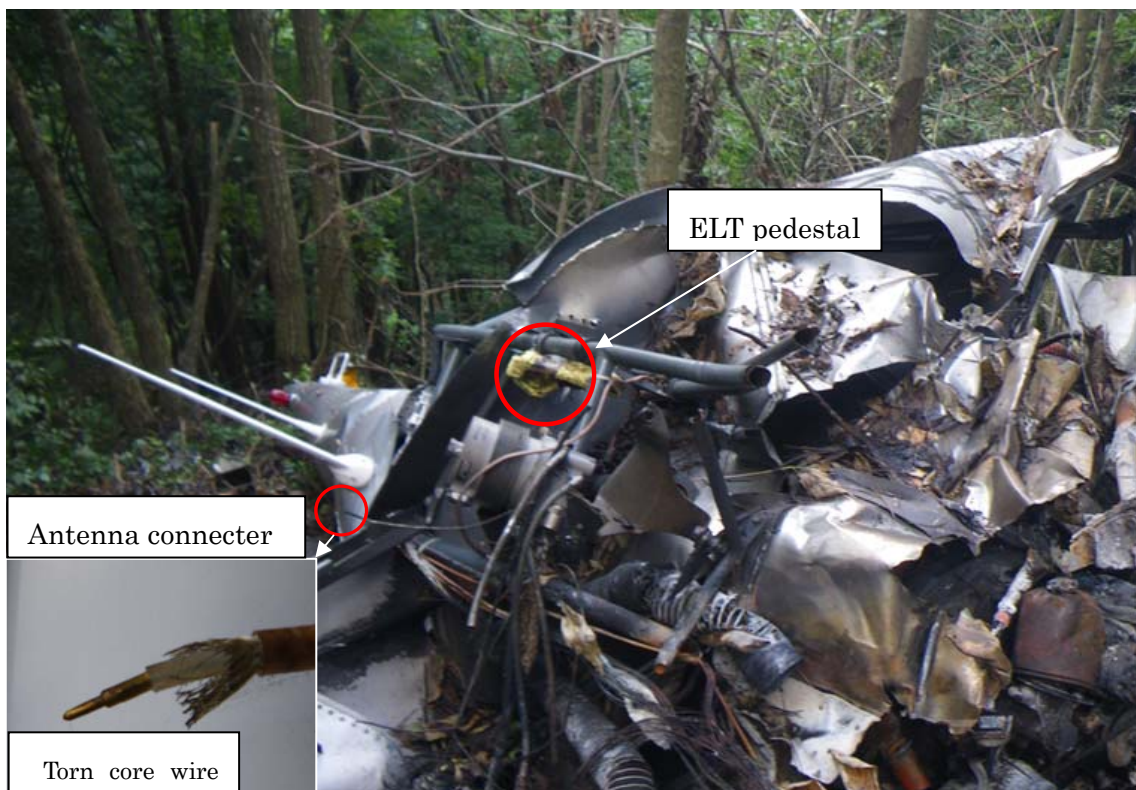
Photo 10 ELT

The Aircraft was equipped with an emergency locator transmitter (hereinafter referred to as "ELT\*<sup>1</sup>"). Regarding the ELT, the core wire of the cable linking the body to an antenna was found cut off on the side of the connector for the antenna joint. The ELT itself was burned out and the condition of batteries and others could not be examined. Any distress signals were not received by the search and rescue satellite system (Cospas-Sarsat) and airplanes which happened to be flying nearby around the time when the accident occurred.

ELTs are so designed as to send emergency signals when they are activated on the strong impact of crashes. But no emergency signal was received from the Aircraft despite the fact that the Aircraft crashed into the ground from the nose. Judging from the condition of the damaged connector part of the cable that links the ELT itself to the antenna, as described in 2.9.2 (1), it is considered highly probable that when the Aircraft crashed into the mountain, the section of the ELT near the antenna was destroyed and the core wire inside was torn apart, making it impossible to send out an urgency signal. In addition, it is considered somewhat likely that a weak signal was sent till ELT was damaged by fire if it was operated, even if the cable had been cut off.

As described in 2.9.2 (2), rules such as those of the U.S. Federal Aviation Administration call for attaching an ELT to the aircraft at a place where damage to the equipment may be minimized. But as far as small aircraft, such as the Aircraft in this case, are concerned, the places where ELTs can be installed are limited due to structural reasons. As a result, it is considered highly probable that ELTs cannot be protected against all types of accident. In this accident, the Aircraft crashed into the mountain at a high speed and the main gearbox was broken and displaced. It is considered probable that damage to ELT antennas cannot be avoided in this kind of accident. But in general, it is considered probable that when ELTs are installed, maximum possible attention must be paid to not only the place of the transmitter but also that of its antenna so that damage of a crash may be minimized.
