**AIRCRAFT ACCIDENT  
INVESTIGATION REPORT**

## DAMAGE TO AIRCRAFT DUE TO OVERRUNNING AFTER REJECTED TAKE-OFF SEMINE TEMPORARY AIRFIELD KURIHARA CITY, MIYAGI PREFECTURE, JAPAN AT ABOUT 16:00 JST, OCTOBER 8, 2017

PRIVATELY OWNED BEECHCRAFT E33, JA3447

December 21, 2018

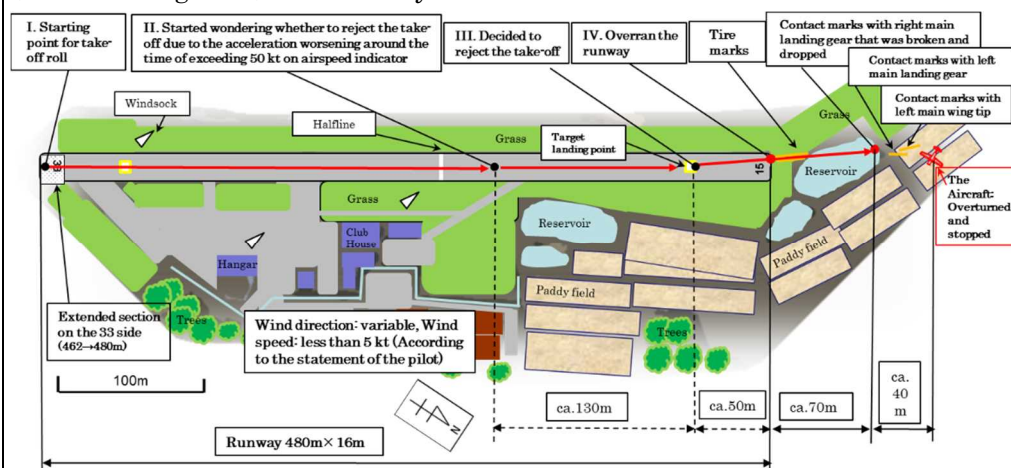
Figure 1 The Airfield layout and Estimated Flight Route

At about 15:58 Japan Standard Time (JST; UTC + 9 hrs), the pilot determined there was almost no wind by checking the windsock at the Airfield, commenced a take-off roll with flaps up and full throttle from the end of the take-off and landing zone (hereinafter referred to as “the Runway”) 33 according to the take-off procedures in the flight manual. (See I. in Figure 1) About the time when the Aircraft passed halfway of the Runway (halfway line) (see II. in Figure 1), the airspeed indicator showed 50 kt but, about the time when exceeding that speed, the acceleration was getting worse. As not seeing any abnormality in the engine output, the pilot suspected that changing to a tail wild might have an effect on it, while wondering whether to reject the take-off for a few seconds, the Runway end was looming ahead. (See II. To III. in Figure 1) The pilot decided to reject the take-off when the Aircraft passed around the target landing point (touchdown point) (III. in Figure 1), hastily positioned the throttle lever to idle and applied brakes, but the Aircraft overran (see IV. in Figure 1) the Runway.

It is somewhat likely that the pilot assumed from his previous experience at the Airfield that the Aircraft would exceed 60 kt and reach close to the take-off speed around the position passing the halfway line (II of Figure 1 and Figure 4). It is also somewhat likely that although the Aircraft's airspeed indicator readings were still at around 50 kt around that position, he was not well aware of the Aircraft's overweight affecting the take-off performance, therefore he did not come up with the effects of overweight even though its acceleration was insufficient, and mistakenly took it that a tail wind affected the Aircraft.

It is probable that as the remained distance to the Runway end was reduced, the pilot judged it as difficult to continue the take-off procedures and decided to reject the take off when the Aircraft passed around the target landing point (III in Figure 1 and Figure 4). It is highly probable that the remained distance to the Runway end was about 50 m and its speed exceeded 60 kt at this position (III in Figure 1 and Figure 4), at which according to the pilot, the Aircraft' speed also exceeded 60 kt; therefore, the Aircraft was not able to stop within the Runway and overran the Runway.

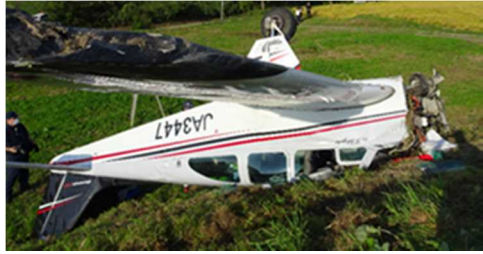
Photo 1 the Aircraft seen after the accident

<p>the left side of the Runway, but the Aircraft was heading toward the reservoir (hereinafter referred to as “the Reservoir”) ahead of the Runway end. The pilot maneuvered to veer to the left side so as not to fall into the Reservoir, but the Aircraft passed over the Reservoir and touched down on the edge of the Reservoir, after that he did not know what was going on, and when he realized, he found the Aircraft upside down with its engines stopped. The two persons seated in the front evacuated to the left side of the Aircraft, and the two persons seated in the aft to its right side.</p> <p>According to the statements of rescue workers who rushed to the accident site, there was almost no wind in the vicinity of the end of the Runway 33.</p> <p>This accident occurred at about 16:00 on October 8, 2017, at Semine Temporary Airfield in Kurihara City, Miyagi Prefecture (38° 40’ 56” N, 141° 01’ 08” E).</p>																											
2.2 Injuries to Persons	One passenger was seriously injured.																											
2.3 Damage to Aircraft	<p>Extent of damage: Destroyed</p> <ol style="list-style-type: none"> <li>1. Nose section: <ul style="list-style-type: none"> <li>Propellers: Damaged, Nose gears: Damaged,</li> <li>Engine mount and Keel: Damaged</li> </ul> </li> <li>2. Both main wings: Damaged</li> <li>3. Right main landing gear: Broken</li> <li>4. Fuselage and Cockpit: Damaged</li> <li>5. Vertical stabilizer: Damaged</li> </ol>																											
2.4 Personnel Information

It is highly probable that running on the grass land at a speed of over 60 kt, the Aircraft continued to run with the airframe contacting with the rough surface such as steps of the Reservoir and others while being broken, rolling over to a paddy field in front of the Runway end, and suffered damage to its airframe.

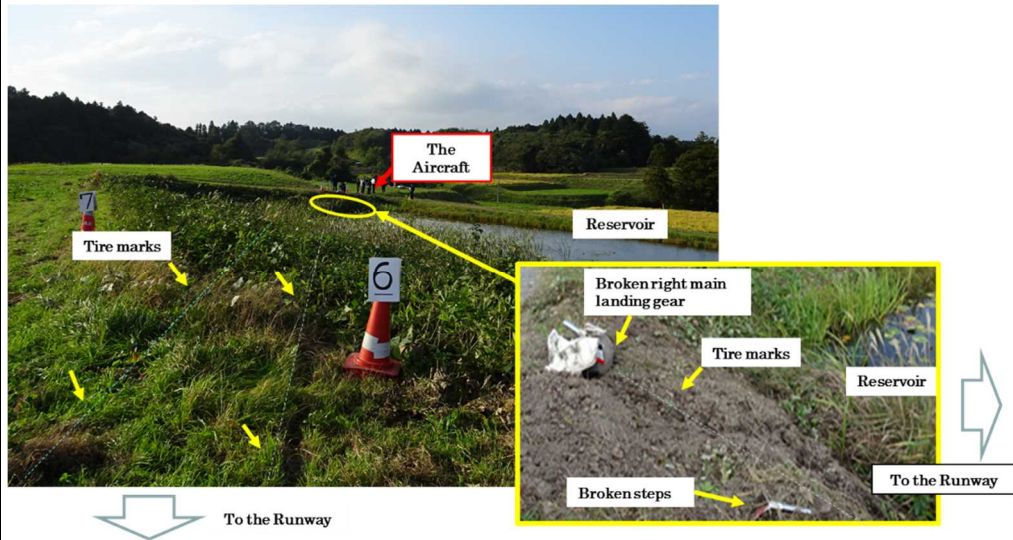
Time	Wind direction	Wind speed kt	15:50	South-southeast	0.5 kt	16:00	South	1.5 kt
Time	Wind direction	Wind speed kt								
15:50	South-southeast	0.5 kt								
16:00	South	1.5 kt								
2.7 Accident Site	<p>The Airfield is located about 60 km north of Sendai Airport, with an elevation of 171 ft, having the Runway 15 / 33 of 480 m in length and 16 m in width.</p> <p>There were no brake marks confirmed on the Runway. The tire marks continued from the grass area in front of the Runway end to the area short of the Reservoir.</p> <p>There were contact marks with the right main landing gear on the Reservoir edge, over which it was found that the broken right main strut and boarding steps dropped. A little ahead from there, the contact marks with the left main landing gear and the left main wing tip were found. (See Figure 1 and Figure 2.)</p>

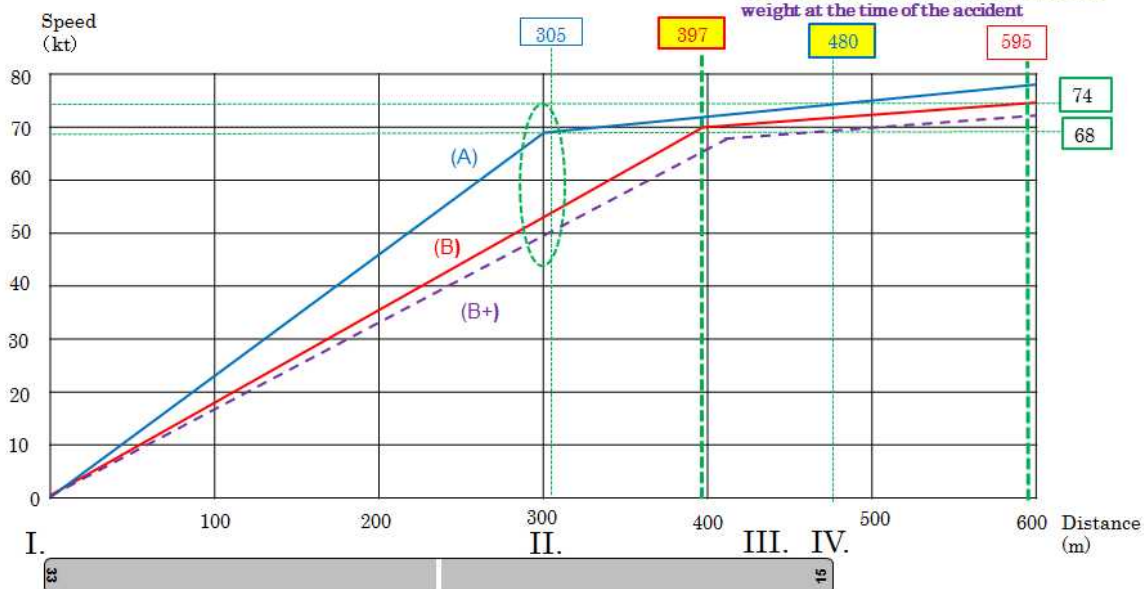
Figure 4 Required distance under each take-off condition and take-off speed

As shown in "(B) No-wind during take-off with the weight at the time of the accident" in Figure 4, based on the Performance charts of the flight manual of the Aircraft, the take-off run is 397 m that is less than 480 m (the Runway length at the Airfield), but the take-off distance is 595 m that is greatly over the Runway length at the Airfield.

It is probable that the pilot did not accurately grasp the fact that the take-off distance of the Aircraft greatly exceeded the Runway length at the Airfield, and continued take-off rolling by assuming that the Aircraft would be able to lift off within the remained distance on the Runway, leading to a delay in making a decision of rejecting the take-off.

It is also highly probable that the reason why the Aircraft overran the Runway was because the weight of the Aircraft exceeded the weight with which the Aircraft would be able to safely take off within the range of the Runway length at the Airfield, and the remained distance to the Runway end was reduced, leading to a delay in making a decision of rejecting the take-off.

Do not depart without the confirmation by the pilot in command before departure that is essential for the safety. This lesson was also given in the safety operations seminars that the pilot regularly participated in, however, he did not consider it by reflecting on his own flight, and not confirm before

<p>departure that the weight of the Aircraft should meet the performance requirements stipulated in its flight manual. As described in 2.8 (6), the JCAB has disseminated the information related to ensuring the confirmation before departure to small aircraft pilots in order to prevent similar accidents. It is desirable for those pilots to follow these advices, as well as to understand these precautions by reflecting on their own flights and to improve their expertise and pilotage when participating in the safety operations seminars.</p>
--	---
