AI2019-3

**AIRCRAFT SERIOUS INCIDENT
INVESTIGATION REPORT**

**PRIVATELY OWNED
JA3500**

STOP OF ENGINE IN FLIGHT PRIVATELY OWNED, CESSNA 172K, JA3500 AT AN ALTITUDE OF ABOUT 1,500 FT (ABOUT 500 M) OVER ISHIKARI CITY, HOKKAIDO, JAPAN AT ABOUT 18:50 JST, OCTOBER 6, 2017

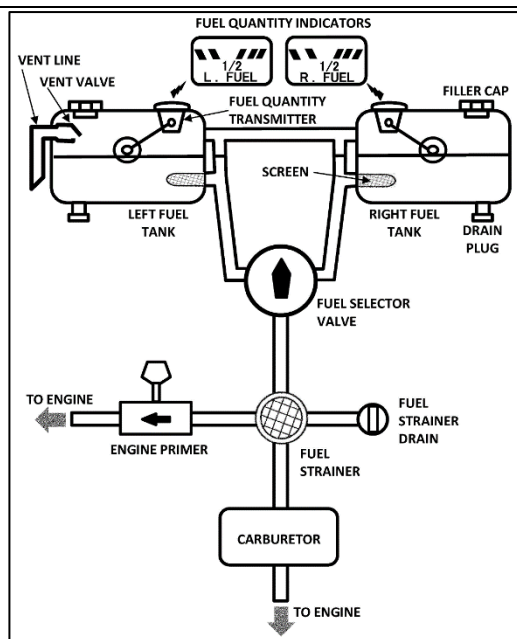
Figure 2 Fuel System

- There was a small amount of water on the bottom of the strainers.
- The vent line in the left fuel tank was not clogged and the vent valve also worked normally.
- The malfunction, such as restricting the fuel flow of the fuel lines from the fuel tanks of the left and right to the carburetor, could not be confirmed.

fuel tanks during pre-flight check, because the deterioration of the sealant applied to the edge of the caps might allow rain water to enter around from the fuel filler caps, and the rain water was not fully drained, which resulted in the engine stop with the water entering in the fuel system.

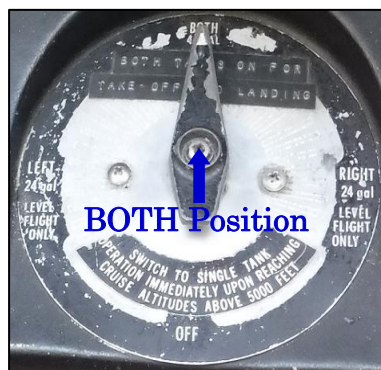
Photo 1 Selector Lever

On the other hand, excessive play parts were confirmed at the hinges (2 places) of the mechanical linkage connecting the selector valve body and the selector lever. On this account, merely selecting the predetermined position by rotating the selector lever would not accurately transmit the rotation motion to the selector valve body via the mechanical linkage, and the valve body was not set in the

<p>intended detent position (a dent in the detent). However, it was possible to set the selector valve body in the detent position by greatly rotating the selector lever beyond the range of the play parts, and it was able to confirm that the selector valve was set in the detent position.</p> <p>How to operate the selector valve is described on the placard of selector valve as follows: “<i>Both tanks on for takeoff and landing</i>”, “<i>Switch to single tank operation immediately upon reaching cruise altitudes above 5,000 ft</i>”. The captain was always flying with the selector valve set in the BOTH position.</p> <p>The captain had left the aircraft’s selector valve in the BOTH position even on the ground, taking into account the circumstances where a one-sided fuel load between tanks would occur at the time of supplying fuel.</p> <p>Neither did the captain nor the passenger remember if they had operated the selector lever except when trying to restart the engine during the flight.</p> <p>(4) Maintenance of the fuel systems</p> <p>The maintenance manual of the aircraft describes the maintenance of the fuel systems as follows: (Excerpt)</p> <ul style="list-style-type: none"> ·Condition inspection of fuel selector valves ······ each 50 hours ·Condition inspection of fuel filler caps ·········· each 50 hours <p>According to the maintenance record of the aircraft, maintenance was carried out in accordance with the maintenance manual set by the aircraft manufacturer.</p> <p>In addition, the selector valve body was replaced with the overhauled valve on June 10, 2017 due to the fuel leak from the valve body.</p> <p>(5) Forced landing site</p> <p>The forced landing site was a flat sand beach facing Ishikari Bay with no big obstacles.</p>

It is probable that there were excessive play parts at the hinge parts of the mechanical linkage connecting the selector valve body and the selector lever, the selector valve was not set in a normal detent position of BOTH; and as the selector valve was moved to the side of the right fuel tank, the fuel flowed from the right tank, which led to an one-sided reduction in fuel between tanks. In addition, judging from the facts that the fuel in the left tank was almost unconsumed, and that there was no malfunction such as restricting the fuel flow of the fuel lines from the fuel tanks of the left and right to the carburetor, it is also somewhat likely that the selector lever was set in the position to restrict the fuel flow from the left tank and the fuel in the left tank was not consumed.

About 49 years had passed since the aircraft was manufactured, therefore, it is probable that there was excessive play parts in the mechanical linkage due to the hinges worn after long-term use.

It is somewhat likely that the captain and the passenger could have prevented from the one-sided reduction in fuel between tanks if they had confirmed not only the position of selector lever by checking visually but also the detent position of the BOTH by actually operating the selector lever during pre-flight check.

According to the maintenance record of the aircraft, maintenance was carried out in accordance with the maintenance manual set by the aircraft manufacturer, however, it is probable that the selector valve was used as it was because it was able to confirm that the selector valve was set in the detent position, and there was no problem in terms of function. It is natural for users to perform maintenance on the aircraft when a malfunction is found, but it is important to make efforts to perform the preventive maintenance, if required, even when excessive play parts are confirmed in selector lever and others.

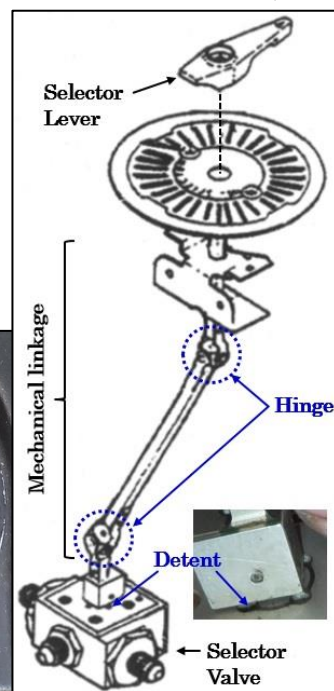
Figure 3 Selector Valve

The selector valve body and the selector lever are connected by a mechanical linkage. When the selector lever is set to the left position, the fuel is supplied from the left wing fuel tank, and when the right position is selected, the fuel is supplied from the right wing fuel tank. When it is set to the BOTH position at the center, the fuel is supplied from the right and left fuel tanks.

In the investigation of the aircraft, the selector lever was at the BOTH position, there was no abnormality in the operation of the selector valve, and no foreign matter or abnormality causing clogging inside the valve could be confirmed.
